Avian Electrocutions on Incorrectly Retrofitted Power Poles

Authors: Dwyer, James F., Harness, Richard E., and Eccleston, Duncan

Source: Journal of Raptor Research, 51(3) : 293-304

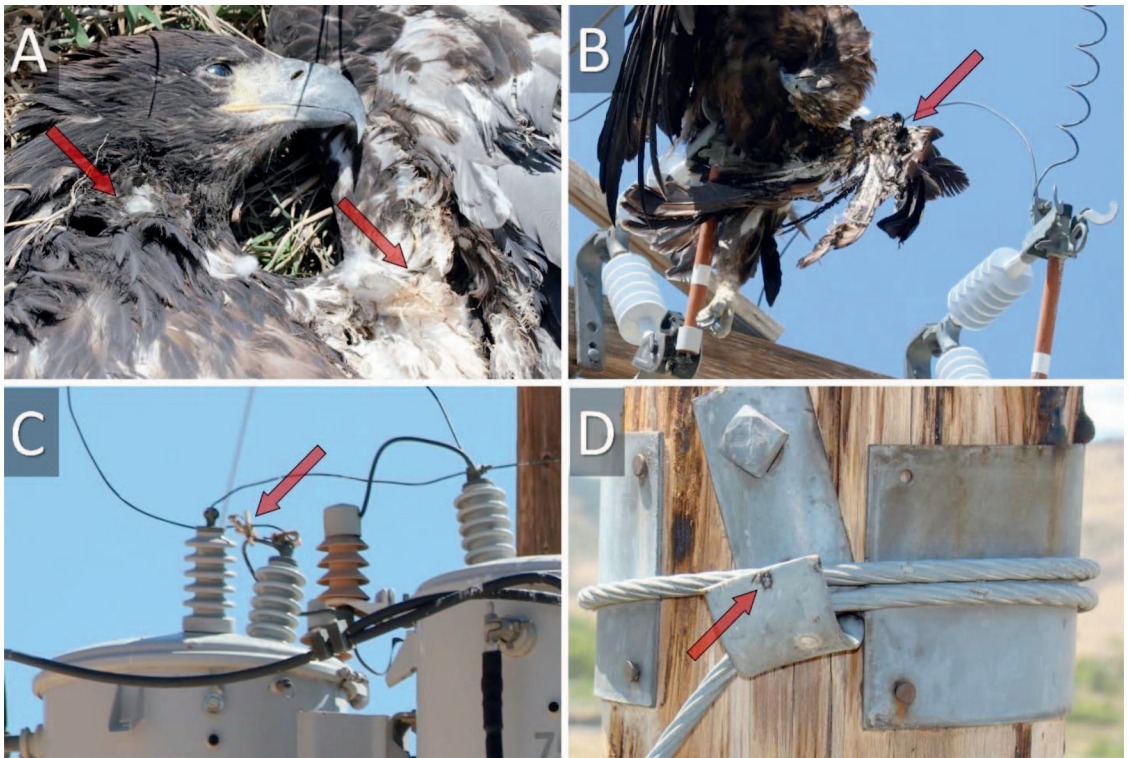
Our evaluations involved identifying burns on carcasses (Kagan 2016) and pole components to confirm electrocution as the cause of death, and to determine contact points between birds and pole components (Fig. 3A; Dwyer 2004, Hurmence and Harness 2004, Viner et al. 2014). We identified species from whole carcasses, or parts of carcasses on pole-mounted equipment (Fig. 3B, C; Cartron et al. 2005, Dwyer 2004), arc marks on equipment (Fig. 3D), and gaps in insulation (see results). In some cases, such as the case illustrated in Fig. 3C, species identifications were impossible. In these situations,

Figure 3. (A) Burns on the neck and axillary feathers of the carcass of an electrocuted Bald Eagle. (B) Burns on the left wing of the carcass of an electrocuted Golden Eagle suspended on energized equipment. (C) The feet of an unidentified electrocuted *Buteo* species grasping an energized jumper. (D) Arc mark on a grounded guy wire connection following the electrocution of a Bald Eagle.

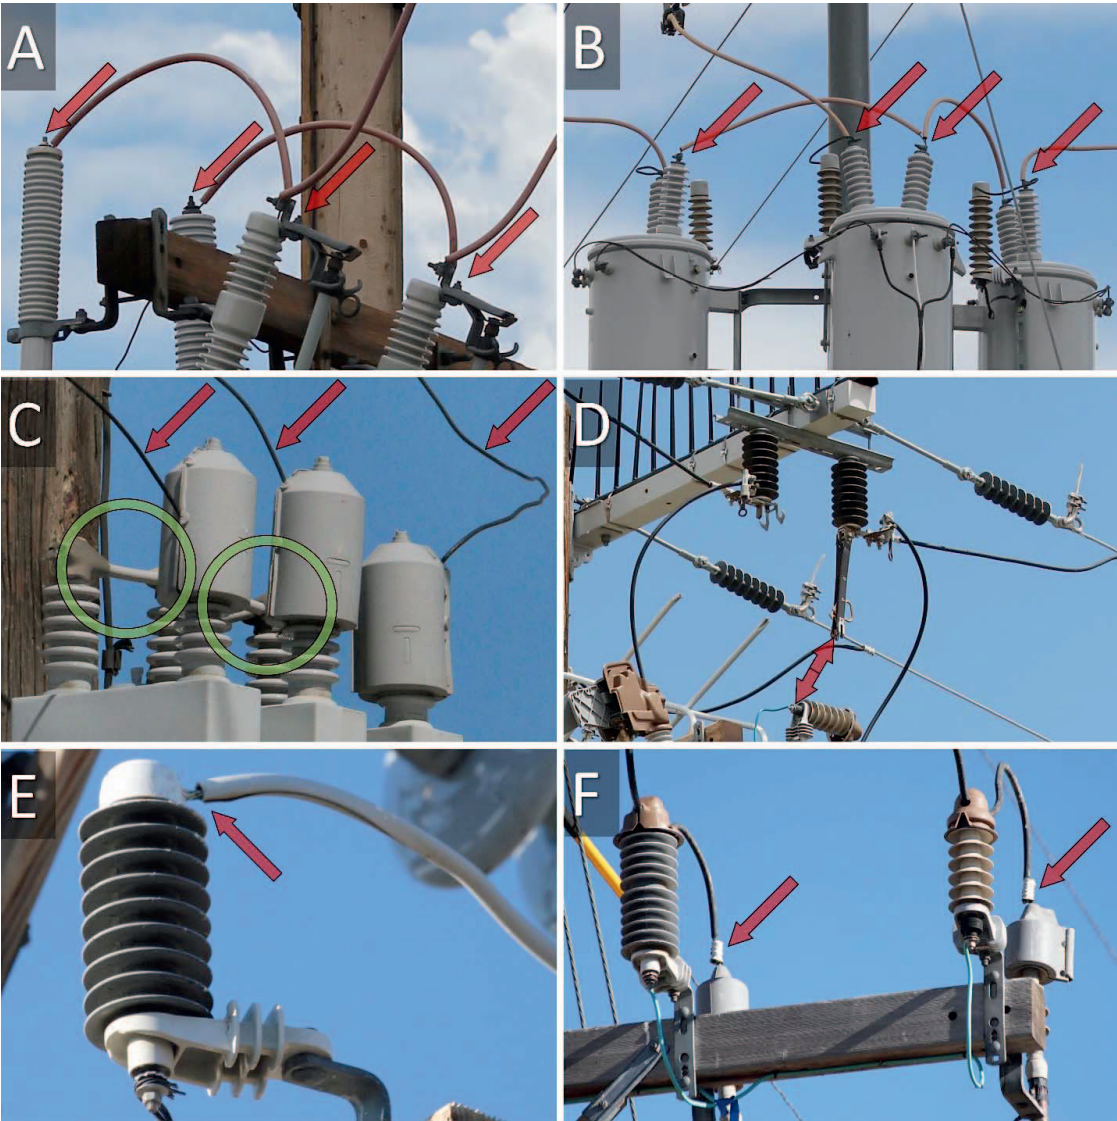
Mitigation plan errors were most frequent, followed by application errors, and product design errors. Components involved in electrocutions differed by error type (Table 3), but all resulted from inadequate insulation. Product design errors occurred when covers did not fully cover all energized parts of the tops of cutouts (Fig. 4A), and when covers fell off (Fig. 4B, C). Among mitigation plan errors, the most common errors were failures to specify covers for all energized equipment and all energized jumpers on poles. We identified omissions of one or more conductor covers and deadend covers (Fig. 4D, E, F), cutout covers and arrester covers (Fig. 5A), bushing covers (Fig. 5B), and jumper covers (Fig. 5C). Mitigation plan errors also occurred where vertical clearances were not adequately considered (Fig. 5D). Application errors consistently resulted from gaps in jumper coverage (Fig. 5E, F).

Figure 5. Arrows indicate retrofitting errors. (A) Mitigation plan error: jumpers covered, but arrester covers (left arrows) and cutout covers (right arrows) absent. (B) Mitigation plan error: jumpers and arresters covered, but bushing covers not installed. (C) Mitigation plan error: bushings and jumpers between bushings (circles) covered, but jumpers exposed above (arrows). (D) Mitigation plan error: insufficient clearance between open switch above and grounded arrester connection below. Redirection materials on the upper crossarm may also push birds into perching near energized components on the lower crossarm. (E) Application error: jumper and arrester covered, but a gap in jumper coverage exists between retrofitting products. (F) Application error: all equipment covered, but gaps in coverage where jumpers connect.

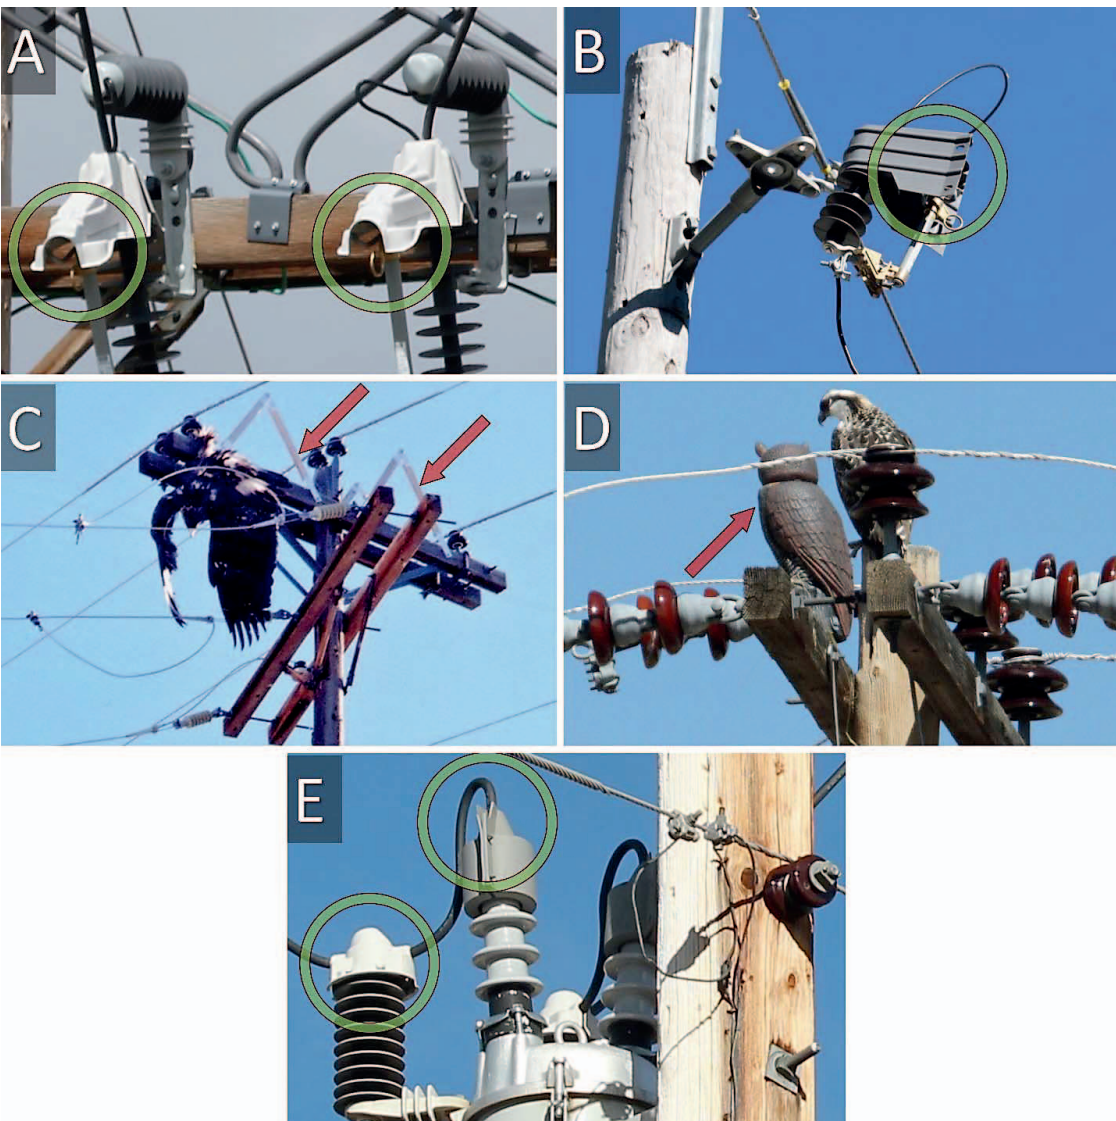
cutout covers that did not cover the entire tops of cutouts have resulted in the development of covers that include greater coverage (Fig. 6A, B). Because many manufacturers state a willingness to work with utilities to refine or develop retrofitting products

Figure 6. Arrows indicate retrofitting errors. Circles indicate correct retrofitting. (A) Cutout covers fully covering all energized parts on the upper portion of cutouts minimize avian electrocution risk. (B) Cutout cover fully covering all energized parts on the upper portion of cutouts minimize avian electrocution risk. (C) Golden Eagle electrocuted on a pole fitted with early model perch discouragers, ineffective in redirecting perching. (D) An Osprey perched next to a plastic owl, ineffective in redirecting perching. (E) Jumper insulation inserted inside insulating covers on arresters and bushings to minimize electrocution risk.

critical link in reducing electrocutions, as demonstrated by shifting retrofitting strategies from largely redirection-based mitigation (Fig. 6C, D) to largely insulation-based products. This change occurred specifically because perch discouragers were not meeting retrofitting objectives on some configura-
