Source: Journal of Raptor Research, 51(3) : 293-304

AVIAN ELECTROCUTIONS ON INCORRECTLY RETROFITTED POWER POLES

JAMES F. DWYER,¹ RICHARD E. HARNESS, AND DUNCAN ECCLESTON
EDM International Inc., Fort Collins, CO 80525 U.S.A.

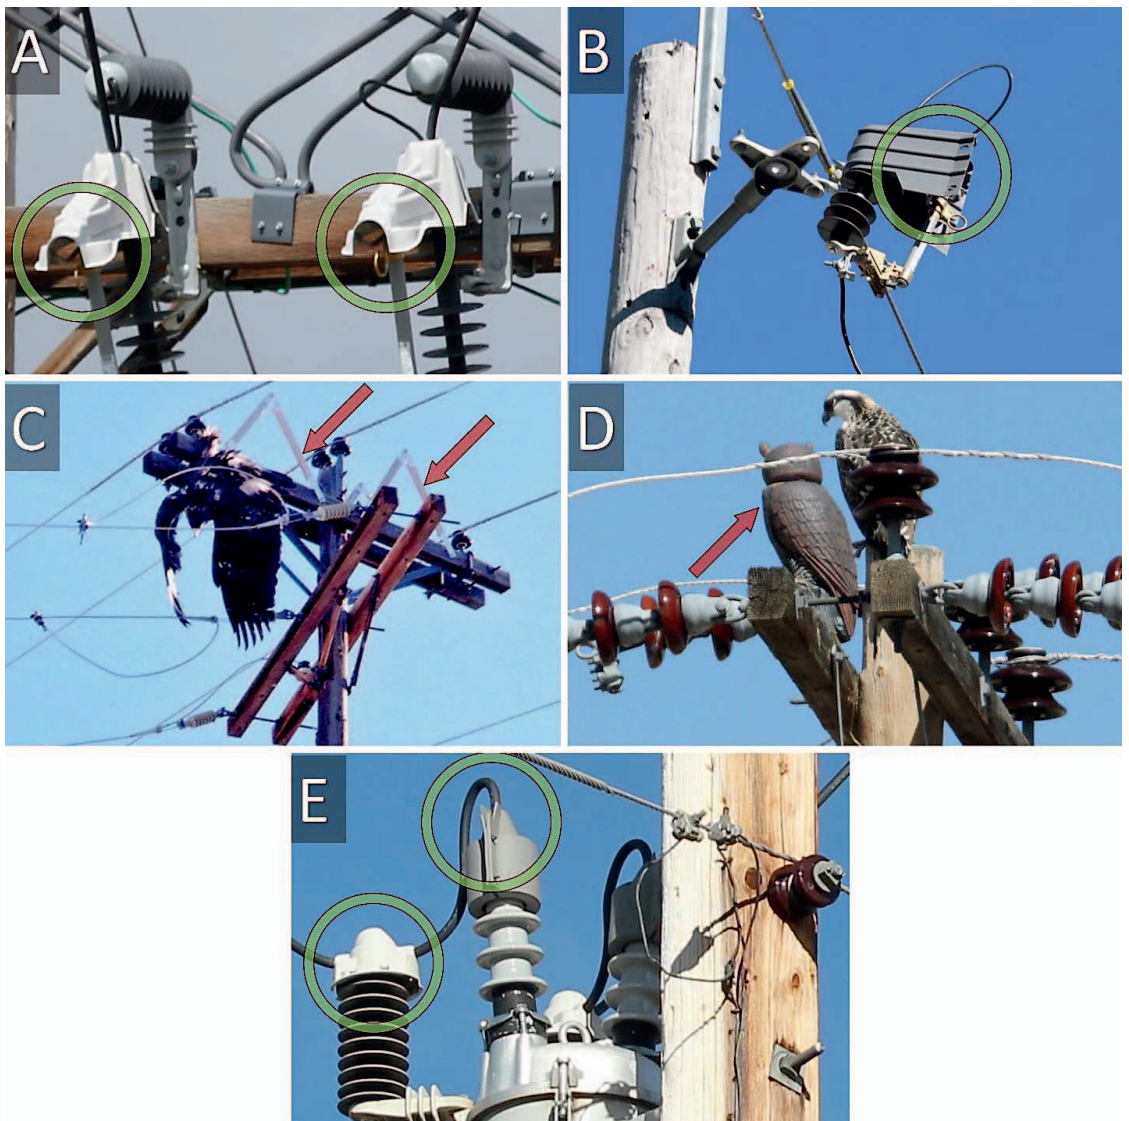
Figure 6. Arrows indicate retrofitting errors. Circles indicate correct retrofitting. (A) Cutout covers fully covering all energized parts on the upper portion of cutouts minimize avian electrocution risk. (B) Cutout cover fully covering all energized parts on the upper portion of cutouts minimize avian electrocution risk. (C) Golden Eagle electrocuted on a pole fitted with early model perch discouragers, ineffective in redirecting perching. (D) An Osprey perched next to a plastic owl, ineffective in redirecting perching. (E) Jumper insulation inserted inside insulating covers on arresters and bushings to minimize electrocution risk.

cutout covers that did not cover the entire tops of cutouts have resulted in the development of covers that include greater coverage (Fig. 6A, B). Because many manufacturers state a willingness to work with utilities to refine or develop retrofitting products

critical link in reducing electrocutions, as demonstrated by shifting retrofitting strategies from largely redirection-based mitigation (Fig. 6C, D) to largely insulation-based products. This change occurred specifically because perch discouragers were not meeting retrofitting objectives on some configura-
