Hydropower-Induced Land Use Change in Fincha'a Watershed, Western Ethiopia: Analysis and Impacts

Source: Mountain Research and Development, 28(1) : 72-80

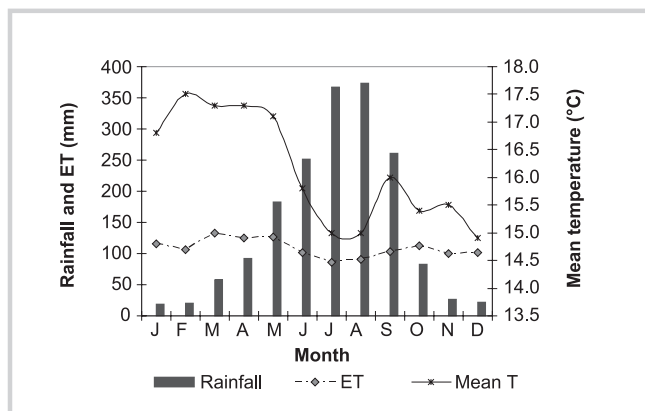
FIGURE 2 Climate conditions in Fincha'a watershed, western Ethiopia. (Source: National Metrological Service Agency 2004)

Weather data were available from a station at Shambu town, which is situated in the middle part of the watershed ($09^{\circ}34'$ N latitude and $37^{\circ}06'$ E longitude and elevation 2430 m). The average annual rainfall over the period of 1970–2003 was 1823 mm. About 80% of the annual rain falls between May and September. The monthly mean temperature varies from 14.9°C to 17.5°C. The average annual Reference Evapotranspiration (based on Penman-Monteith) is 1320 mm, with low monthly variations (Figure 2).
