Authors: Inbar, Moshe, and Llerena, Carlos A.

Source: Mountain Research and Development, 20(1) : 72-79

Erosion Processes in High Mountain Agricultural Terraces in Peru

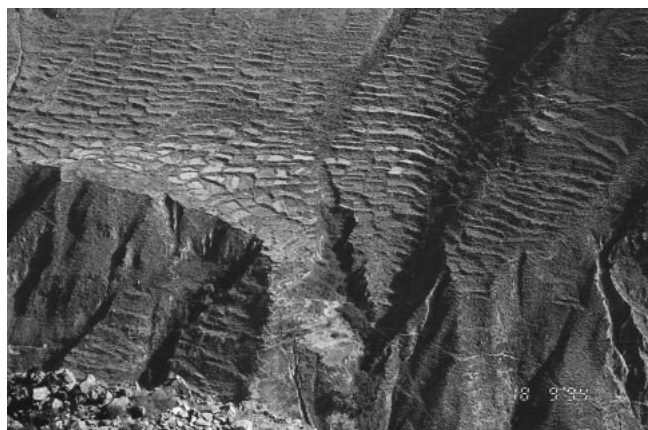
FIGURE 2 View of the steep slopes in the Santa Eulalia river valley. Paths of frequent debris flows, known locally as *huaycos*, are clear. Terraces are built on slopes steeper than 400°. (Photo by authors)

slides, known locally as *huaycos*, left visible paths and alluvial cones (Figure 2). Due to the rapid incision rate, channels are narrow and no floodplain has developed. Due to the rugged landscape, settlements are distributed on the higher flat terrains below available water sources.
