Reducing Vehicle Collisions With the Central American Tapir in Central Belize District, Belize

Tropical Conservation Science
Volume 11: 1–7
© The Author(s) 2018
Reprints and permissions:
sagepub.com/journalsPermissions.nav
DOI: 10.1177/1940082918789827
journals.sagepub.com/home/trc

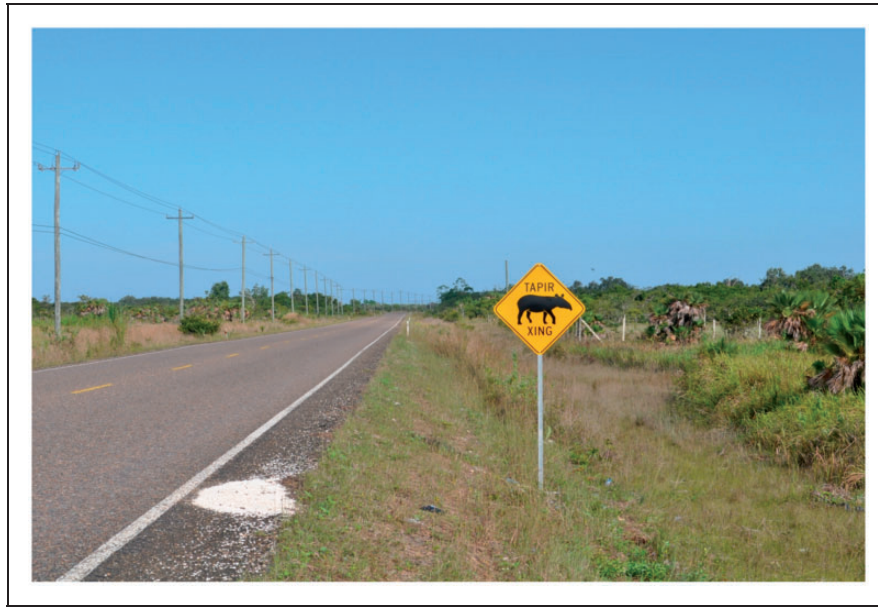
Figure 2. Two sets of reflective wildlife crossing signs were installed at two hot spots identified for tapir-vehicle collisions.

A vehicle's breaking distance directly correlates with its travel velocity: The faster the vehicle travels, the longer its breaking distance (Fambro, Koppa, Picha, & Fitzpatrick, 2000). We therefore assumed that slower moving vehicles are less likely to have fatal collisions with tapirs than faster moving vehicles. In an effort to reduce the speed of vehicles traveling through the area, we installed two pairs of standard wildlife crossing signs ($n=4$) in early December 2012 (Figure 2). One pair of signs was installed 3 km apart, one each on either side of the road; the second pair was installed 2 km apart,

one each on either side of the road, in total they cover 6 km stretch of the Burrell Boom road. We measured vehicle speeds ($n=100$) at the halfway point between each set of signs. To determine whether signs affected vehicular speed, we collected speed data from 1700 h to 2000 h before and after deploying the warning signboards. We tested these data to see whether the signs affected the mean and median values of speed; the latter being a tool used to determine effective and adequate speed limits (Homburger, Hall, Loutzenheiser, & Reilly, 1996).
