Landslide Hazard and Risk Zonation Mapping in the Río Grande Basin, Central Andes of Mendoza, Argentina

Source: Mountain Research and Development, 22(2) : 177-185

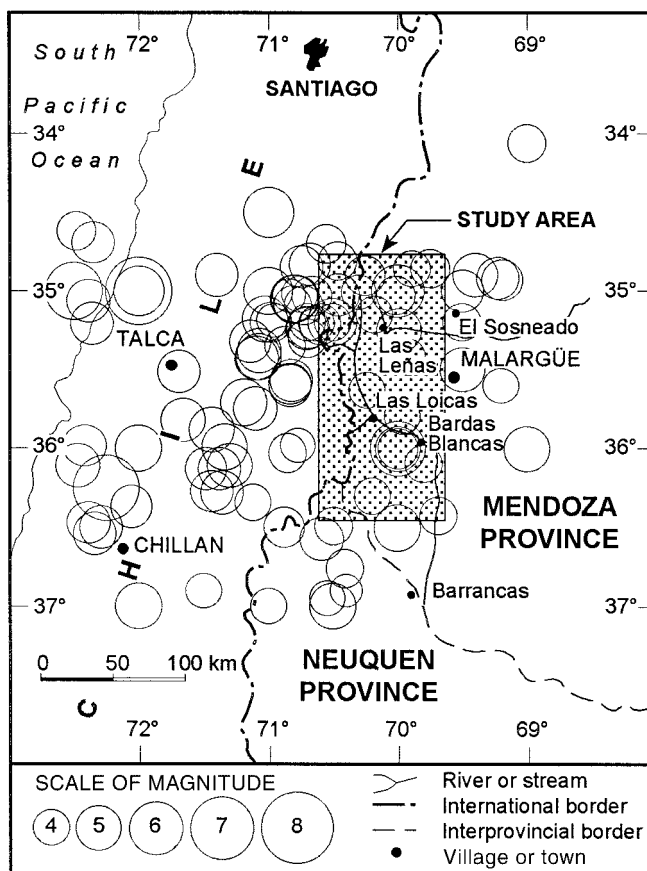
FIGURE 3 Location of earthquakes (epicenters and magnitudes).

sity of Chile. Ninety earthquakes with magnitudes greater than 4 have occurred in the area. Figure 3 shows the location of the epicenters and magnitudes in the study area and the surrounding zones; the figure shows that there is an increase in the number of earthquakes and in their magnitudes toward the west.

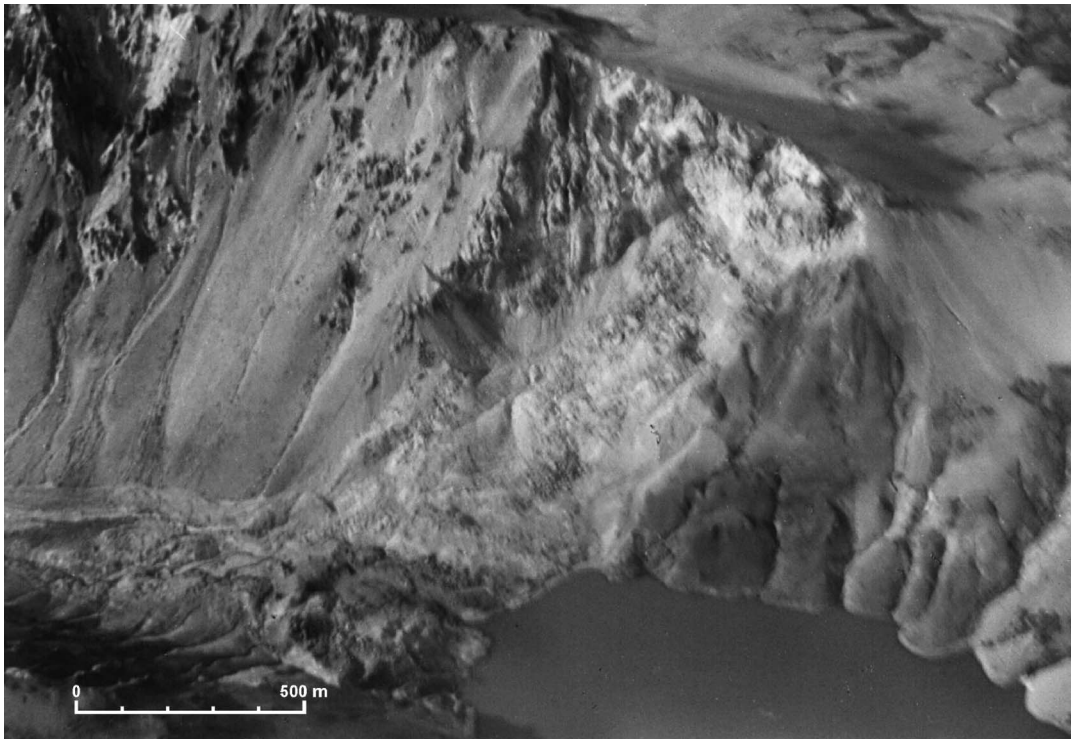
FIGURE 4 South aerial view of a landslide and the resulting dam at the headwaters of the Cajón Bayo creek in the Río Pehuenche basin. (Photo by Luis Lenzano and Carlos Aguado)

In the study area it was possible to detect a reactivated landslide (slump) at the headwaters of the Cajón Bayo creek at the Río Pehuenche basin. Tuffs of the lower Tihuelitense (lower Quaternary age) are characterized by outcrops about 300–400 m thick, in subhorizontal position, with andesitic composition arising from eruptions of Volcano Campanario. A small 600-m-long landslide that deviated the creek about 50 m to the north can be observed in the 1963 aerial photos. In the satellite image of March 1985, no change was detected in the sector. Instead, on the 1986 images, a 1500-m-long lake that formed upstream from the landslide was detected (Figure 5; slump B39). In March 1992 the region was observed from a plane. A reactivated slide had occurred in the same sector as the one before, but this time it was more important, and the mass movements crossed the valley floor and extended far up the opposite wall. A lake was formed after the landslide obstructed the Cajón Bayo valley floor in 1986 (Figure 4). In March 1992, minor drainage of the lake through the base of the mass was also observed. This characteristic, and the prevailing lithology (friable tuffs), a steep slope, and the presence of snow ablation water, are negative factors that may affect stability. It is quite probable that at some time the natural dam will break. Were the water mass to drain suddenly, catastrophic downstream flooding would affect the Pehuenche road (Provincial Route 224) and the locality of Las Loicas.
