Variations in Inlet Behavior and Shoreface Sand Resources: Factors Controlling Management Decisions, Figure Eight Island, NC, USA

Author: Cleary, William J.

Source: Journal of Coastal Research, 36(sp1) : 148-163

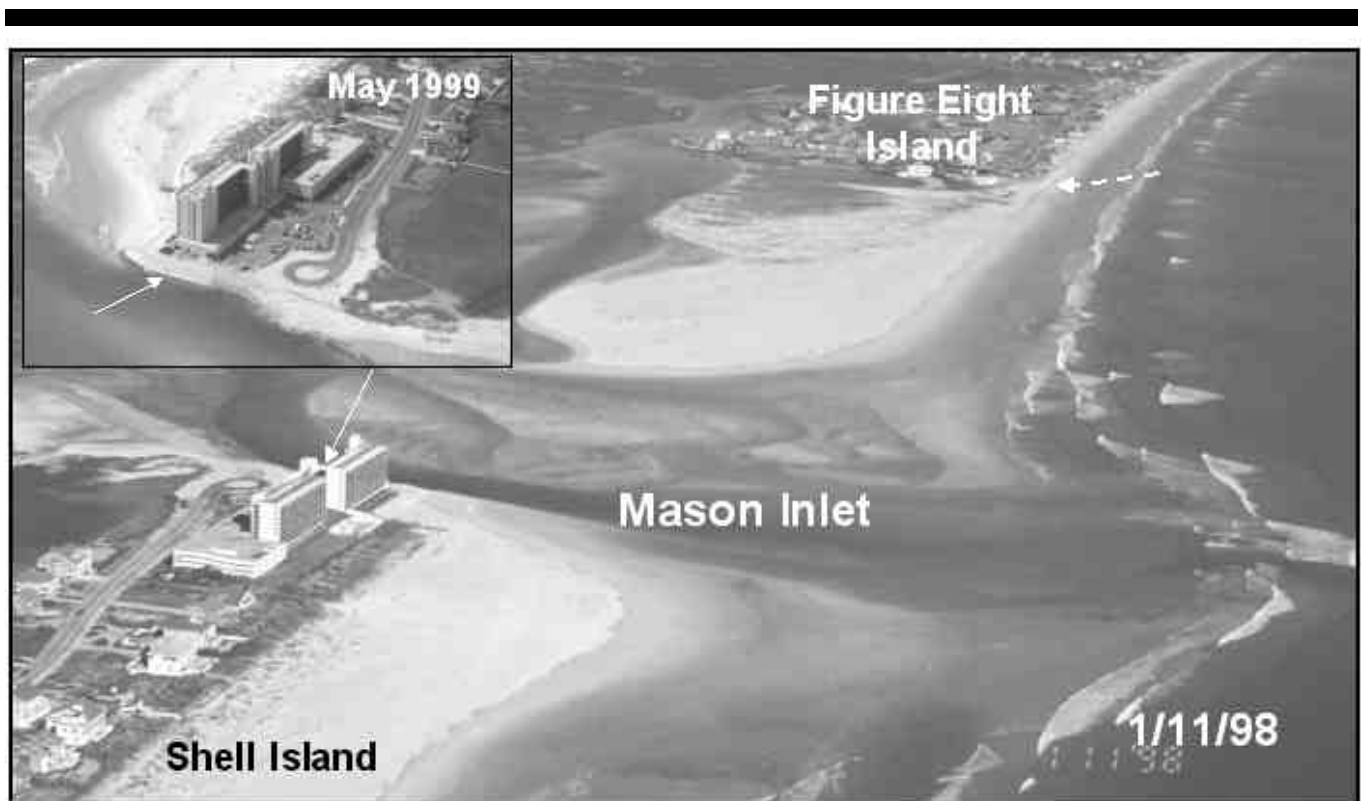
Figure 3. North view (1/11/98) of Mason Inlet and adjacent Figure Eight Island and Wrightsville Beach. Insert (5/99) shows oversized sand bags at base of threatened Shell Island Resort. Note clogged interior channels and position of ebb channel.

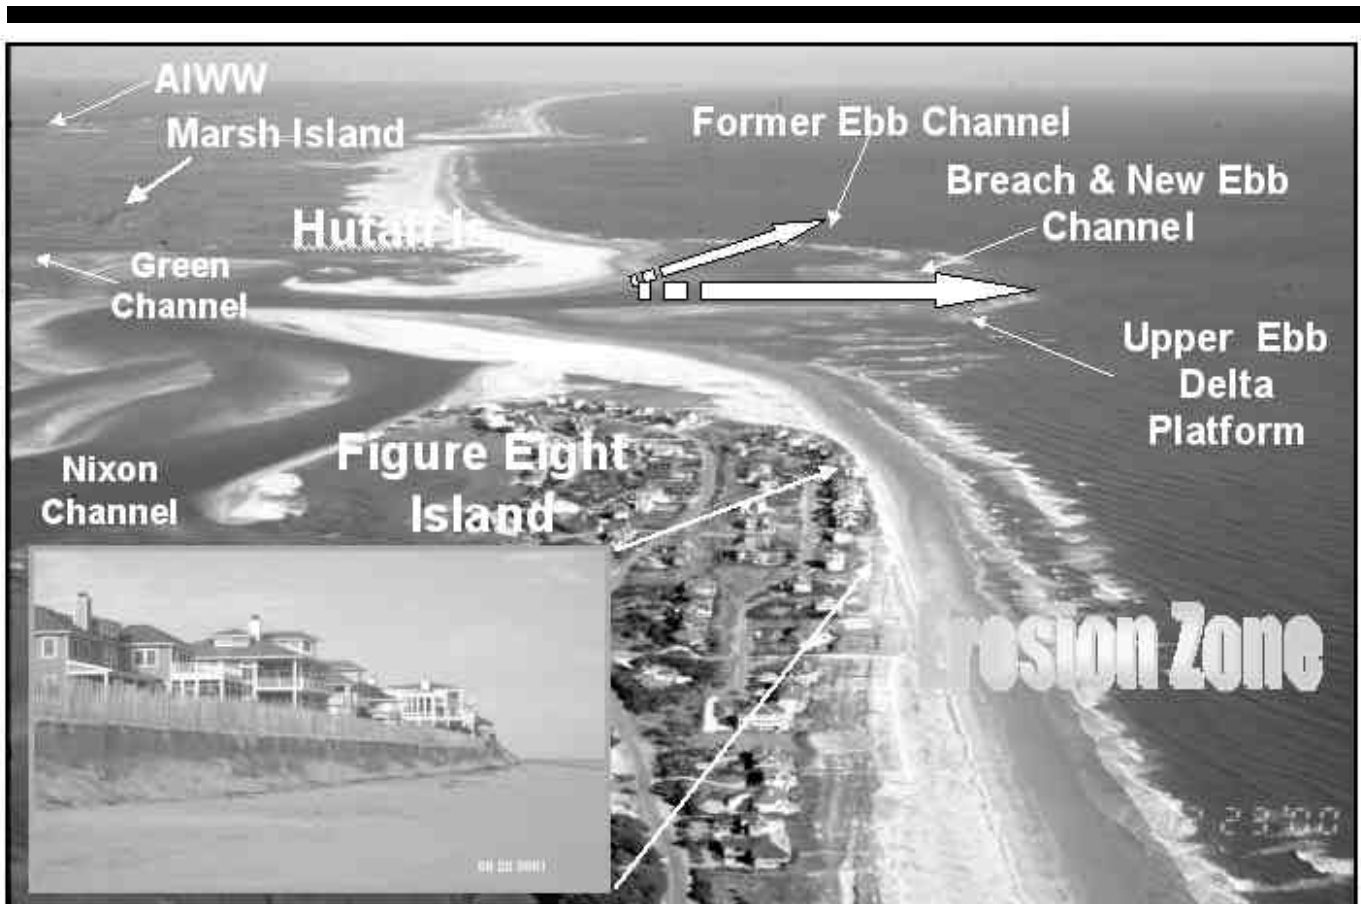
Figure 6. Oblique north view (12/00) of Rich Inlet, Figure Eight Island and Hutaff Island. Rapid erosion of oceanfront stemmed from northeasterly migration and realignment of ebb channel. Ebb delta breaching occurred several months earlier setting the stage for a southerly migration of the channel. Insert shows the current condition (9/01) of the eroding oceanfront.

Data indicate that the ebb channel has begun to track in a southerly direction; and as a result a reversal in the shoreline change patterns it will probably occur as the barrier planforms are altered accordingly. The continual repositioning of the ebb shoals to more favorable southwesterly locations will have an increasing positive impact on the Figure Eight Island shoreline. It is difficult to predict what time span is involved in the migration of the ebb channel along the 800 m long pathway to its optimum position. It may be as much as a decade or more, but there is a high probability that a breach across the narrow, low-relief spit will shorten the time lag considerably (Figs. 6, 8 D).
