## **Water Quality at Selected Sites in the Konashen COCA, Southern Guyana**

## Chapter 4

### Water quality at selected sites in the Konashen COCA, Southern Guyana

*Maya Trotz*

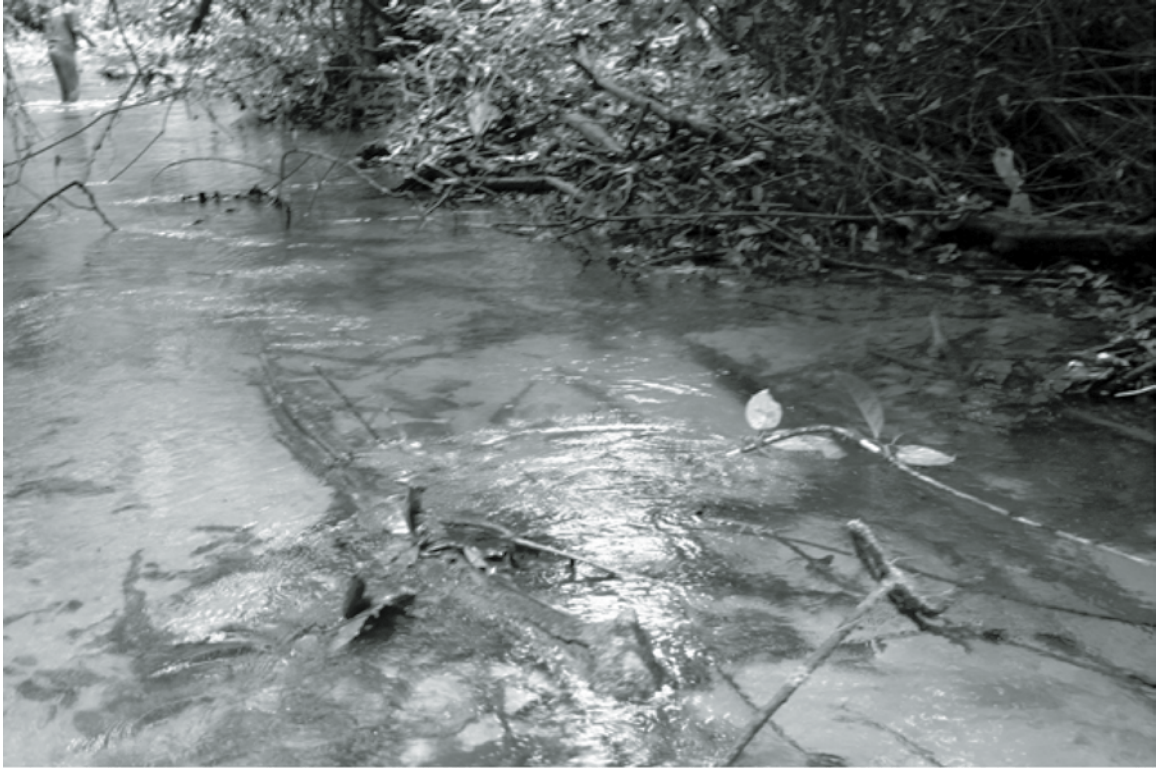
GR-AM-03: Acarai creek

**Acarai:** The Acarai site was located below the Acarai Mountains adjacent to a creek that empties into the Sipu River. This creek was underlain with sand and rock and showed no human or industrial signs of pollution. Oral recollection from the Wai-Wai community signaled the presence of an illegal small-scale gold mining operation in the area around 1990. The two small creeks and a small stagnant pond sampled around the area were well shaded, covered with leaves, and less than a meter deep at the time.

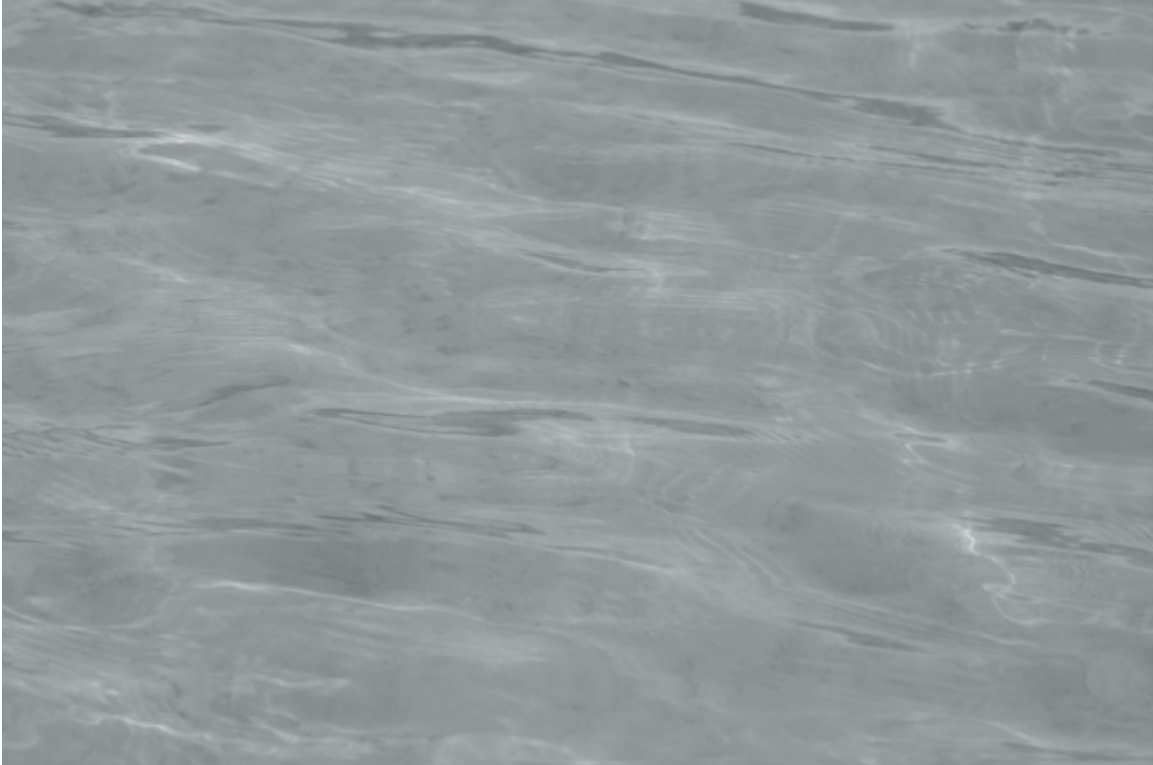
GR-ER-13: Kanaperu fishing ground

**Essequibo:** The major river running through the Konashen District is the Essequibo which empties into the Atlantic Ocean. Sampling was conducted between the mouth of the Sipu River and the Kanaperu fishing ground. The village moved from Akuthopono in 2000 following a massive flood.
