Water Quality at Selected Sites in the Konashen COCA, Southern Guyana

Source: A Rapid Biological Assessment of the Konashen Community
Owned Conservation Area, Southern Guyana: 35

Water quality at selected sites in the Konashen COCA, Southern Guyana

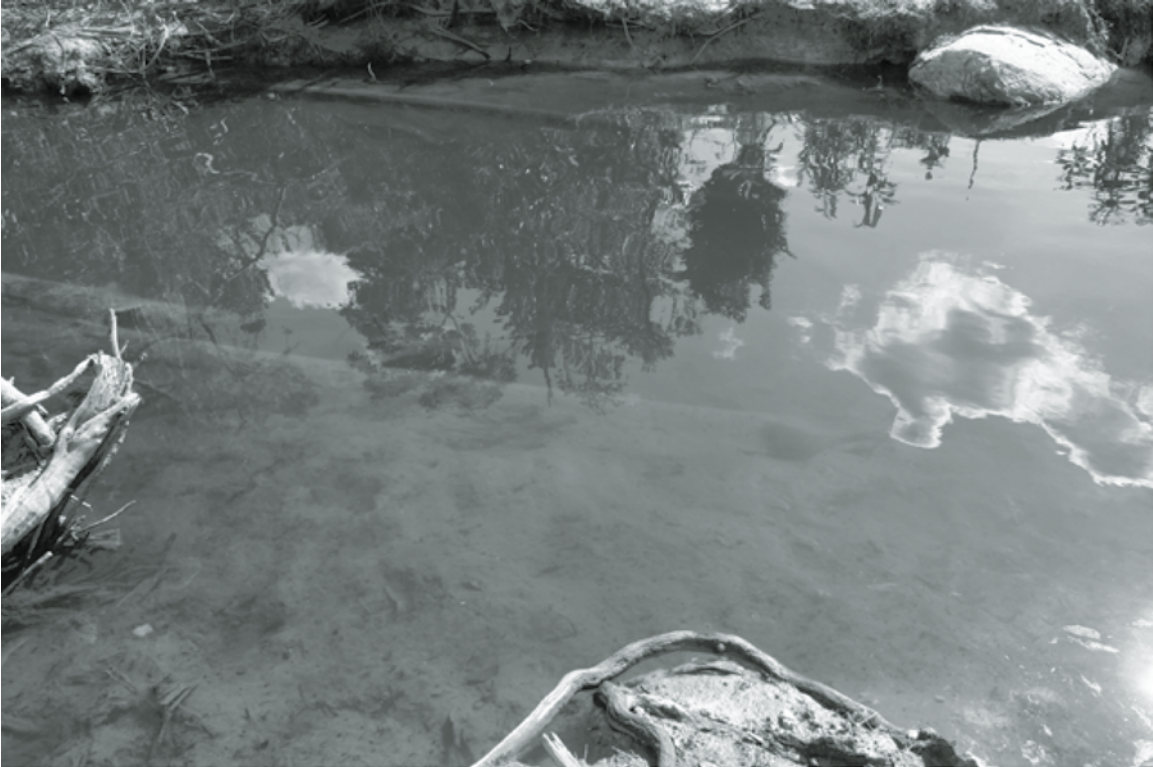
GR-MA-02: Downstream of bathing area at the creek in Masakenari

NTU standards, and a 1.412 mS/cm conductivity standard. 100% DO_{sat} was calibrated using MQ water that had been equilibrated with the atmosphere. Measurements were taken as a function of depth (0, 0.8 m and the bottom) at various locations along the center of the Essequibo River, Sipu River, Acarai creek and Komoa River of Guyana. Sampling was also done in creeks and ponds around Sipu, Acarai, Kamoia, Akuthopono and Masakenari. In Masakenari, well water was sampled at the four village pipes and surface water was sampled upstream and downstream of a creek used for domestic purposes.

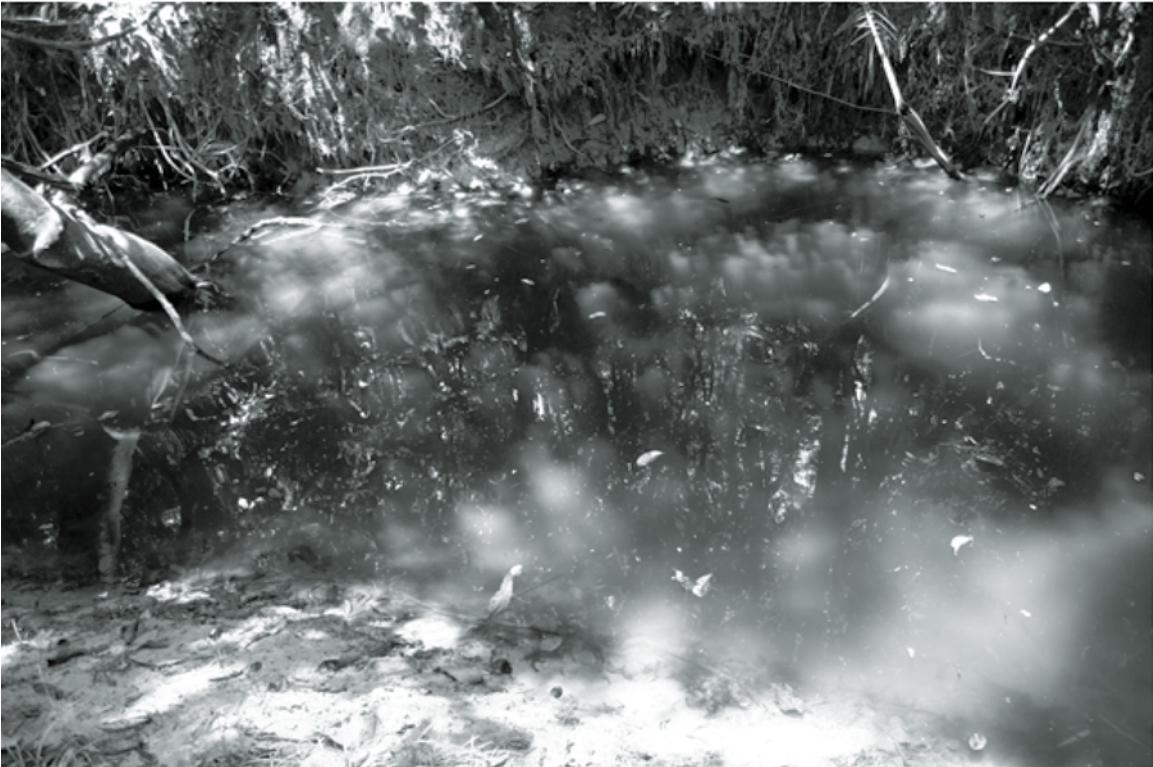
GR-SR-04: Creek off of the Sipu River

Palm Swamp bet Masakenari and Akuthopono (GR-MA-08)	Creek off of Sipu River (GR-SR-04)	Isolated pool adjacent to Acarai Creek (GR-AM-05)	Creek off of Kamoa River (GR-KR-08)
pH	4.81	5.9	4.83	4.89
DO (mg/L)	2.85	4.73	3.19	6.15
Turbidity (NTU)	23.7	19.4	27.1	7.3
Alkalinity (mg/L CaCO₃)	–	27.5	–	10
Conductivity (mS/cm)	0.016	0.03	0.012	0.011

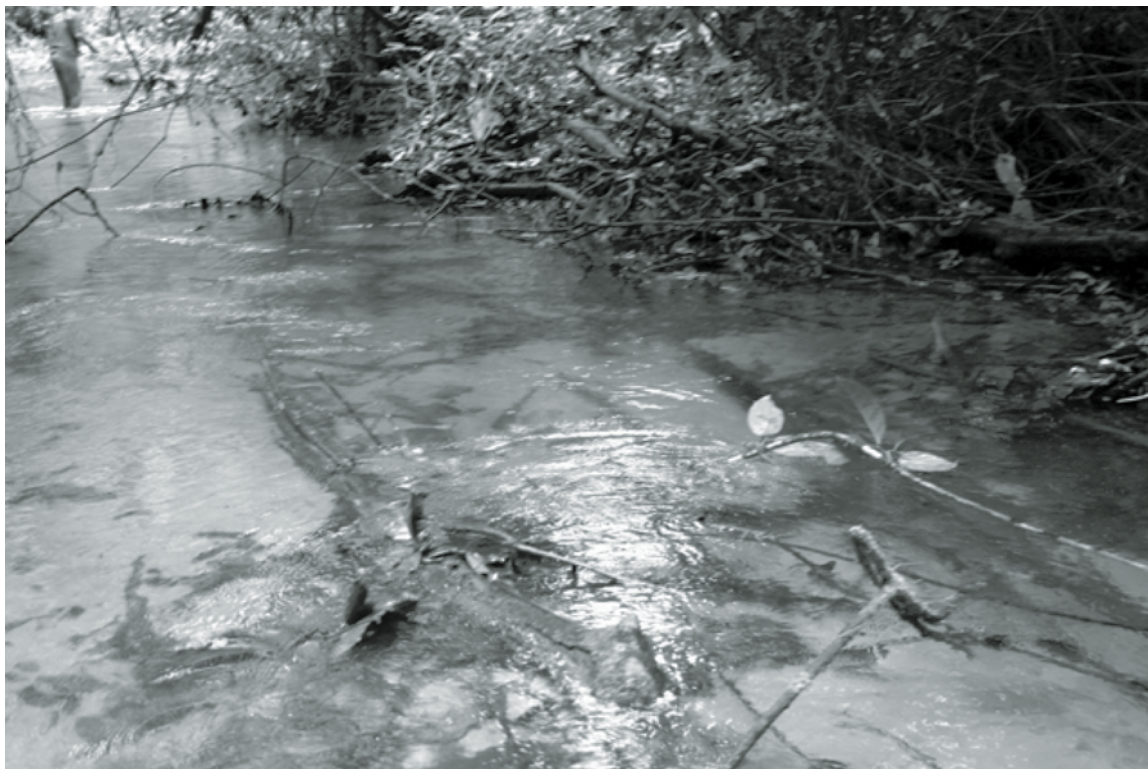
GR-AM-03: Acarai creek

Acarai: The Acarai site was located below the Acarai Mountains adjacent to a creek that empties into the Sipu River. This creek was underlain with sand and rock and showed no human or industrial signs of pollution. Oral recollection from the Wai-Wai community signaled the presence of an illegal small-scale gold mining operation in the area around 1990. The two small creeks and a small stagnant pond sampled around the area were well shaded, covered with leaves, and less than a meter deep at the time.

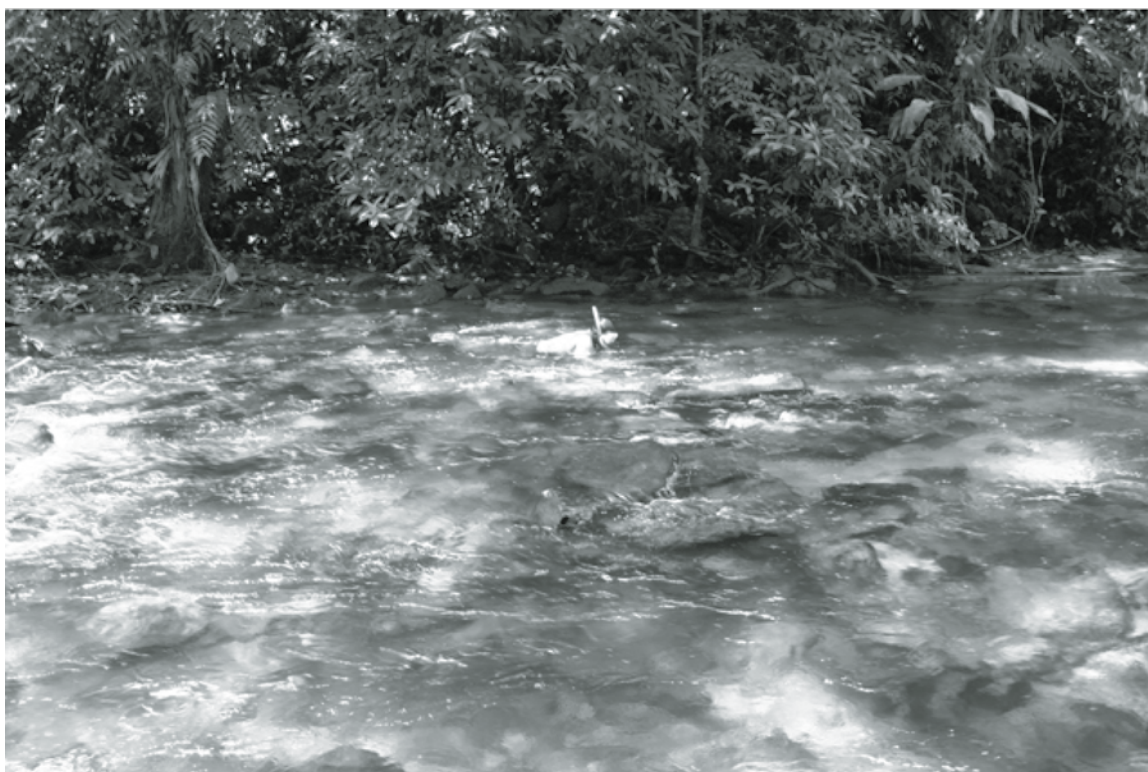
GR-AM-04: Acarai creek

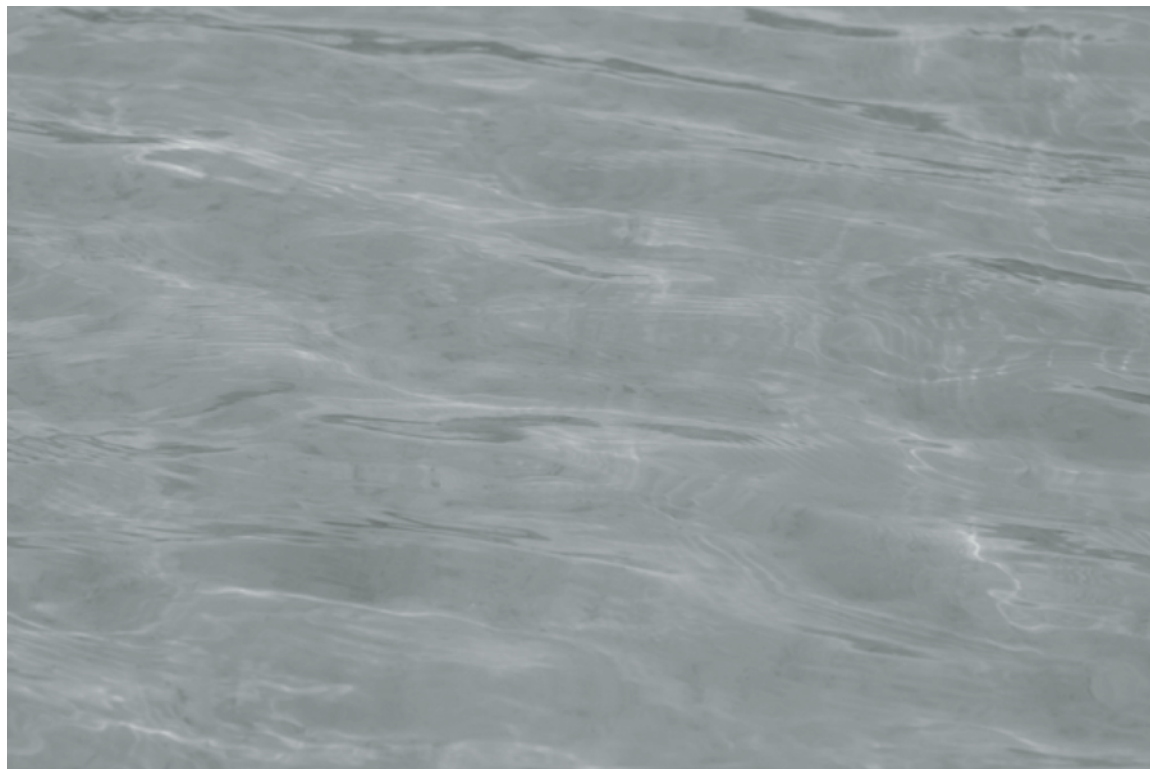
GR-ER-13: Kanaperu fishing ground

A water quality monitoring program should be established in the area to expand and continue the work begun during this rapid assessment. Such a program should be conducted on a quarterly basis at selected sampling sites along the Essequibo River (e.g. GR-KR-14, GR-ER-17, GR-ER-01, GR-ER-14, GR-ER-15), and in the village (GR-MA-01 – GR-MA-07). This quarterly monitoring should provide two samples each, during the dry and wet seasons.

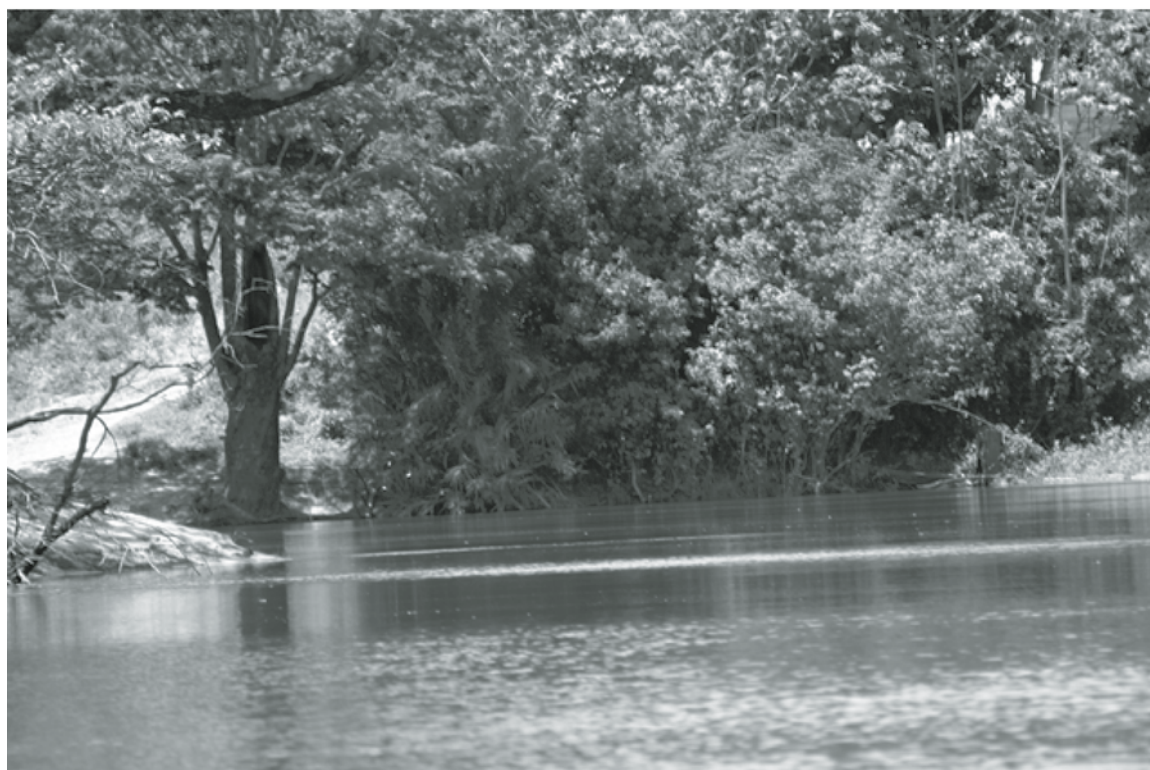
GR-ER-01: Akuthopono Landing
