## **Water Quality at Selected Sites in the Konashen COCA, Southern Guyana**

### Water quality at selected sites in the Konashen COCA, Southern Guyana

*Maya Trotz*

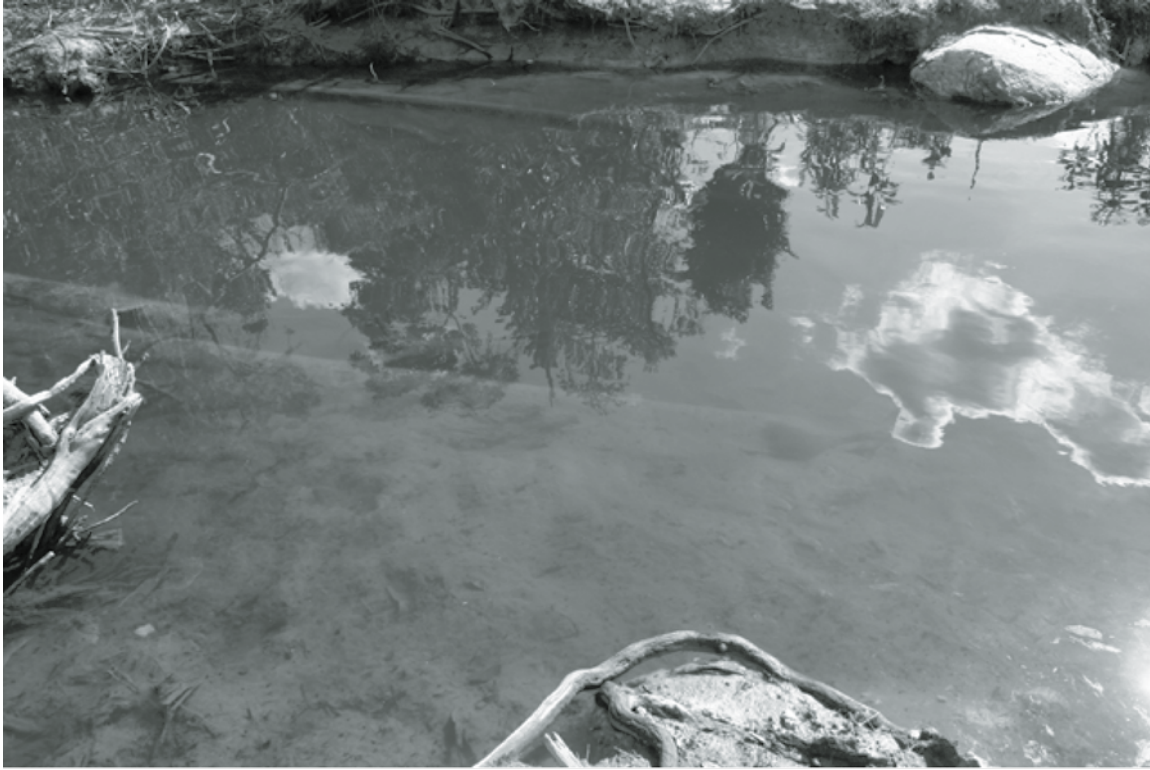
GR-MA-02: Downstream of bathing area at the creek in Masakenari

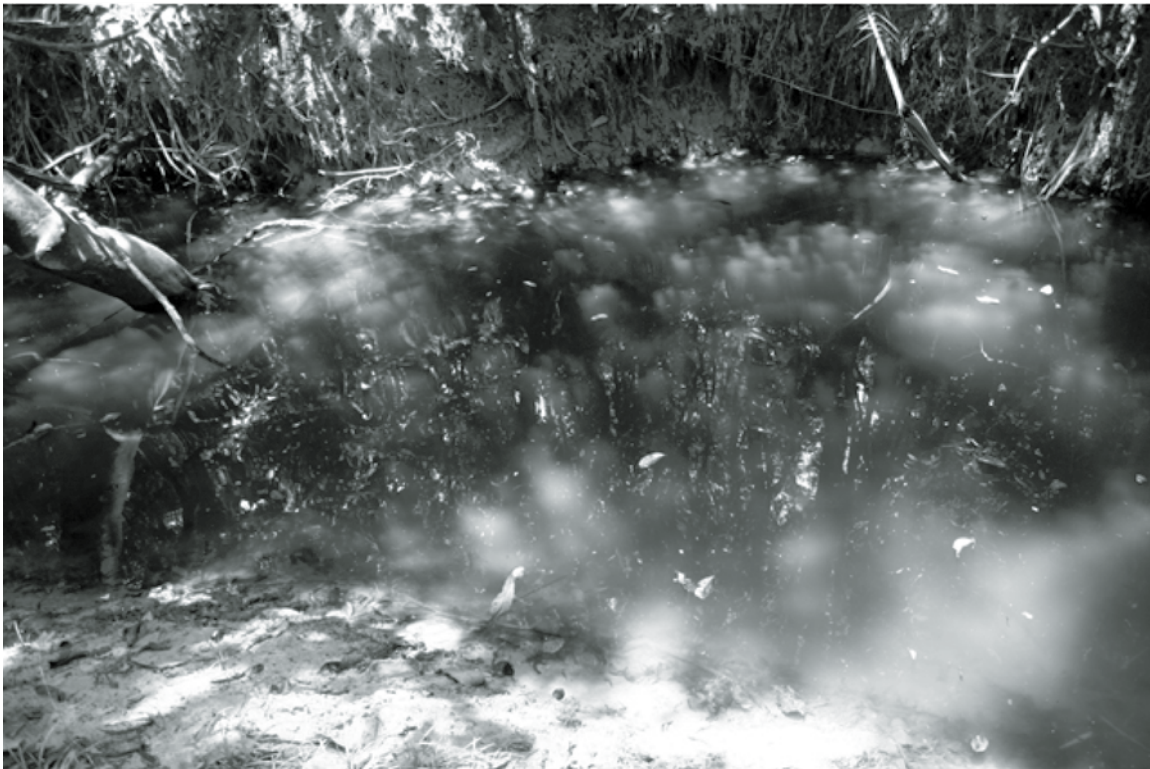
GR-SR-04: Creek off of the Sipu River

Palm Swamp bet Masakenari and Akuthopono (GR-MA-08)	Creek off of Sipu River (GR-SR-04)	Isolated pool adjacent to Acarai Creek (GR-AM-05)	Creek off of Kamoa River (GR-KR-08)
pH	4.81	5.9	4.83	4.89
DO (mg/L)	2.85	4.73	3.19	6.15
Turbidity (NTU)	23.7	19.4	27.1	7.3
Alkalinity (mg/L CaCO <sub>3</sub> )	–	27.5	–	10
Conductivity (mS/cm)	0.016	0.03	0.012	0.011

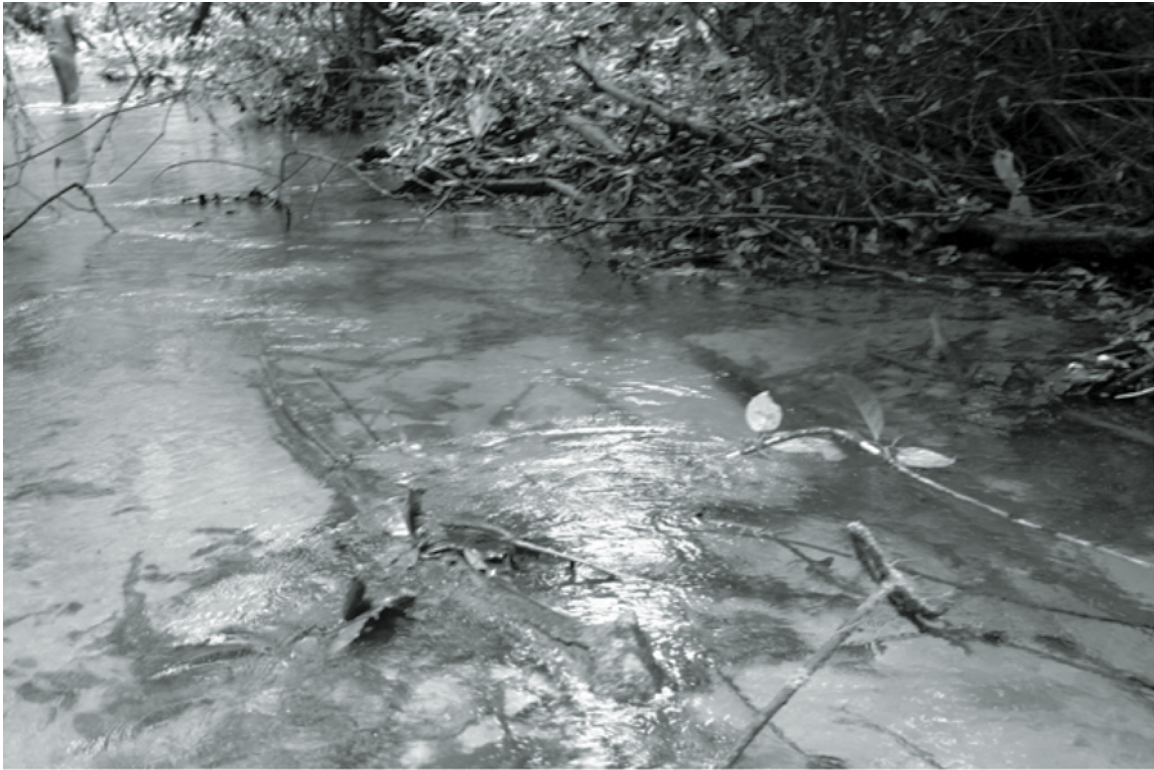
GR-AM-03: Acarai creek

**Acarai:** The Acarai site was located below the Acarai Mountains adjacent to a creek that empties into the Sipu River. This creek was underlain with sand and rock and showed no human or industrial signs of pollution. Oral recollection from the Wai-Wai community signaled the presence of an illegal small-scale gold mining operation in the area around 1990. The two small creeks and a small stagnant pond sampled around the area were well shaded, covered with leaves, and less than a meter deep at the time.

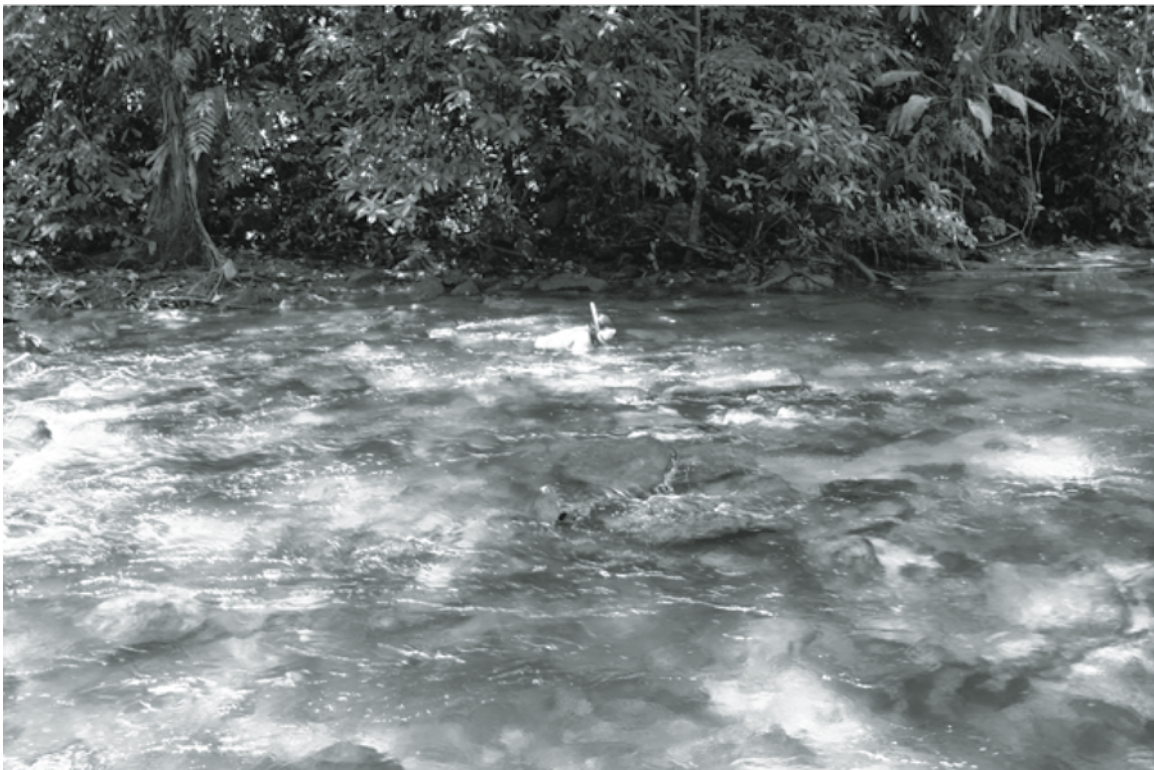
GR-AM-04: Acarai creek
