Source: Mountain Research and Development, 20(1) : 72-79

# Erosion Processes in High Mountain Agricultural Terraces in Peru

**Key words:** soil erosion; agricultural terraces; Peru; plot experiments; rainfall simulation; morphometric analysis.

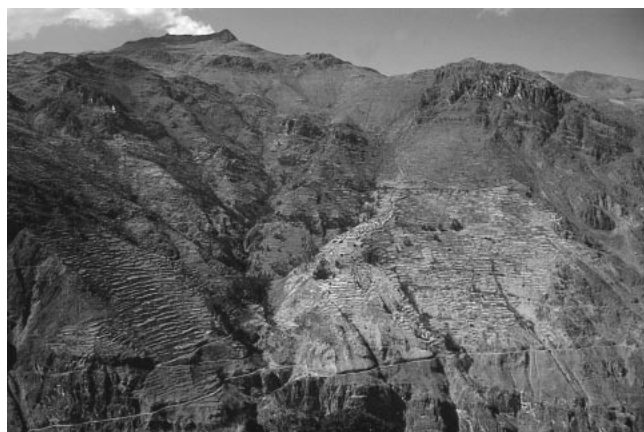
**FIGURE 3** View of San Juan de Iris village above the Santa Eulalia River, at an altitude between 3500 and 3800 m. (Photo by authors)

The community of San Juan de Iris (Figure 3) is a typical small Andean sierra village of about 100 households (families) at an elevation of 3400–3600 m. Each farmer, or *comunero*, has about 10–20 terraces, each covering an area of 70–300 m<sup>2</sup>. All active terraces are irrigated, the others having been abandoned. The main crops are potatoes, corn, alfalfa, and beans. Cows are the main livestock for milk production. Each farmer owns about 10 cows; goats, sheep, and pigs are present in smaller quantities. Except for the terraces where alfalfa is grown, there is no grazing of livestock on the terraces. A small number of llamas and horses are used mainly for transport. The trend in recent years has been to grow more alfalfa for livestock production, abandoning the traditional potato and corn crops.

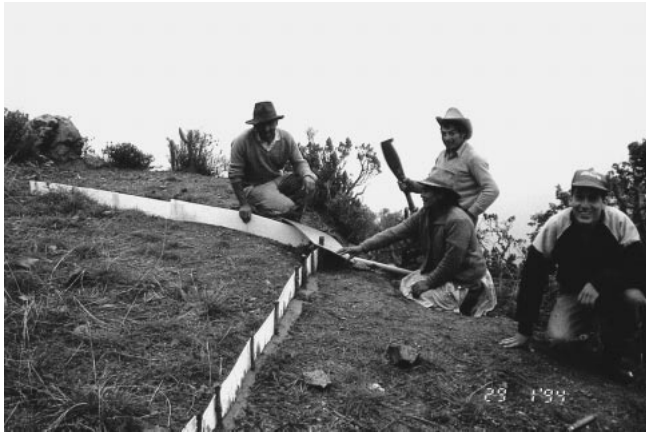
**FIGURE 4** Experimental plot for measuring run-off and sediment yield on an abandoned terrace. (Photo by authors)

aces after rainstorms. The plot area for each terrace was between 50 and 100 m<sup>2</sup>. The plot was bordered by a plastic fence closed at a lower apex, with a plastic tube delivering water and sediment through a pipe to closed containers (Figure 4). Rainfall was measured by a daily rain gauge reading. Water and sediment were collected after each rainfall, and either the total amount or a sample was kept for sediment content and analysis at the laboratory. Data collection was regular, despite the theft of some water containers.

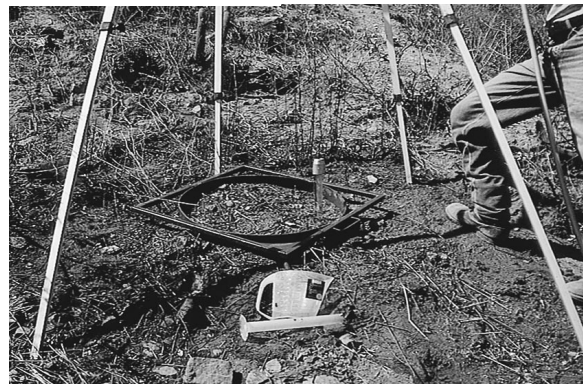
**FIGURE 6** Rain simulation on an abandoned terrace in San Juan de Iris. (Photo by authors)

All tests were carried out in the dry season under dry antecedent soil moisture conditions. Infiltration was high on the cultivated and low-gradient terraces. On high, steep slopes, run-off started after 15–20 minutes, and rates of infiltration were 15–20 mm/h. Run-off and sediment yield were high at the steep slope sites and low on the cultivated and low gradient ter-
