Authors: Lasanta, Teodoro, Arnáez, José, Oserín, Marco, and Ortigosa, Luis M.

Source: Mountain Research and Development, 21(1) : 69-76

# Marginal Lands and Erosion in Terraced Fields in the Mediterranean Mountains

A Case Study in the Camero Viejo (Northwestern Iberian System, Spain)

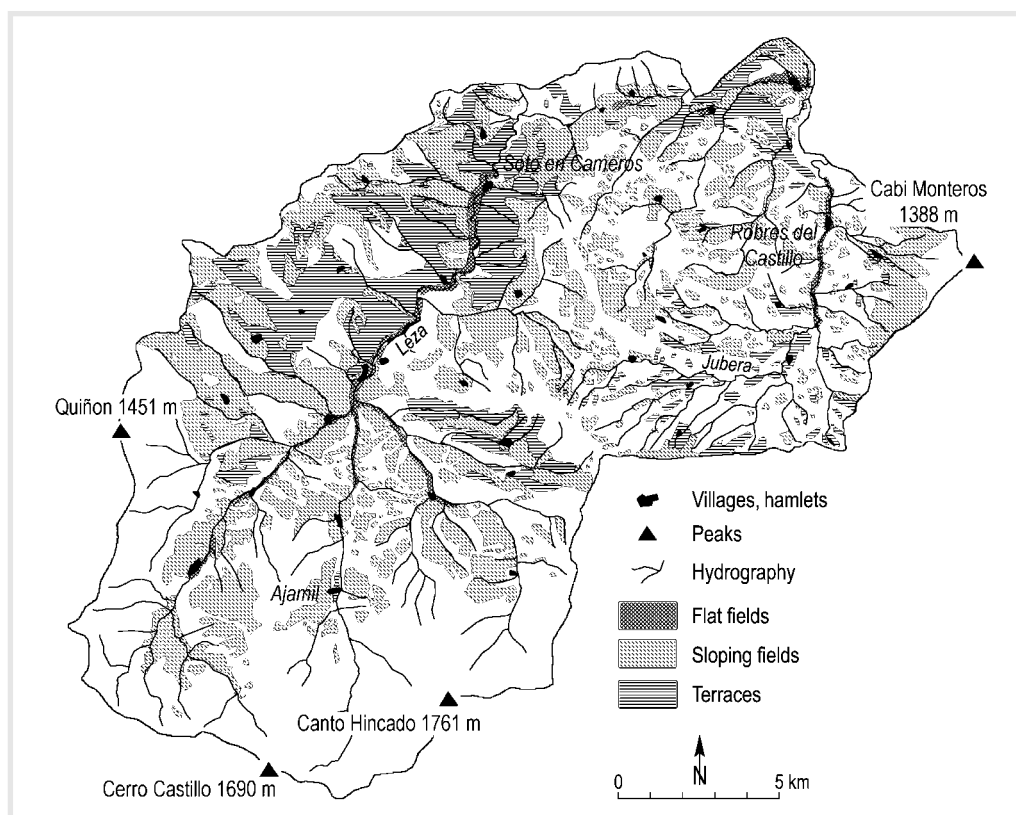
**FIGURE 2** Historical farmland and types of fields in the high valleys of the Leza and Jubera (Camero Viejo). The map was drawn on the basis of aerial photographs (1956 and 1977) and was adapted by means of a GIS.

Depending on the inclination of their fields, farmers in the Camero Viejo used different cultivation methods. In 1956, flat fields represented only 3% of the total farmed area (Figure 2). They were well fertilized and irrigated. On slopes near villages, terraces were built to preserve the soil, support the infiltration of water, and increase yields. Terraces represented 28% of the total cultivated area (4412 ha). The rest of the farmed area (69%) consisted of sloping fields. Some of these fields were worked permanently (one year with cereals, the next in fallow) while others were cultivated sporadically (in times of great population growth), with long fallow periods.

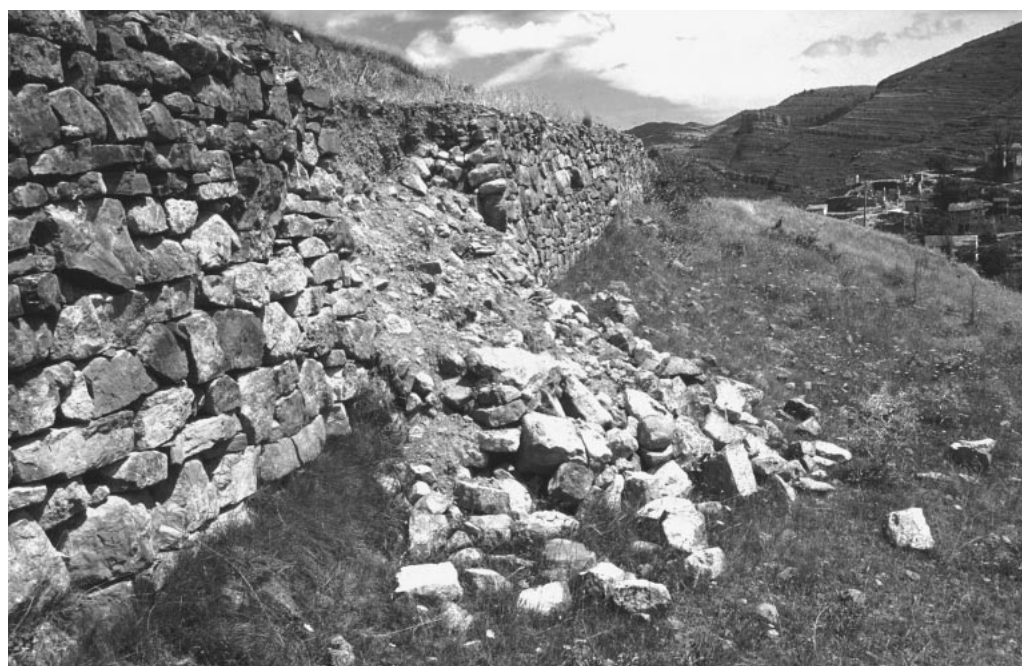
**FIGURE 5** Collapse of a terrace wall at the foot of a hill near a village resulting from hydrological pressure higher up (Soto en Cameros, Leza Valley). Fields in this gently sloping area were only abandoned within the last 10 years. (Photo by L. Ortigosa)

The most important erosion process observed on terraced fields was the collapse of terrace walls as a consequence of massive soil movement (small landslides; see Figure 5). Landslides generate an arcuate surface failure and leave the small scarp of the terrace unprotected and susceptible to erosion. On average, each slide was found to move 3.31 m<sup>3</sup> of soil and terrace wall. The volume of soil moved was calculated to be 38.80 m<sup>3</sup>/100 m of wall.

increasing the volume of accumulated soil and its tendency to slide down the slope. However, the most influential factor in this erosion process seems to be the slope's hydrological function. The highest landslide rate (72.8 m<sup>3</sup>/100 m of terrace wall) was observed on concave slopes, particularly on the lower part of hillslopes (Table 1). Terraces located in these areas receive water from the upper part of the hillslopes. Moreover, their deep and loam-sandy soils retain more moisture. The more a soil's weight increases due to its absorption of water, the greater the likelihood is that a landslide will be triggered (Arnáez et al 1992).

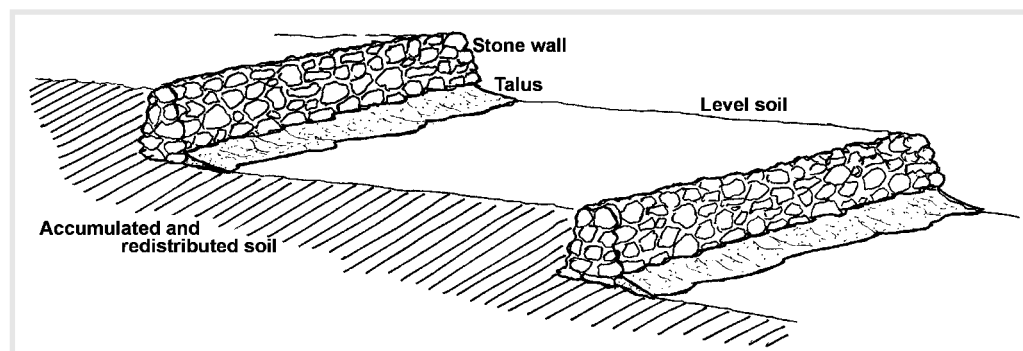
**FIGURE 7** Sectors of an abandoned terrace. (Drawing by Karl Herweg)

terrace (Figure 7) was affected and how the field was used. The talus at the foot of a terrace wall (accumulation of material that has been eroded from fields above) produced high runoff coefficient values (49.7%) and had low wetting front values (12.7 cm as an average). These areas were very prone to erosion: the erosion rate obtained by means of the rainfall simulation test was 25 g/m<sup>2</sup>/h. This hydromorphological behavior was caused by the talus gradient and the scarce plant cover in this section of terraces. Where the soil was level on a terrace, erosion rates were more moderate (Table 2).
