Relationships Between Landsliding and Land Use in the Likhu Khola Drainage Basin, Middle Hills, Nepal

Source: Mountain Research and Development, 22(1) : 48-55

John Gerrard and Rita Gardner

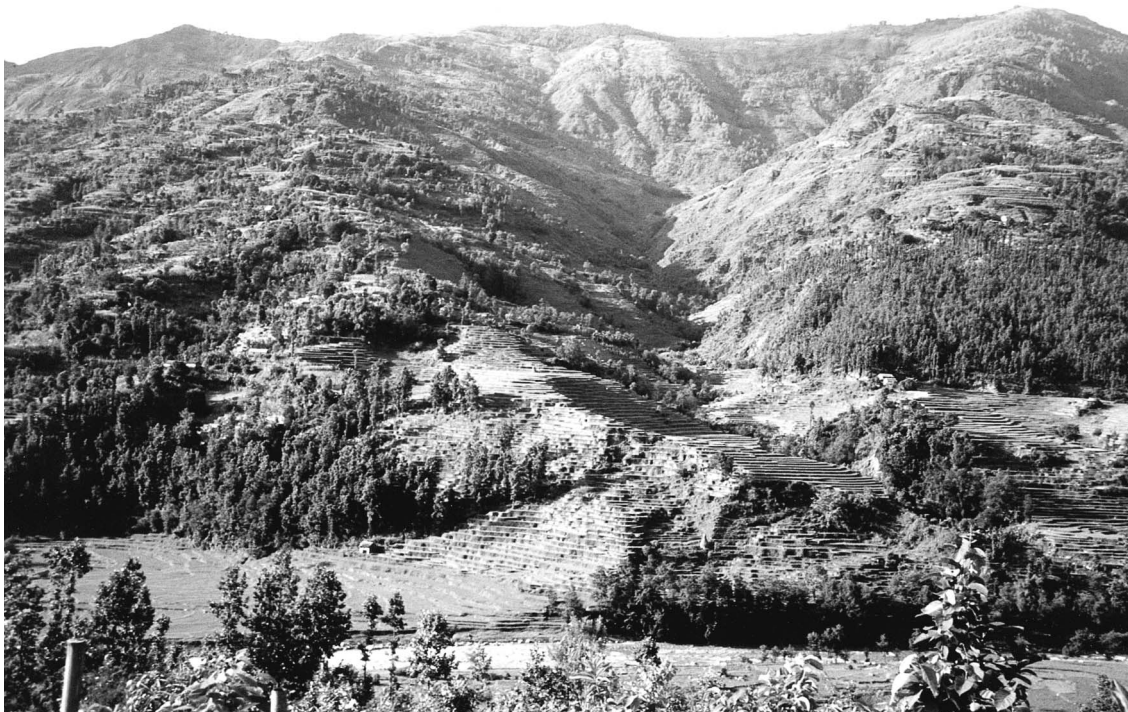
FIGURE 3 General view of the Dee subcatchment of the Likhu Khola (visible in the foreground), with *khet* terraces on the lower slopes and patches of woodland and *bari* terraces on the higher slopes. A few landslide scars are visible. (Photo by John Gerrard)
