## **Relationships Between Landsliding and Land Use in the Likhu Khola Drainage Basin, Middle Hills, Nepal**

Source: Mountain Research and Development, 22(1) : 48-55

# Relationships Between Landsliding and Land Use in the Likhu Khola Drainage Basin, Middle Hills, Nepal

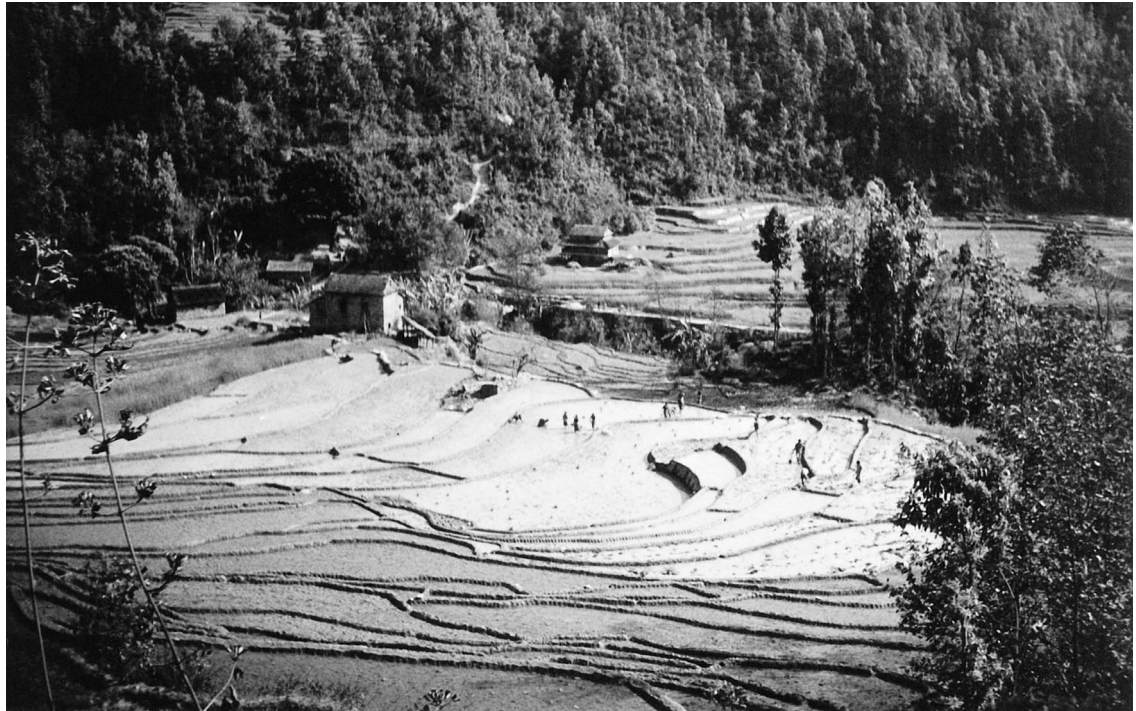
**FIGURE 4** Rice transplanting on *khet* terraces low down on the valley side. Remnants of *sal* woodland in the background, in various states of degradation. (Photo by John Gerrard)
