## **Landslide Hazard and Risk Zonation Mapping in the Río Grande Basin, Central Andes of Mendoza, Argentina**

Source: Mountain Research and Development, 22(2) : 177-185

# Landslide Hazard and Risk Zonation Mapping in the Río Grande Basin, Central Andes of Mendoza, Argentina

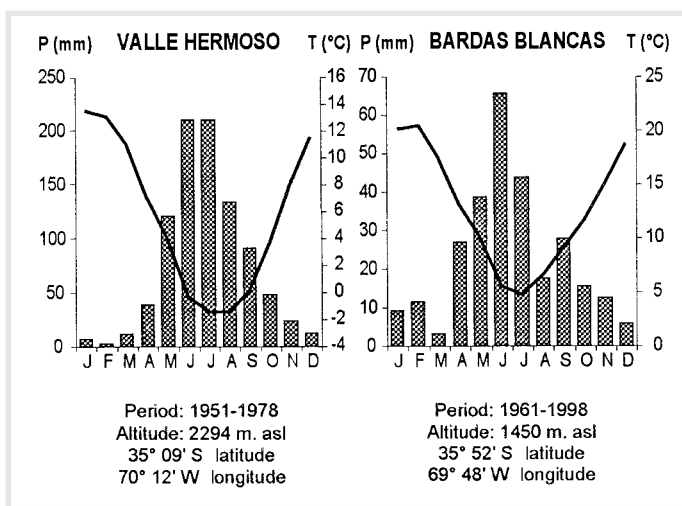
**FIGURE 2** Monthly mean precipitation and temperature in Valle Hermoso and Bardas Blancas meteorological stations.

There are 2 meteorological stations in the zone, with interrupted records: (1) Valle Hermoso (35°09'S, 70°12'W) at 2294 m, and (2) Bardas Blancas (35°52'S, 69°48'W) at 1450 m. The mean monthly precipitation and temperature records show 2 well-defined periods, one in winter and the other in summer (Figure 2). The monthly mean maximum precipitation coincides with the monthly mean minimum temperature. In Valle Hermoso the mean monthly temperature from June to August is below 0°C. At this station the higher monthly precipitation occurs in the winter as snow, whereas in Bardas Blancas it can be snow or rain and occurs from May to June. Annual mean precipitation varies from 400 mm in Bardas Blancas to 940 mm in Valle Hermoso.

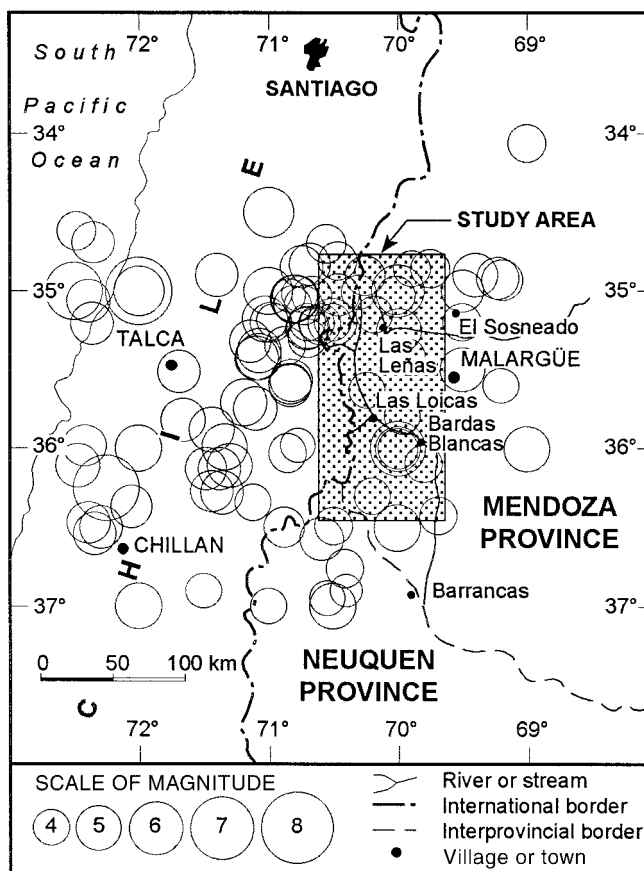
**FIGURE 3** Location of earthquakes (epicenters and magnitudes).

sity of Chile. Ninety earthquakes with magnitudes greater than 4 have occurred in the area. Figure 3 shows the location of the epicenters and magnitudes in the study area and the surrounding zones; the figure shows that there is an increase in the number of earthquakes and in their magnitudes toward the west.

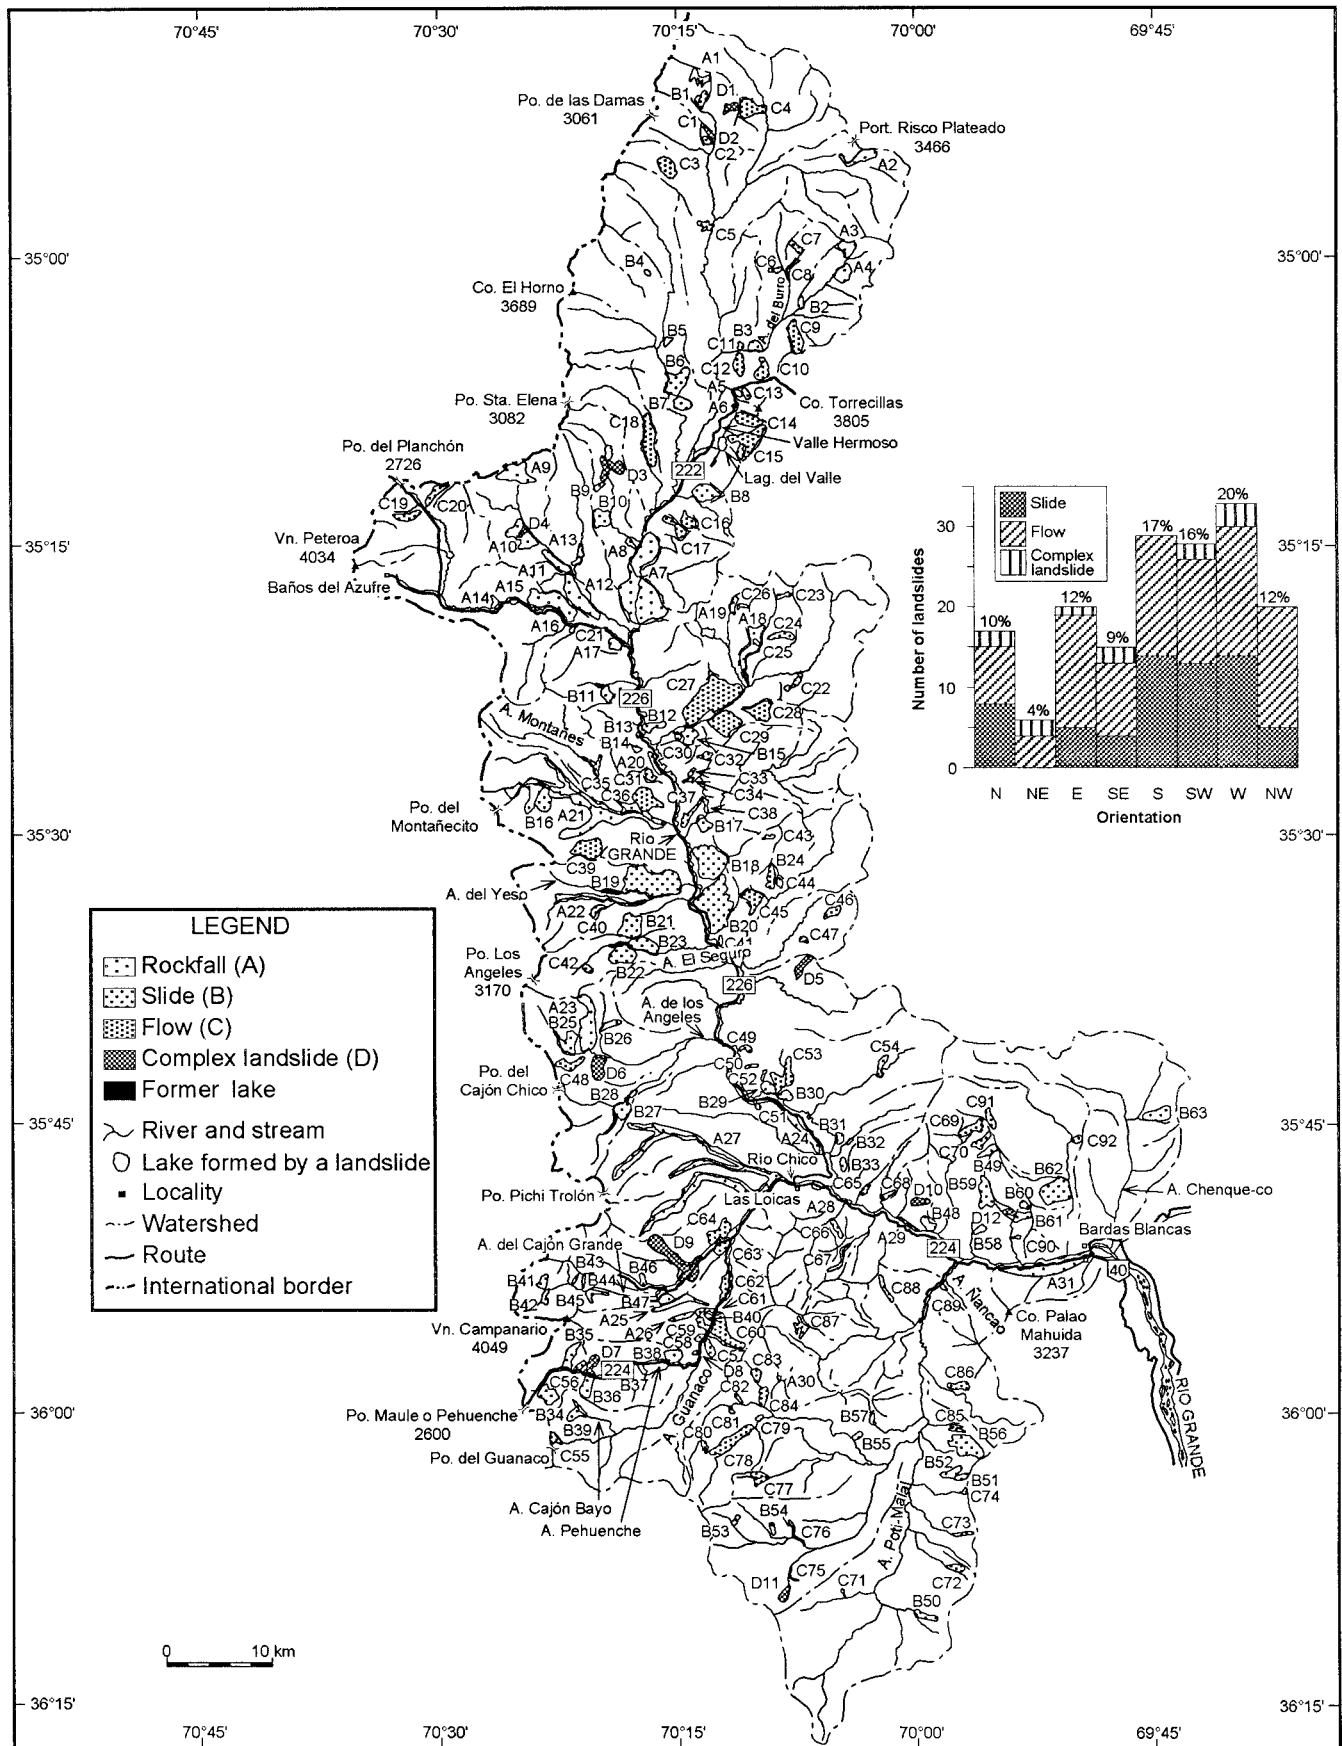
**FIGURE 5** Inventory and location of landslides in the study area in the Río Grande basin.

The Río Grande valley has a north–south trend. Analyzing the orientation of 198 landslides represented in Figure 5, the flows, slides, and complex landslides are preferably oriented toward the west, south, and south-west. The predominance of flows and slides oriented toward the south and to the west is partly the result of those slopes being colder; they accumulate more snow and it remains there longer. Therefore, during the snowmelt season the amount of water is higher. The snow that remains in the cold slopes produces a more intense chemical and physical weathering of the rock, because of the presence of water in cracks and caverns, which freezes and thaws, and the hydration of clays and anhydrite.

We prepared 2 maps. The distribution and classification of landslides are shown on the first map (inventory map; Figure 5). The second—a landslide hazard and risk zonation map (Figure 6)—was prepared taking into account the zones subject to landslide hazard and the degree of loss to a given element or set of elements at risk in the region because of the occurrence of a particular phenomenon of a given magnitude (Coburn et al 1994).

Landslides are identified on the maps and classified according to Varnes (1984), on the basis of the type of movement and material involved, and they are individualized as follows: (A) rockfalls, (B) slides, (C) flows, (D) complex landslides. The number following each capital letter indicates the number of the landslide in each category.

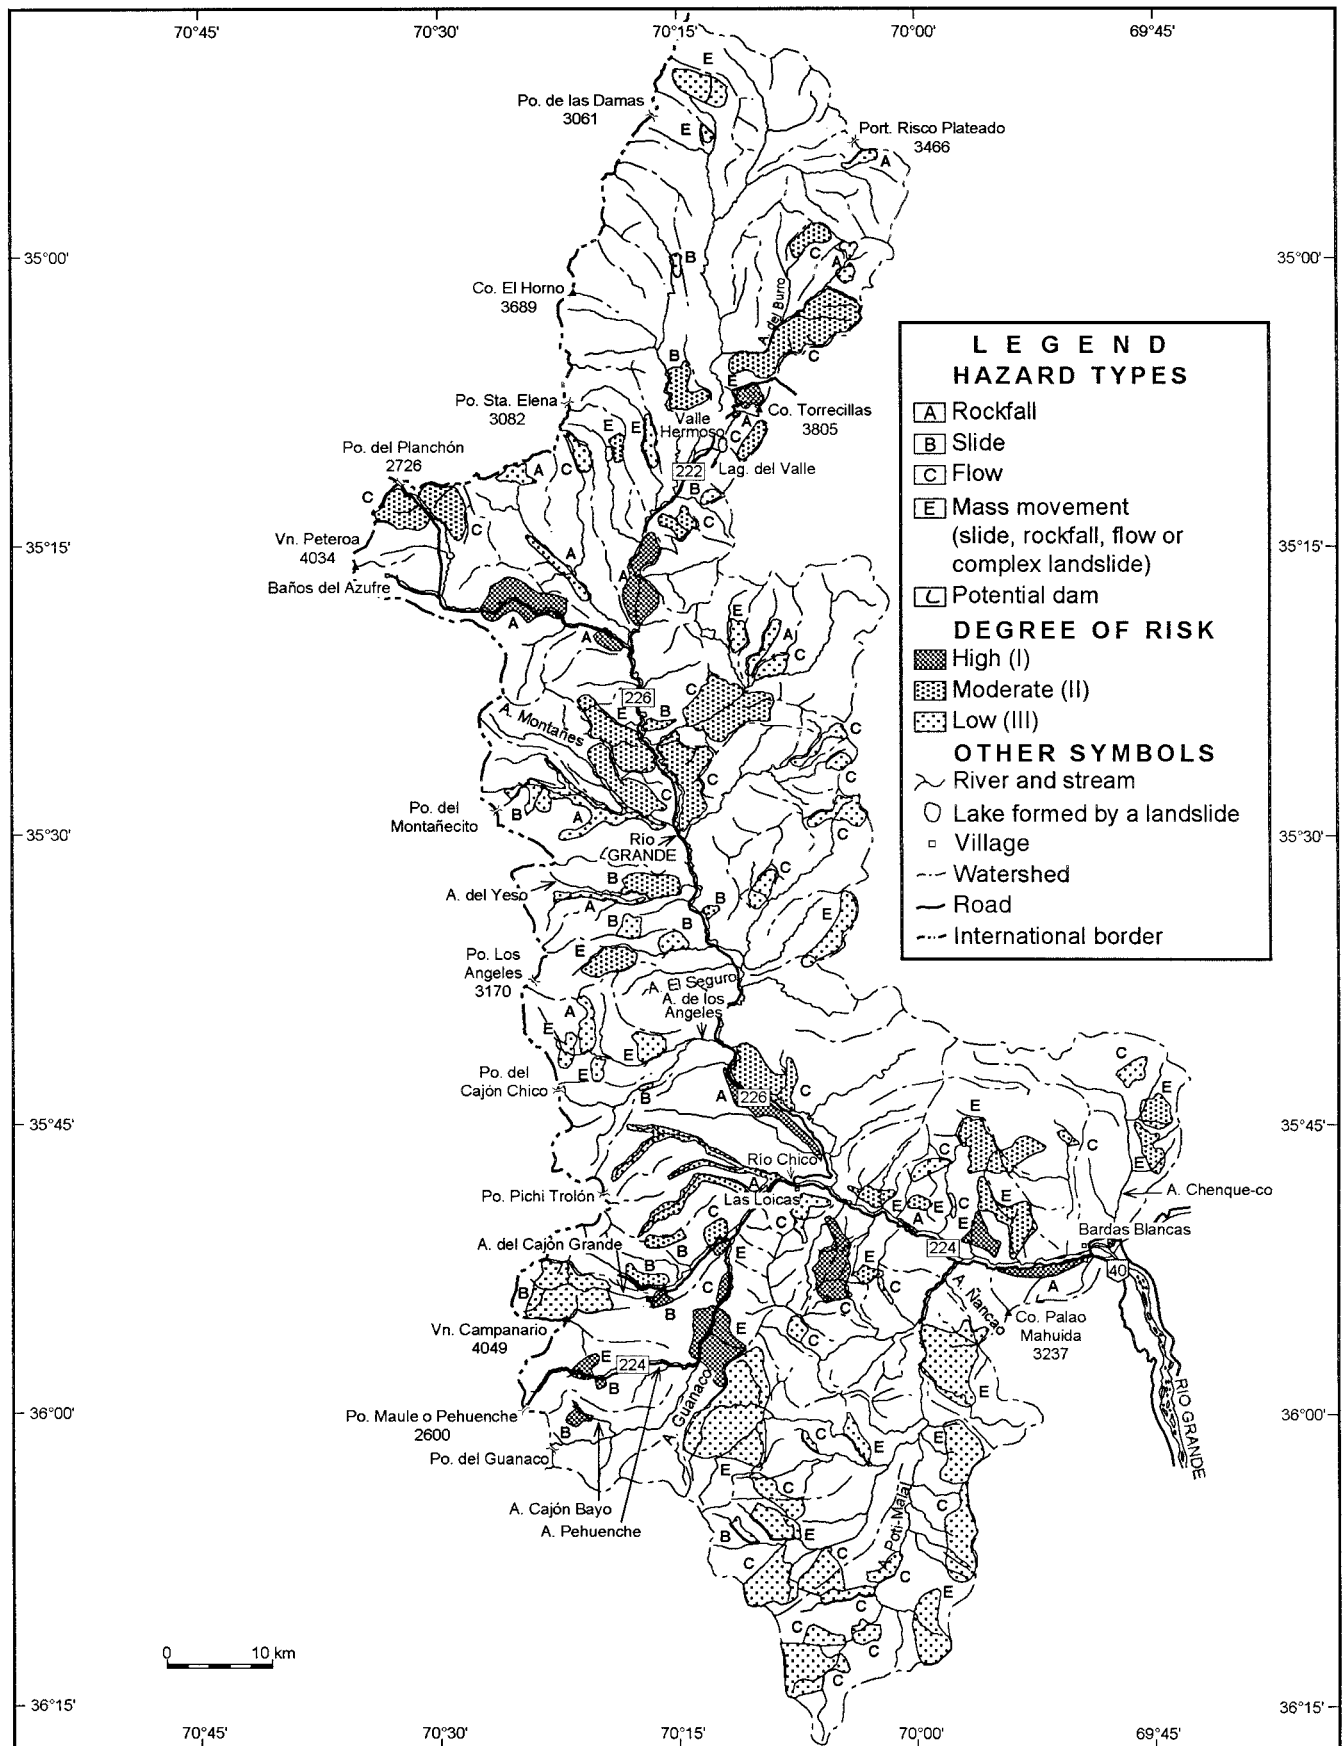
**FIGURE 6** Map of landslide hazards and risk zonation in the Río Grande basin.

A landslide risk map was obtained showing the hazards and elements at risk according to UNDRO/UNESCO (See Coburn et al 1994) definitions. The risk map shows that the major hazards and the greatest potential risk are concentrated along the Río Grande valley and its tributaries where the roads, routes, and settlements are located. Three risk degrees were distinguished as follows (Figure 6):

- *Degree I (high risk)*. This is the category with the highest degree of hazard and risk, where rockfalls, flows, or slides that could occur would affect Provincial routes 222 and 224, roads, bridges, or small, populated centers. Rockfalls are probably the most frequently observed mass movements in mountain areas. The areas where rockfalls occur are subject to events of lesser magnitude that occur more frequently; therefore, construction should be avoided.

- *Degree II (moderate risk)*. This category covers areas vulnerable to the potential occurrence of landslides, but the threat to infrastructure in the area is not as great because the hazard zones are far away. Through field observations in March 1996, it was possible to detect the occurrence of a debris flow that flowed from the headwaters of Arroyo Chenque-Co after a heavy rainstorm (Degrees II and III; Figure 6). Highway No. 40 and a small bridge were damaged (Degree I; Figure 6).

- *Degree III (low risk)*. The occurrence of a potential landslide is relatively remote, and the expected damage to the infrastructure is very slight.
- *Potential dam*. The potential occurrence of a specific hazard induced by large mass movements that could cross the valley floor up to the opposite slope, thus damming a river or a creek, was considered as a slide hazard zone. In case the dam is broken, a catastrophic flood could occur, posing high risk to inhabited areas and infrastructure located downstream.
