Landslide Hazard and Risk Zonation Mapping in the Río Grande Basin, Central Andes of Mendoza, Argentina

Source: Mountain Research and Development, 22(2) : 177-185

This paper presents an inventory of landslides and hazard and risk zonation mapping along the Río Grande basin in the Central Andes of Mendoza. The mapping was based on field work combined

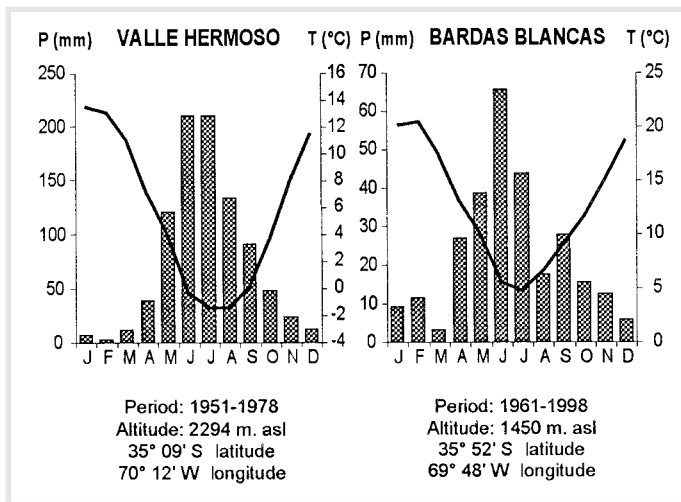
FIGURE 2 Monthly mean precipitation and temperature in Valle Hermoso and Bardas Blancas meteorological stations.

There are 2 meteorological stations in the zone, with interrupted records: (1) Valle Hermoso (35°09'S, 70°12'W) at 2294 m, and (2) Bardas Blancas (35°52'S, 69°48'W) at 1450 m. The mean monthly precipitation and temperature records show 2 well-defined periods, one in winter and the other in summer (Figure 2). The monthly mean maximum precipitation coincides with the monthly mean minimum temperature. In Valle Hermoso the mean monthly temperature from June to August is below 0°C. At this station the higher monthly precipitation occurs in the winter as snow, whereas in Bardas Blancas it can be snow or rain and occurs from May to June. Annual mean precipitation varies from 400 mm in Bardas Blancas to 940 mm in Valle Hermoso.

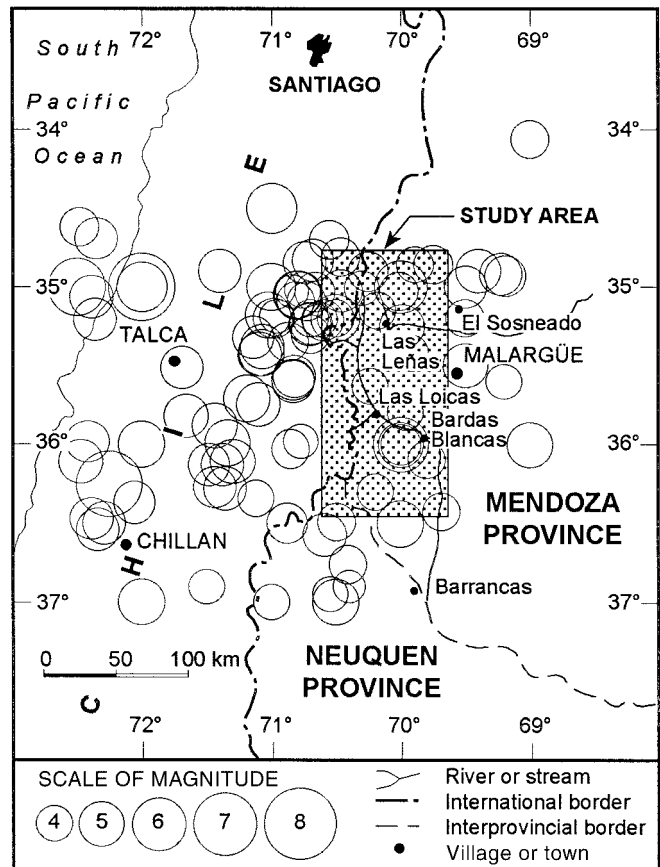
FIGURE 3 Location of earthquakes (epicenters and magnitudes).

sity of Chile. Ninety earthquakes with magnitudes greater than 4 have occurred in the area. Figure 3 shows the location of the epicenters and magnitudes in the study area and the surrounding zones; the figure shows that there is an increase in the number of earthquakes and in their magnitudes toward the west.

Seismic activity is recognized as the predominant factor in triggering landslides. Because of scarce historical information on the occurrence of landslides, it was not possible to relate them to earthquakes, except for a reactivated slide that occurred in the subbasin of the Cajón Bayo creek, a tributary of the Río Pehuenche. On the basis of satellite images, it was calculated that this slide (Figure 4) occurred between March 1985 and February 1986. The landslide may have been induced by 7 earthquakes (Richter magnitude > 5) that occurred in the general vicinity of the Cajón Bayo area (estimated epicentral location between 70 and 200 km).

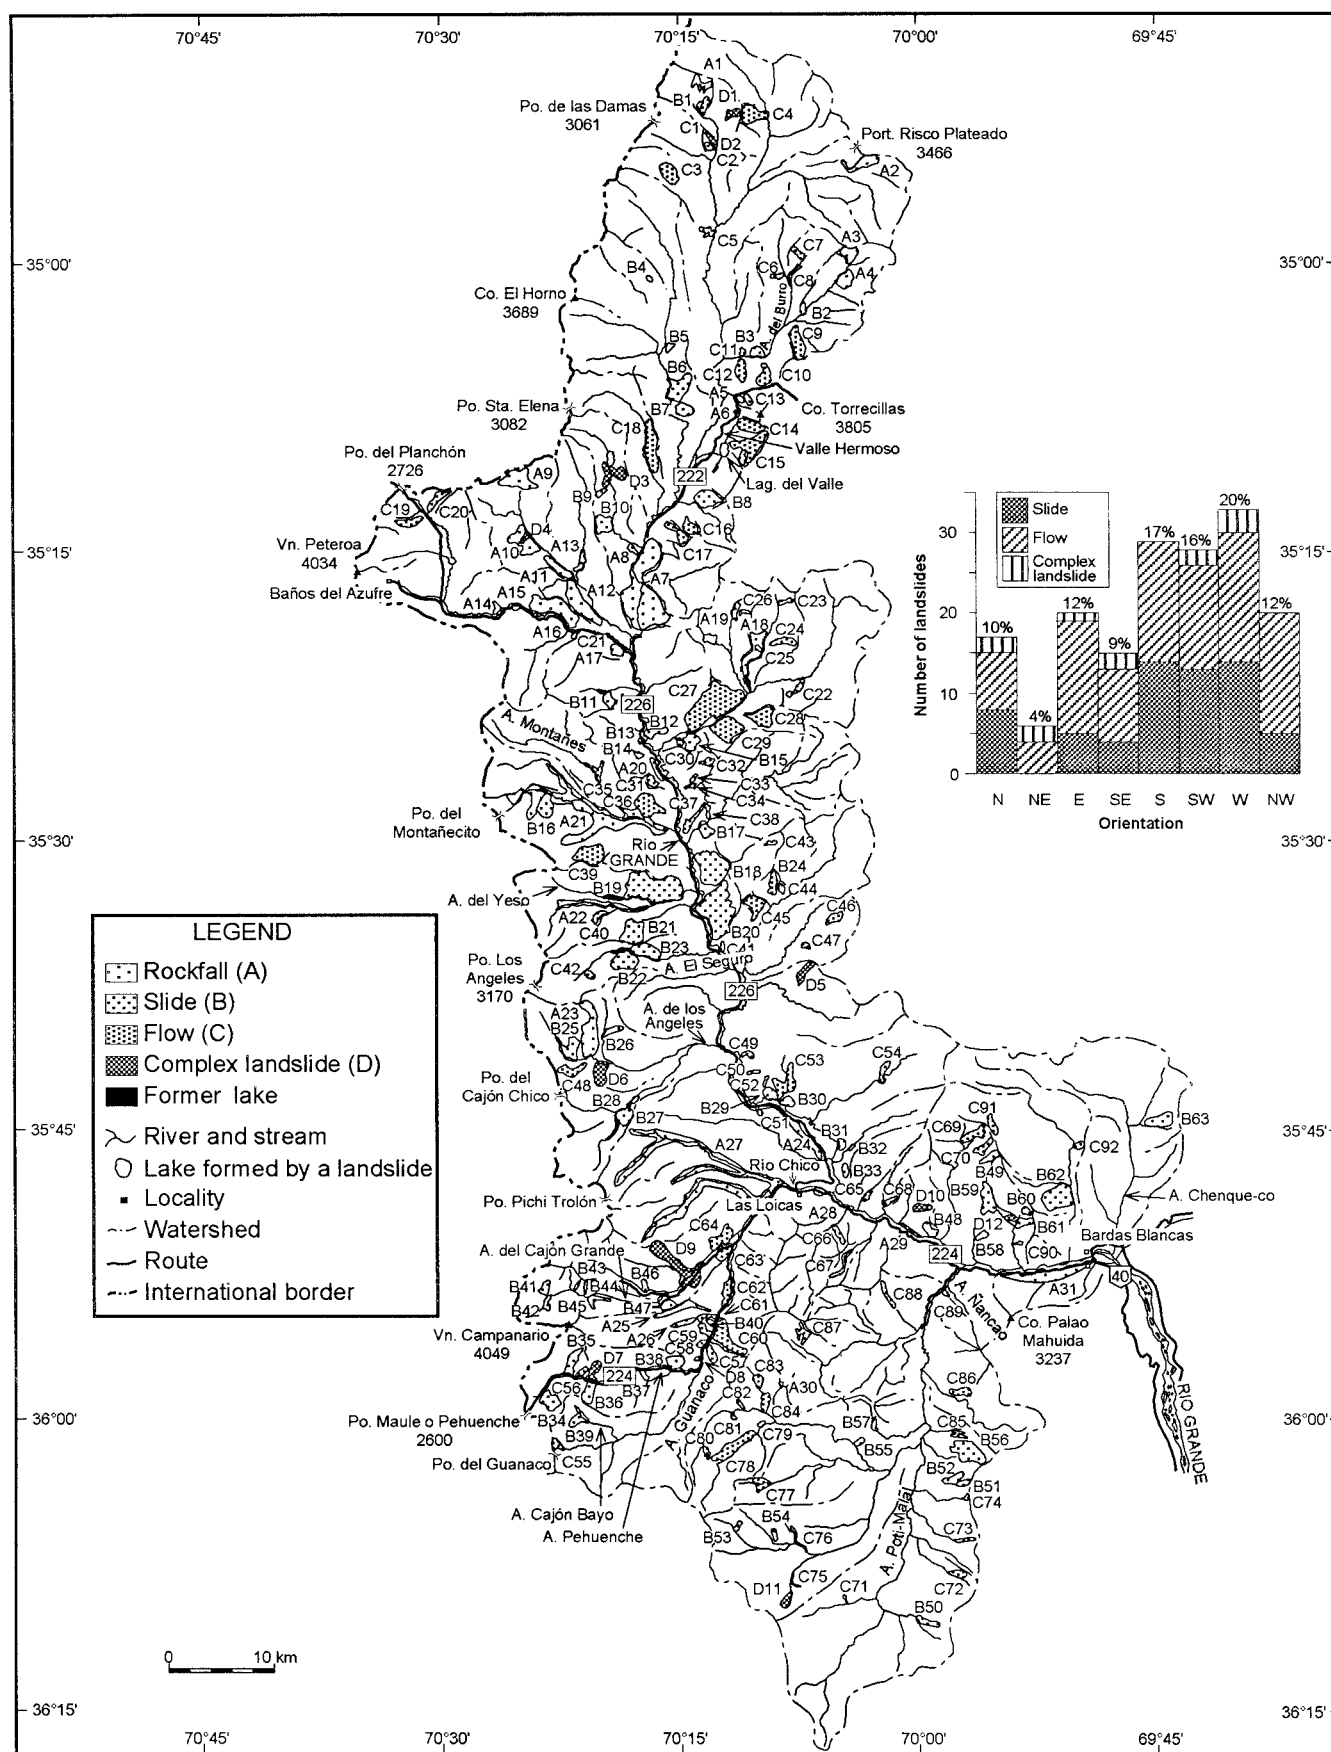
FIGURE 5 Inventory and location of landslides in the study area in the Río Grande basin.

The Río Grande valley has a north–south trend. Analyzing the orientation of 198 landslides represented in Figure 5, the flows, slides, and complex landslides are preferably oriented toward the west, south, and south-west. The predominance of flows and slides oriented toward the south and to the west is partly the result of those slopes being colder; they accumulate more snow and it remains there longer. Therefore, during the snowmelt season the amount of water is higher. The snow that remains in the cold slopes produces a more intense chemical and physical weathering of the rock, because of the presence of water in cracks and caverns, which freezes and thaws, and the hydration of clays and anhydrite.

We prepared 2 maps. The distribution and classification of landslides are shown on the first map (inventory map; Figure 5). The second—a landslide hazard and risk zonation map (Figure 6)—was prepared taking into account the zones subject to landslide hazard and the degree of loss to a given element or set of elements at risk in the region because of the occurrence of a particular phenomenon of a given magnitude (Coburn et al 1994).

Landslides are identified on the maps and classified according to Varnes (1984), on the basis of the type of movement and material involved, and they are individualized as follows: (A) rockfalls, (B) slides, (C) flows, (D) complex landslides. The number following each capital letter indicates the number of the landslide in each category.

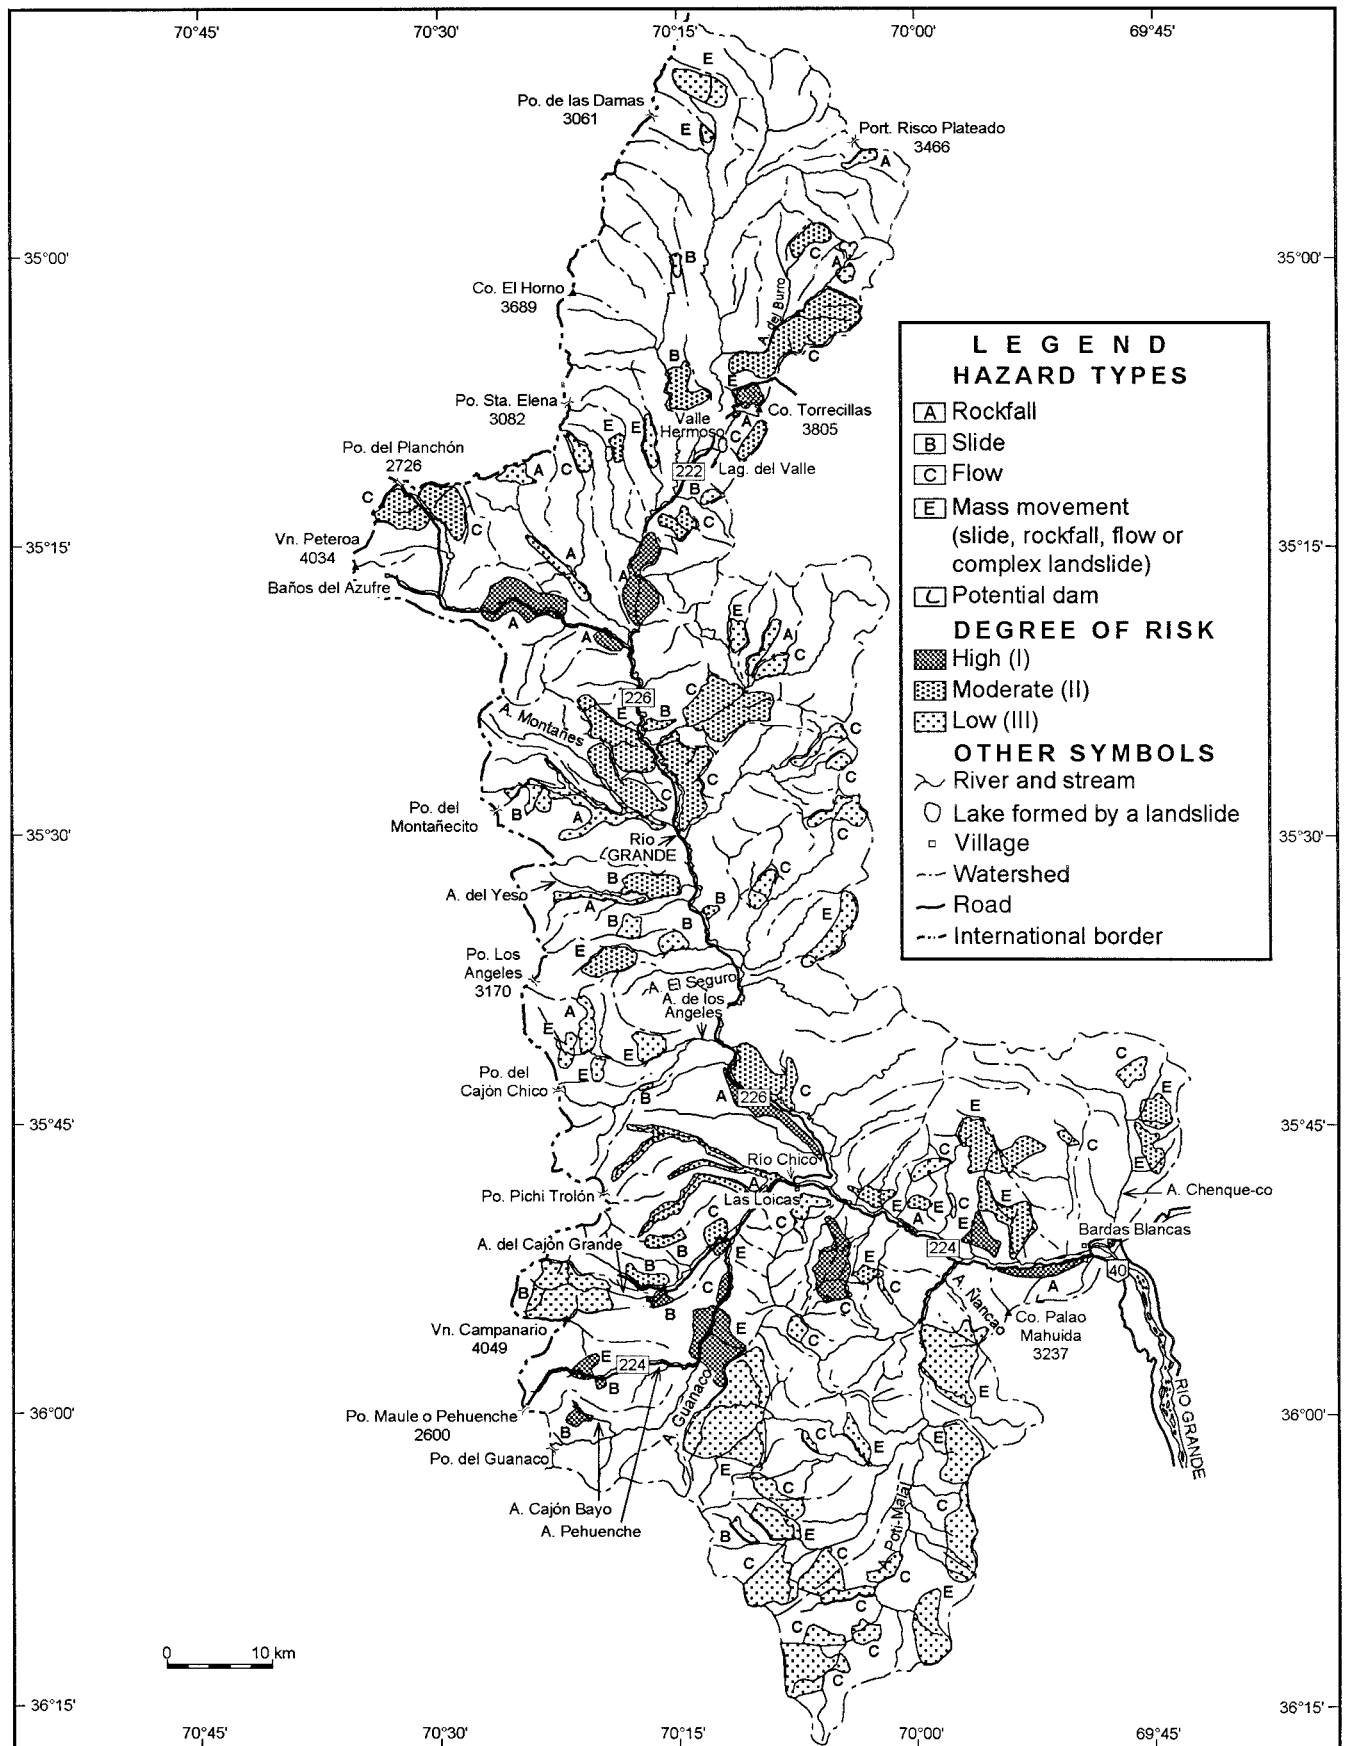
FIGURE 6 Map of landslide hazards and risk zonation in the Río Grande basin.

A landslide risk map was obtained showing the hazards and elements at risk according to UNDRO/UNESCO (See Coburn et al 1994) definitions. The risk map shows that the major hazards and the greatest potential risk are concentrated along the Río Grande valley and its tributaries where the roads, routes, and settlements are located. Three risk degrees were distinguished as follows (Figure 6):

- *Degree I (high risk)*. This is the category with the highest degree of hazard and risk, where rockfalls, flows, or slides that could occur would affect Provincial routes 222 and 224, roads, bridges, or small, populated centers. Rockfalls are probably the most frequently observed mass movements in mountain areas. The areas where rockfalls occur are subject to events of lesser magnitude that occur more frequently; therefore, construction should be avoided.

- *Degree II (moderate risk)*. This category covers areas vulnerable to the potential occurrence of landslides, but the threat to infrastructure in the area is not as great because the hazard zones are far away. Through field observations in March 1996, it was possible to detect the occurrence of a debris flow that flowed from the headwaters of Arroyo Chenque-Co after a heavy rainstorm (Degrees II and III; Figure 6). Highway No. 40 and a small bridge were damaged (Degree I; Figure 6).

- *Degree III (low risk)*. The occurrence of a potential landslide is relatively remote, and the expected damage to the infrastructure is very slight.
- *Potential dam*. The potential occurrence of a specific hazard induced by large mass movements that could cross the valley floor up to the opposite slope, thus damming a river or a creek, was considered as a slide hazard zone. In case the dam is broken, a catastrophic flood could occur, posing high risk to inhabited areas and infrastructure located downstream.
