Source: Mountain Research and Development, 24(1) : 19-23

Managing Debris Flow Risks

Security Measures for a Hazard-Prone Resort in Switzerland

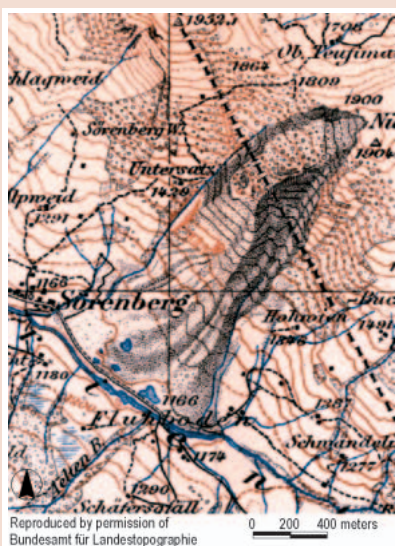
FIGURE 2 1918 topographic map, showing the open scars on either side of the mass and the typical accumulation features developed in 1910 and 1912. The few houses with the church (at the center of the village) are located in a safe place. (Map reproduced by permission of Bundesamt für Landestopographie, BA024084)

Analysis of past events makes an important contribution to the understanding of present and future hazards in a particular location. A number of historic documents such as maps (Figure 2), postcards or photographs, as well as a detailed description of the 1910 events by the famous geologist Albert Heim, provided the necessary information to reconstruct the sequence of landslide events in the 20th century. Between 1860 and 1910 the entire complex shifted downhill by more than 30 m in a large vertical movement. In 1910 another large vertical movement occurred, lasting several days and causing 2 major lateral collapses and massive debris flows of over 3 million m³. Throughout the rest of the 20th century development was irregular. Several lateral and frontal collapses occurred in 1912, 1922, and 1986, with 6 decades of geomorphic inactivity in between.

At the beginning of the 20th century the area now occupied by the village was used as grazing land. The map (Figure 2) indicates that the existing few houses in Sörenberg were arranged around the church in a safe place. Within the accumulation area of the 1910, 1912 and 1922 debris flows, only a very few isolated houses were destroyed.

Sörenberg's development into the tourist resort that it is today took place only over the past 30 to 40 years. The 1918 map (Figure 2) clearly shows that at that time only very few buildings were located in what was once a highly active accumulation area. Today this area is completely covered by houses (Figure 3). The long period of geomorphic inactivity following the events of 1922 was interpreted as a sign of future security. An analysis by experts in 1974 proved that there was no immediate threat, but did not altogether exclude the possibility of damaging events. An indication of the uncertainty of the situation was provided by displacement measurements begun in 1978. These clearly show that the whole mass is continuously moving about 3 to 10 cm per year. The speed of this movement increased dramatically in 1999 but has slowed down again since.
