Managing Debris Flow Risks

Source: Mountain Research and Development, 24(1) : 19-23

Security Measures for a Hazard-Prone Resort in Switzerland

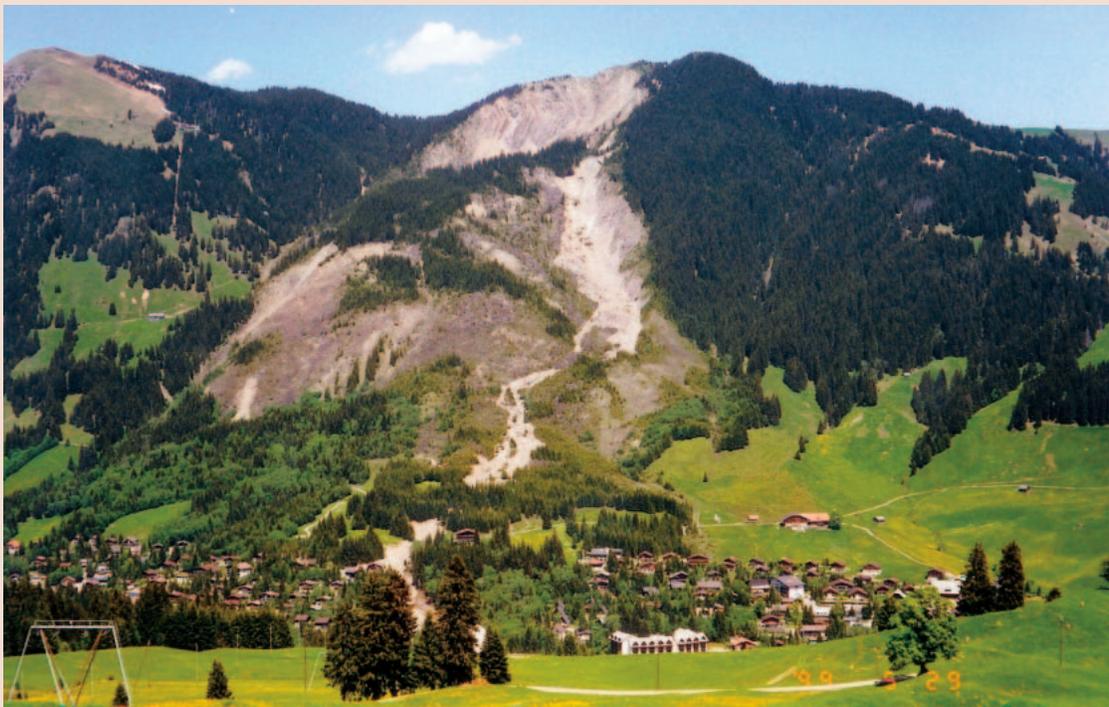
FIGURE 1 The tourist resort of Sörenberg, located in the Entlebuch Biosphere Reserve, Central Switzerland. The village is located at the foot of a deep-seated landslide complex. The bright surfaces mark the geomorphological zones active in 1999. (Photo by author)

Sörenberg is a typical small tourist resort located on the periphery of the Swiss Alps in Central Switzerland (Figure 1). The village has developed only during the last 40 years; prior to that, it was known as a spa. Today, about 800 housing units—mainly secondary homes (chalets and tourist apartments)—are situated on old debris flow deposits. In addition, a number of sports and leisure facilities have been constructed in recent years. The slopes above the village belong to a large (15 million m³)

and deep-seated (100 m) landslide complex (sagging or rock flow). Signs of instability in this area have been apparent since the mid 19th century or even earlier.

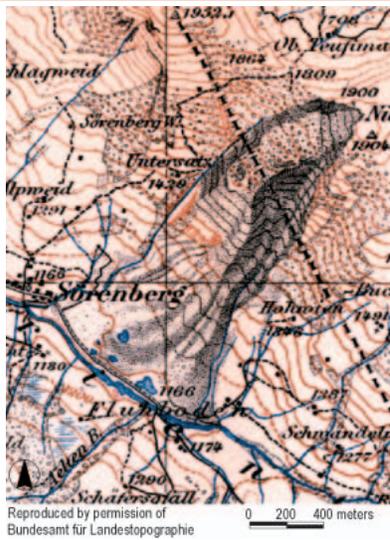
FIGURE 2 1918 topographic map, showing the open scars on either side of the mass and the typical accumulation features developed in 1910 and 1912. The few houses with the church (at the center of the village) are located in a safe place. (Map reproduced by permission of Bundesamt für Landestopographie, BA024084)

Analysis of past events makes an important contribution to the understanding of present and future hazards in a particular location. A number of historic documents such as maps (Figure 2), postcards or photographs, as well as a detailed description of the 1910 events by the famous geologist Albert Heim, provided the necessary information to reconstruct the sequence of landslide events in the 20th century. Between 1860 and 1910 the entire complex shifted downhill by more than 30 m in a large vertical movement. In 1910 another large vertical movement occurred, lasting several days and causing 2 major lateral collapses and massive debris flows of over 3 million m³. Throughout the rest of the 20th century development was irregular. Several lateral and frontal collapses occurred in 1912, 1922, and 1986, with 6 decades of geomorphic inactivity in between.

At the beginning of the 20th century the area now occupied by the village was used as grazing land. The map (Figure 2) indicates that the existing few houses in Sörenberg were arranged around the church in a safe place. Within the accumulation area of the 1910, 1912 and 1922 debris flows, only a very few isolated houses were destroyed.

Sörenberg's development into the tourist resort that it is today took place only over the past 30 to 40 years. The 1918 map (Figure 2) clearly shows that at that time only very few buildings were located in what was once a highly active accumulation area. Today this area is completely covered by houses (Figure 3). The long period of geomorphic inactivity following the events of 1922 was interpreted as a sign of future security. An analysis by experts in 1974 proved that there was no immediate threat, but did not altogether exclude the possibility of damaging events. An indication of the uncertainty of the situation was provided by displacement measurements begun in 1978. These clearly show that the whole mass is continuously moving about 3 to 10 cm per year. The speed of this movement increased dramatically in 1999 but has slowed down again since.
