Sand dune management problems and techniques, Spain.

Source: Journal of Coastal Research, 36(sp1) : 325-332

ABSTRACT

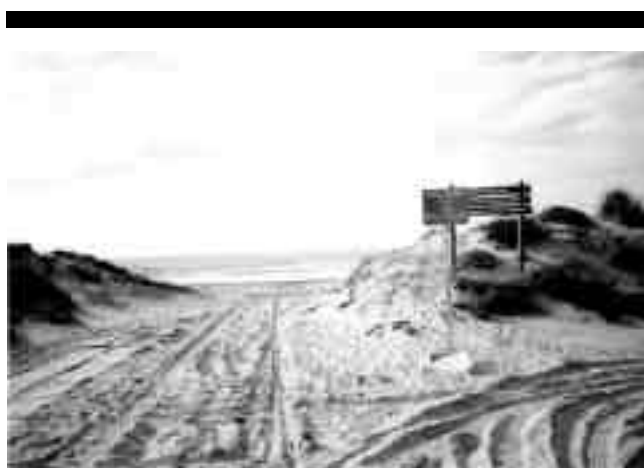
Figure 1. Typical dune breaching in La Bota (Huelva, Spain), Gómez-Pina 1997

Figures from GÓMEZ-PINA(1999) are representative of dune degradation in La Bota beach (Huelva). Figure 1 shows a typical dune breach caused by off-road vehicles and human trampling. Figure 2 depicts the existing public road, crossing the foredunes longitudinally. The removal of this road is part of a very ambitious integrated dune management project being carried out by the National Spanish Coast Directorate, Ministry of Environment.

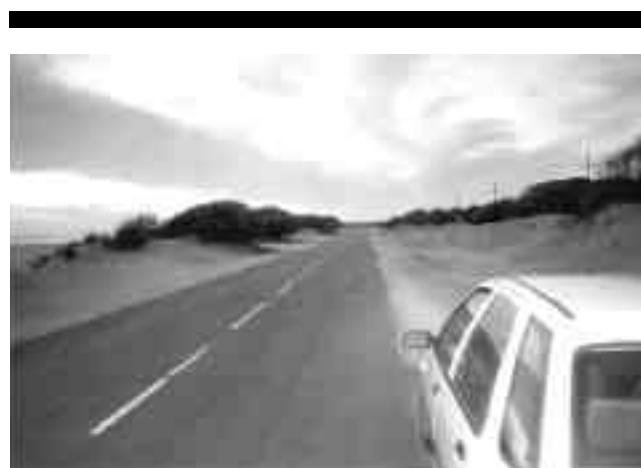
Figure 2. Existing road alongside La Bota beach (Huelva, Spain), Gómez-Pina 1997.

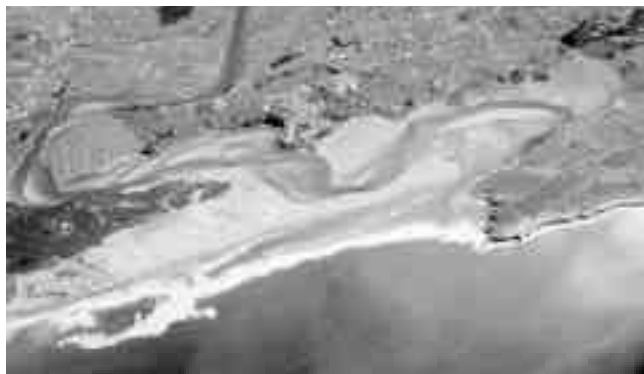
Figure 6. An aerial view of Liencres spit (Cantabrian, Spain) after breaching.

Figure 6 depicts an aerial view of Liencres spit after dune breaching. In Figure 7 sand accumulation caused by willow fences can be seen. Elevated dune walkovers and fencing are shown in Figure 8.

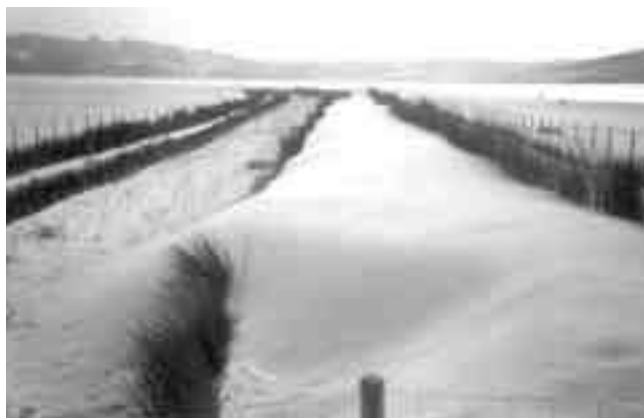
Figure 7. A detail of dune restoration in Liencres spit (Cantabrian, Spain)
