Hurricane-induced shoreline change and post-storm recovery: northeastern Yucatan Peninsula, Mexico

Source: Journal of Coastal Research, 75(sp1): 1192-1196

Mulcahy, N.; Kennedy, D.M., and Blanchon, P., 2016. Hurricane-induced shoreline change and post-storm recovery: northeastern Yucatan Peninsula, Mexico. *In:* Vila-Concejo, A.; Bruce, E.; Kennedy, D.M., and McCarroll, R.J. (eds.), *Proceedings of the 14th International Coastal Symposium* (Sydney, Australia). *Journal of Coastal Research*, Special Issue, No. 75, pp. 1192 - 1196. Coconut Creek (Florida), ISSN 0749-0208.

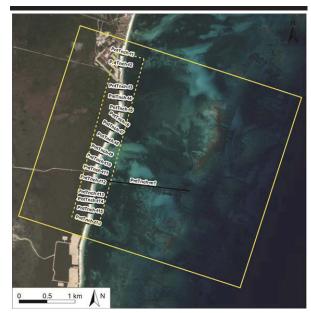
Punta Tanchacte is situated behind a fringing reef which encloses a lagoon 1.35 - 1.80 km wide and 3 - 4 m deep (Figure 2). It is characterised by the highest foredunes in the study area, which range from 3.0 - 6.5 m above MHW.

Figure 2. Punta Tanchacte, showing the location of the transects measured in this study.

Storm waves from Hurricane Wilma reworked the beach and part of the foredune at Punta Tanchacte. Lower sections of foredune were overtopped, and the beach widened to 78.2 ± 8.6 m. This represented an average increase of 16.3 ± 3.9 m, but varied from 24.6 m at the southern end to 7.7 m in the north.

By June 2006, eight months after Hurricane Wilma, the beach had narrowed to 74.7 ± 8.3 m. However, this was highly variable, with the greatest erosion experienced at the southern end (9.7 m), no change in the centre of the zone, and shoreline accretion further north (2.7 m). By April 2010, a further 48 months later, the beach had undergone continued erosion at all sites, with an average reduction of 11.8 ± 5.7 m since June 2006, amounting to 15.5 ± 4.9 m since Hurricane Wilma (Figure 3).

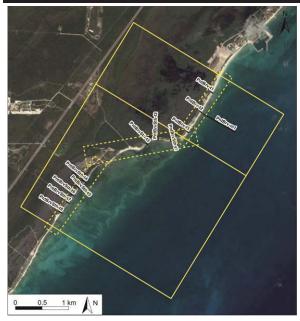
In contrast, Punta Brava, situated in the south of the study area, is directly exposed to waves from the Caribbean Sea due to its location within a gap in the Mesoamerican Reef Tract (Figure 4). The site has a relatively steep shoreface, and the dunes reach up to 3.0 m above MHW.

Figure 4. Punta Brava (top box), showing the location of the transects measured in this study.

Storm waves inundated the site during Hurricane Wilma, reworking and overwashing the beach and foredune. Considerable volumes of sediment, including large coral boulders, were transferred into the backdune and mangrove wetlands. As a result, the barrier beach eroded by an average of 5.3 ± 4.8 m, with the greatest erosion at the southernmost site.

By June 2006, the barrier beach had undergone some shoreline recovery. The response was, however, highly variable, with on average 6.3 ± 6.7 m of accretion. The barrier beach was therefore 1.1 ± 2.0 m wider than the pre-storm beach width, indicating the shoreline had largely recovered. By June 2010, the shoreline had shifted once again, with shoreline transgression of up to 4.4 m at the northern and southern ends of the site, contrasting beach accretion of 2.8 m in the centre (Figure 5). This indicates that the prevailing energy regime, and other site-specific factors, contribute to regular shoreline movement at Punta Brava.
