Avian Electrocutions in Western Rajasthan, India

Source: Journal of Raptor Research, 47(4) : 352-364

AVIAN ELECTROCUTIONS IN WESTERN RAJASTHAN, INDIA

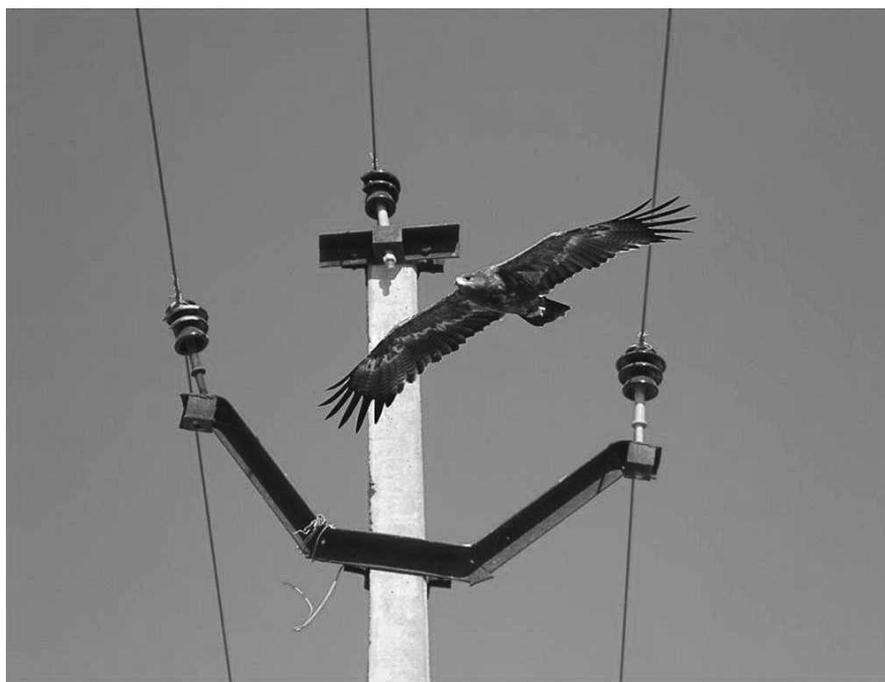
Figure 1. Typical 11-kV concrete pole with a grounded metal cross-arm. A Steppe Eagle (*Aquila nipalensis*), a common raptor in Rajasthan, India, with a wingspan of 165–190 cm, provides a reference for relative size.

grounded metal rebar, and affixed with metal cross-arms and pole-top insulator supports (Fig. 1). Because the rebar lattice within the concrete is conductive and grounded, the metal cross-arms attached to the pole are indirectly grounded. This creates pole configurations that are functionally similar to metal poles, where electrocution risk is substantially higher than on wooden poles (e.g., Harness 1998, Janss and Ferrer 1999, Garrido and Fernández-Cruz 2003).

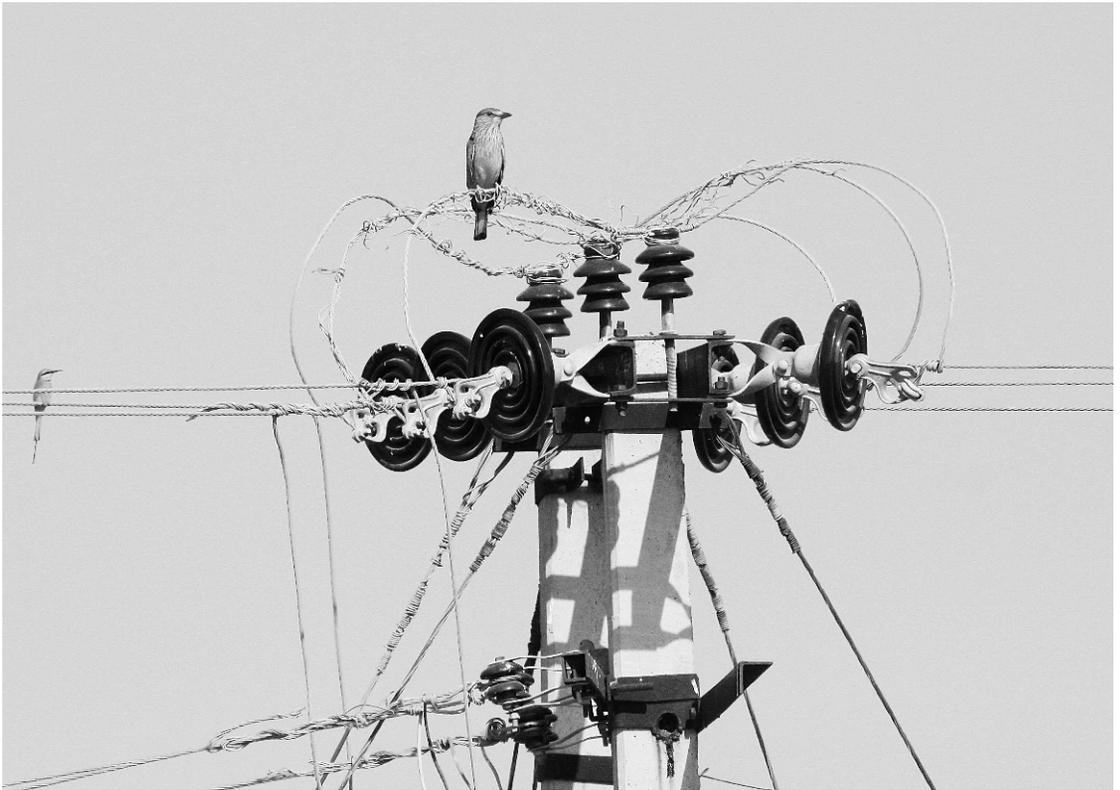
Figure 4. Indian Roller (*Coracias benghalensis*) perched on a typical 11-kV utility pole with six jumpers in Rajasthan, India.

The jumper count equaled the number of jumpers on each pole (Fig. 4). Jumpers are short wires that connect energized devices such as switches and transformers to the primary circuit wires running between poles. Jumpers are also used to connect primary wires at poles where lines diverge or change direction. Counting the number of jumpers allowed us to incorporate all energized equipment in a single modeled variable. This avoided problems with lack of independence among variables, which otherwise would have arisen if we quantified each type of pole-mounted equipment separately (Dwyer et al. 2013).

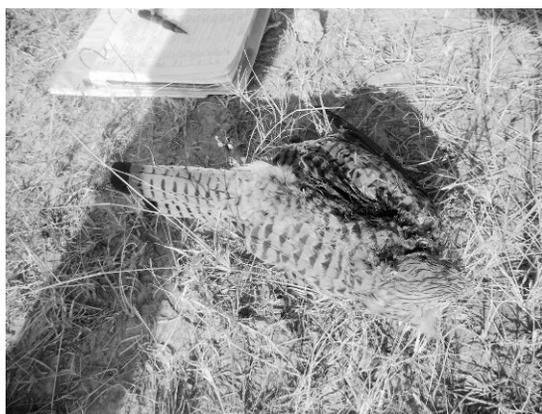
Figure 6. Eurasian Kestrel (*Falco tinnunculus*) with electric burn marks visible on the left scapulars, found beneath an energized utility pole in Rajasthan, India.
