Erosion Processes in High Mountain Agricultural Terraces in Peru

Authors: Inbar, Moshe, and Llerena, Carlos A.

Source: Mountain Research and Development, 20(1) : 72-79

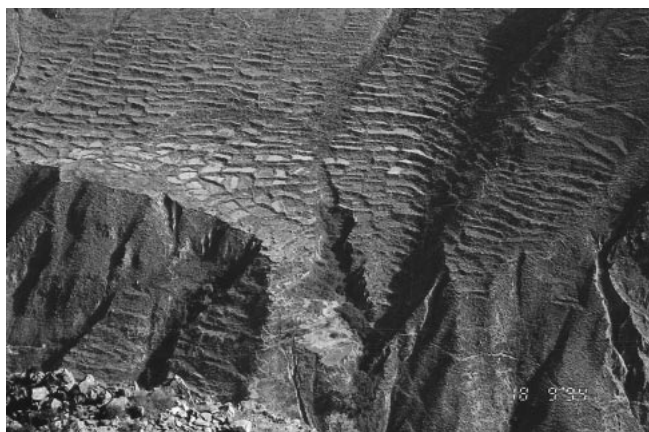
FIGURE 2 View of the steep slopes in the Santa Eulalia river valley. Paths of frequent debris flows, known locally as *huaycos*, are clear. Terraces are built on slopes steeper than 400°. (Photo by authors)

slides, known locally as *huaycos*, left visible paths and alluvial cones (Figure 2). Due to the rapid incision rate, channels are narrow and no floodplain has developed. Due to the rugged landscape, settlements are distributed on the higher flat terrains below available water sources.

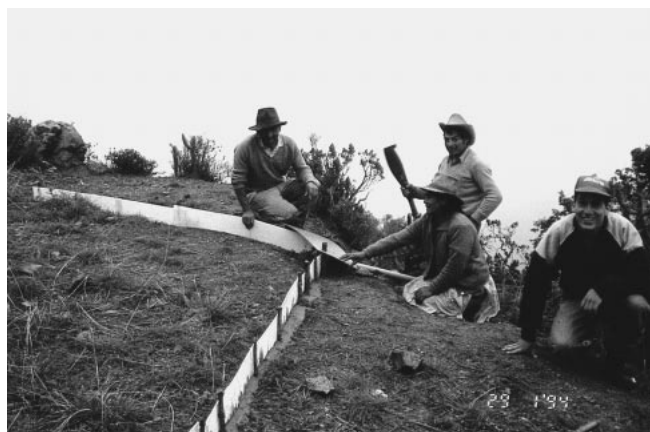
FIGURE 4 Experimental plot for measuring run-off and sediment yield on an abandoned terrace. (Photo by authors)

Eight experimental plots were installed on abandoned terraces and one control plot on a cultivated terrace in order to measure run-off and sediment yield from ter-

aces after rainstorms. The plot area for each terrace was between 50 and 100 m². The plot was bordered by a plastic fence closed at a lower apex, with a plastic tube delivering water and sediment through a pipe to closed containers (Figure 4). Rainfall was measured by a daily rain gauge reading. Water and sediment were collected after each rainfall, and either the total amount or a sample was kept for sediment content and analysis at the laboratory. Data collection was regular, despite the theft of some water containers.

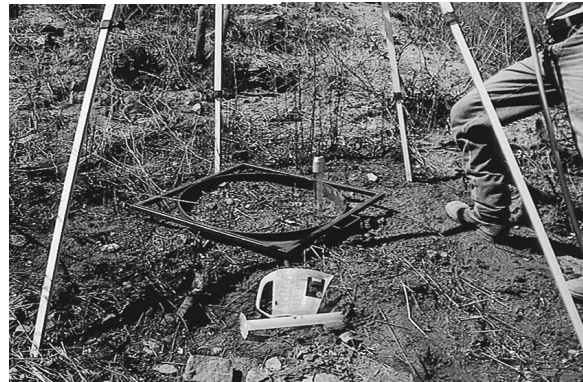
FIGURE 6 Rain simulation on an abandoned terrace in San Juan de Iris. (Photo by authors)

All tests were carried out in the dry season under dry antecedent soil moisture conditions. Infiltration was high on the cultivated and low-gradient terraces. On high, steep slopes, run-off started after 15–20 minutes, and rates of infiltration were 15–20 mm/h. Run-off and sediment yield were high at the steep slope sites and low on the cultivated and low gradient ter-
