Marginal Lands and Erosion in Terraced Fields in the Mediterranean Mountains

Source: Mountain Research and Development, 21(1) : 69-76

A Case Study in the Camero Viejo (Northwestern Iberian System, Spain)

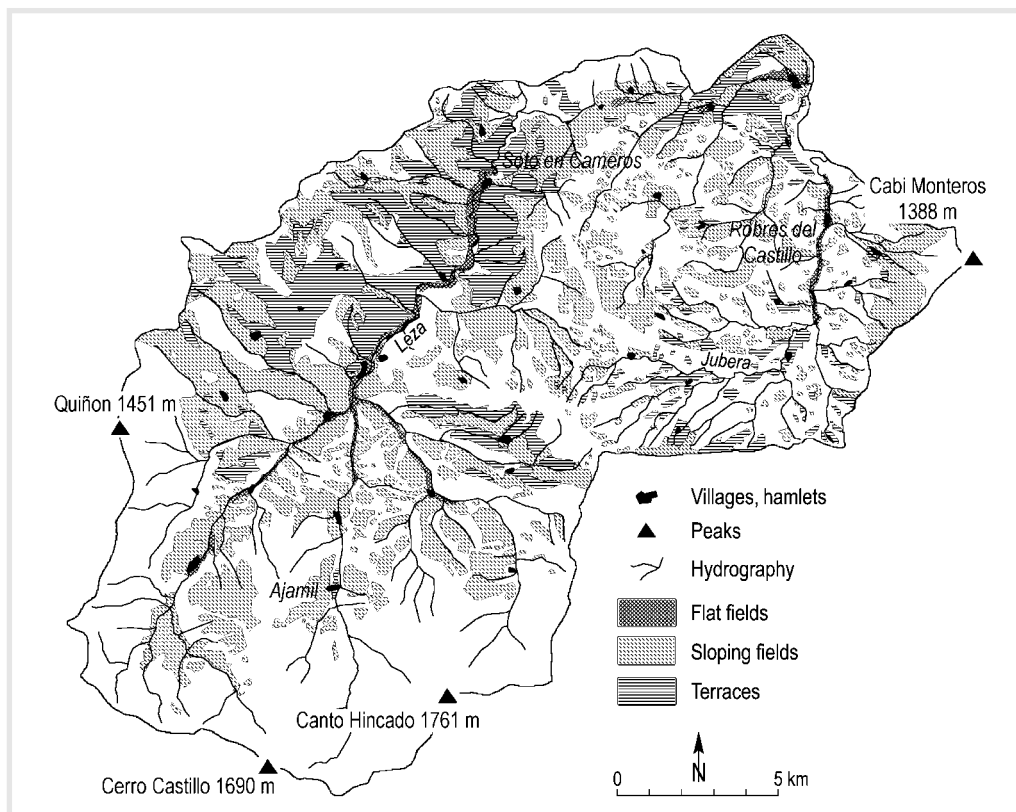
FIGURE 2 Historical farmland and types of fields in the high valleys of the Leza and Jubera (Camero Viejo). The map was drawn on the basis of aerial photographs (1956 and 1977) and was adapted by means of a GIS.

Depending on the inclination of their fields, farmers in the Camero Viejo used different cultivation methods. In 1956, flat fields represented only 3% of the total farmed area (Figure 2). They were well fertilized and irrigated. On slopes near villages, terraces were built to preserve the soil, support the infiltration of water, and increase yields. Terraces represented 28% of the total cultivated area (4412 ha). The rest of the farmed area (69%) consisted of sloping fields. Some of these fields were worked permanently (one year with cereals, the next in fallow) while others were cultivated sporadically (in times of great population growth), with long fallow periods.

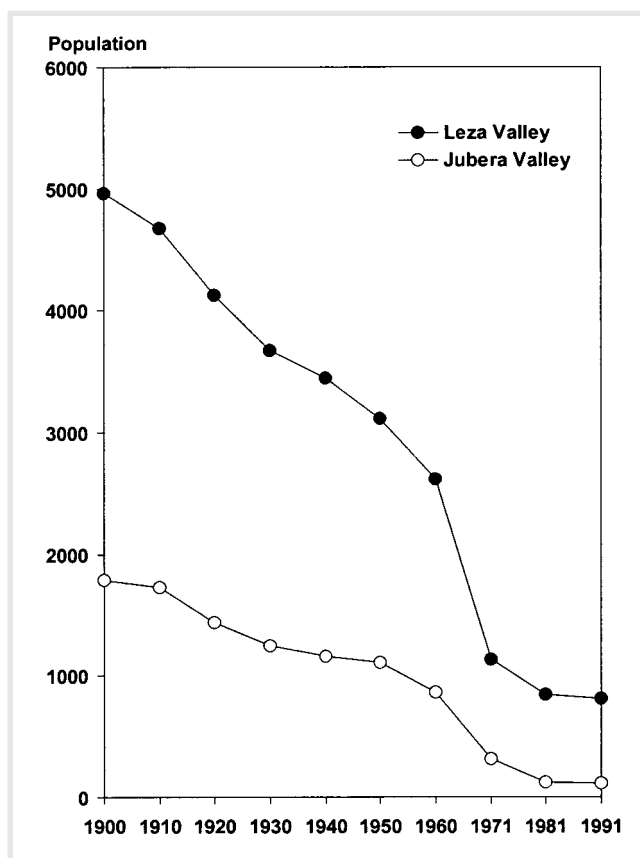
FIGURE 3 Demographic trends in the Camero Viejo (1900–1991).

Figure 3 shows the demographic trends in the two valleys in the study area. The 6754 inhabitants registered in 1900 represented a population density of 17

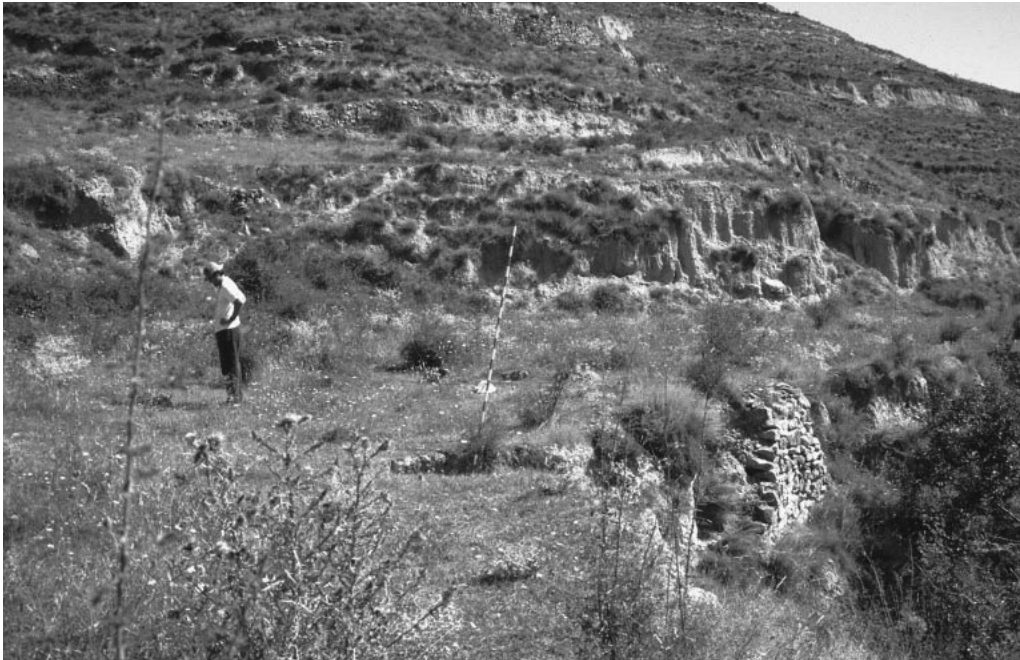
FIGURE 4 Erosion and spread of scrub on high terraces abandoned since the 1940s or 1950s. The 20–25° slope is concave. The terraces are located at a considerable distance from the village of Terroba, Leza Valley. (Photo by L. Ortigosa)

Previously cultivated land was definitively abandoned and started being recolonized by scrub (Figure 4). Some abandoned fields and hillslopes were afforested with *Pinus sylvestris* for the control of hydro-

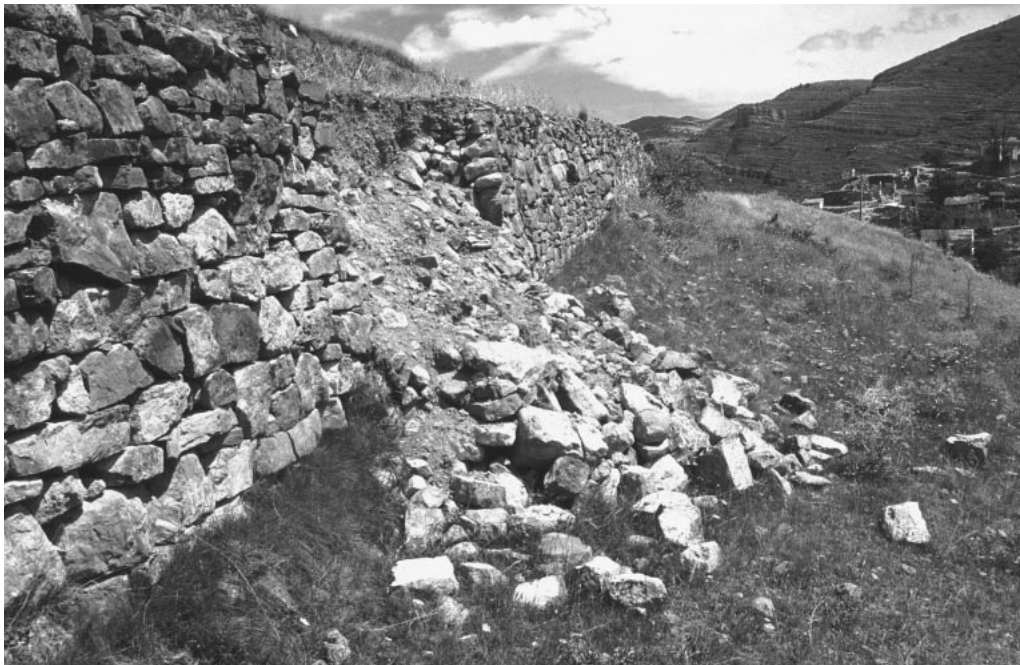
FIGURE 5 Collapse of a terrace wall at the foot of a hill near a village resulting from hydrological pressure higher up (Soto en Cameros, Leza Valley). Fields in this gently sloping area were only abandoned within the last 10 years. (Photo by L. Ortigosa)

The most important erosion process observed on terraced fields was the collapse of terrace walls as a consequence of massive soil movement (small landslides; see Figure 5). Landslides generate an arcuate surface failure and leave the small scarp of the terrace unprotected and susceptible to erosion. On average, each slide was found to move 3.31 m³ of soil and terrace wall. The volume of soil moved was calculated to be 38.80 m³/100 m of wall.

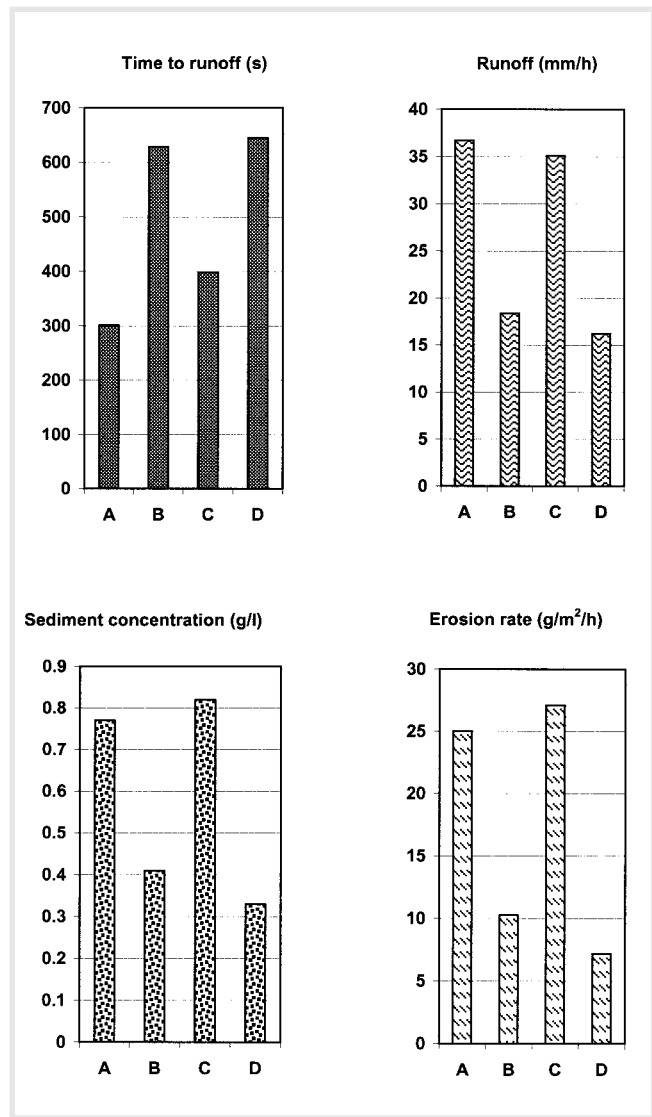
FIGURE 6 Runoff and erosion on abandoned terraces. A, talus at the foot of terrace walls; B, level soil (cultivated field); C, heavily grazed terraces; D, lightly grazed terraces.

Sheet wash erosion was also found on terraced fields. Figure 6, Table 2, and Table 3 show hydrological and sedimentological results of rainfall simulation tests. These results differed depending on what section of a

terrace (Figure 7) was affected and how the field was used. The talus at the foot of a terrace wall (accumulation of material that has been eroded from fields above) produced high runoff coefficient values (49.7%) and had low wetting front values (12.7 cm as an average). These areas were very prone to erosion: the erosion rate obtained by means of the rainfall simulation test was 25 g/m²/h. This hydromorphological behavior was caused by the talus gradient and the scarce plant cover in this section of terraces. Where the soil was level on a terrace, erosion rates were more moderate (Table 2).

highest runoff values (runoff coefficient 41.4%) in the study area. On these plots, runoff began 398 seconds after the rainfall event had started. On lightly grazed plots, runoff began much later (after 645 seconds) and the runoff coefficient was moderate (15.7%). The erosional response also depended on the use of the terraces. The highest sediment concentrations (27.1 g/m²/h) were found on intensively grazed terraces.
