Marginal Lands and Erosion in Terraced Fields in the Mediterranean Mountains

Source: Mountain Research and Development, 21(1) : 69-76

A Case Study in the Camero Viejo (Northwestern Iberian System, Spain)

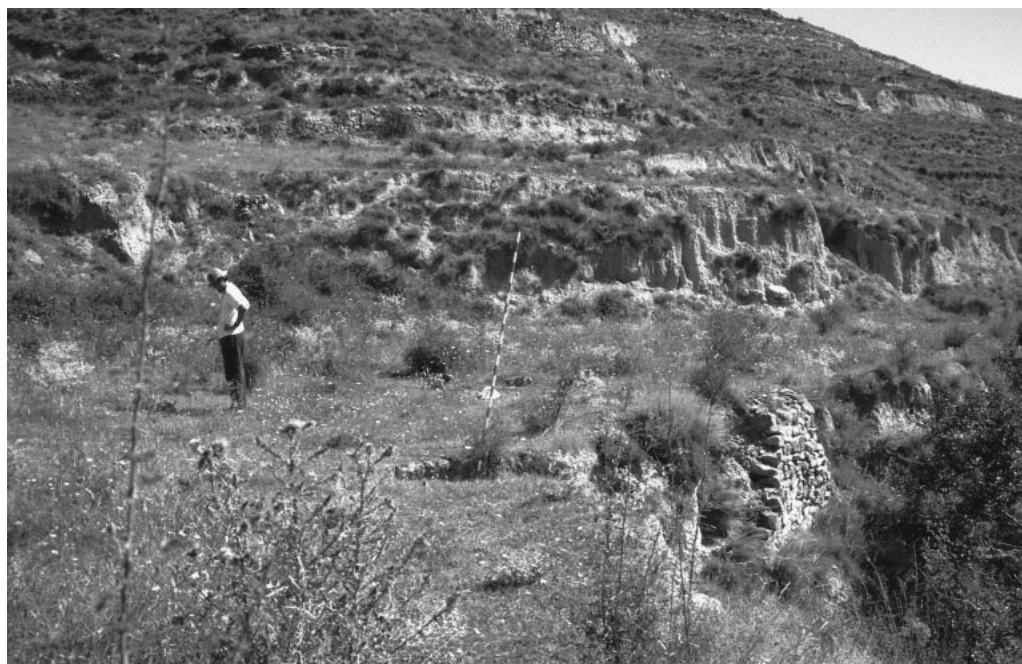
FIGURE 4 Erosion and spread of scrub on high terraces abandoned since the 1940s or 1950s. The 20–25° slope is concave. The terraces are located at a considerable distance from the village of Terroba, Leza Valley. (Photo by L. Ortigosa)

Previously cultivated land was definitively abandoned and started being recolonized by scrub (Figure 4). Some abandoned fields and hillslopes were afforested with *Pinus sylvestris* for the control of hydro-

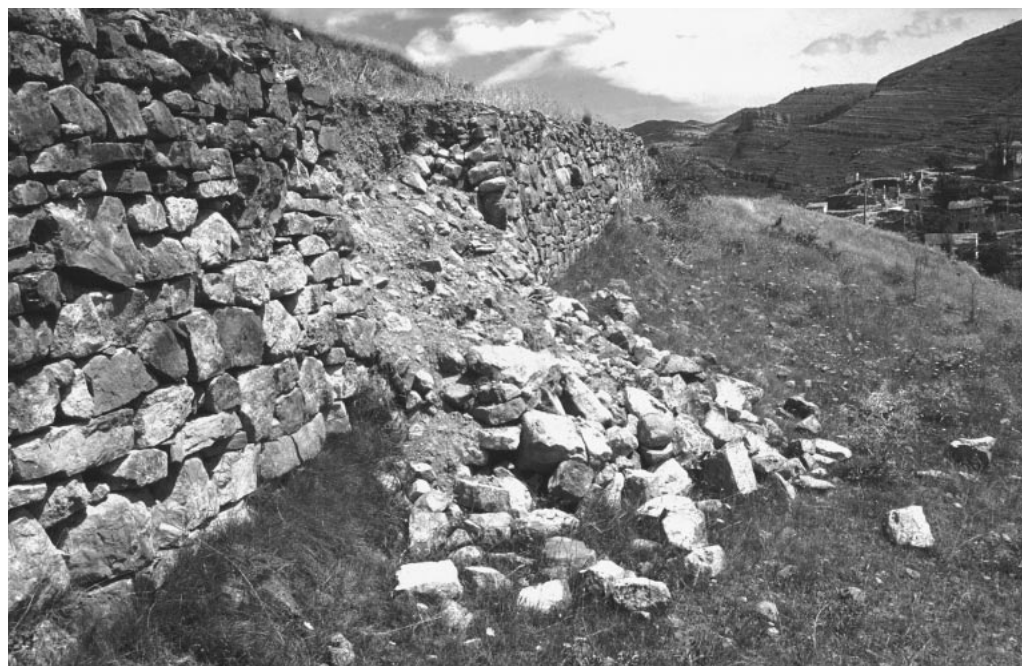
FIGURE 5 Collapse of a terrace wall at the foot of a hill near a village resulting from hydrological pressure higher up (Soto en Cameros, Leza Valley). Fields in this gently sloping area were only abandoned within the last 10 years. (Photo by L. Ortigosa)

The most important erosion process observed on terraced fields was the collapse of terrace walls as a consequence of massive soil movement (small landslides; see Figure 5). Landslides generate an arcuate surface failure and leave the small scarp of the terrace unprotected and susceptible to erosion. On average, each slide was found to move 3.31 m³ of soil and terrace wall. The volume of soil moved was calculated to be 38.80 m³/100 m of wall.

increasing the volume of accumulated soil and its tendency to slide down the slope. However, the most influential factor in this erosion process seems to be the slope's hydrological function. The highest landslide rate (72.8 m³/100 m of terrace wall) was observed on concave slopes, particularly on the lower part of hillslopes (Table 1). Terraces located in these areas receive water from the upper part of the hillslopes. Moreover, their deep and loam-sandy soils retain more moisture. The more a soil's weight increases due to its absorption of water, the greater the likelihood is that a landslide will be triggered (Arnáez et al 1992).

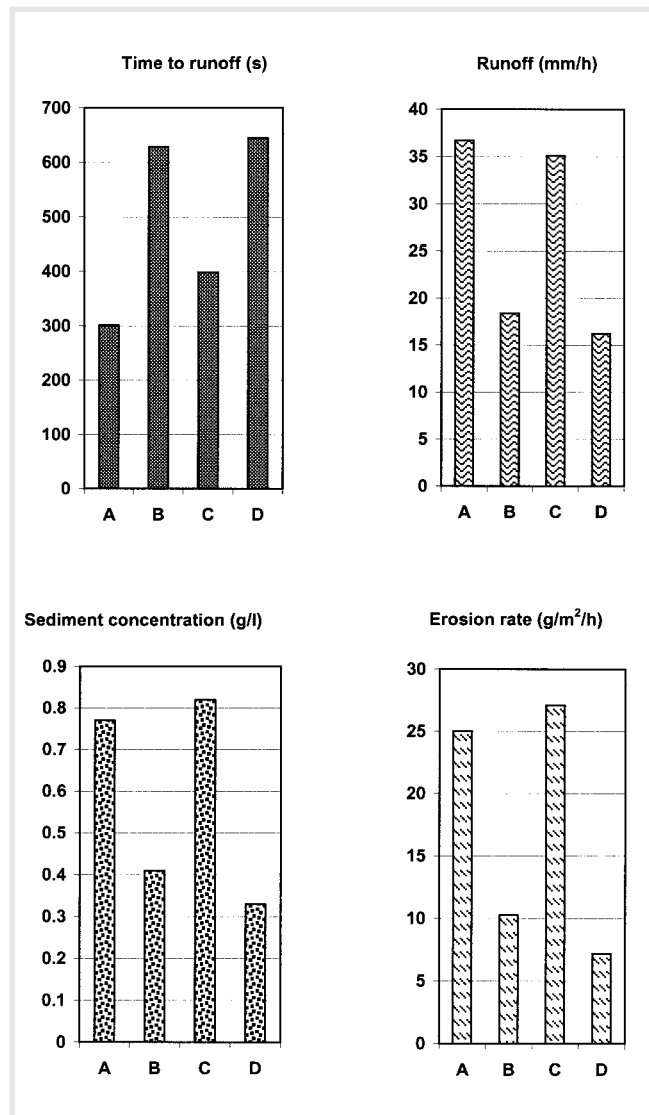
FIGURE 6 Runoff and erosion on abandoned terraces. A, talus at the foot of terrace walls; B, level soil (cultivated field); C, heavily grazed terraces; D, lightly grazed terraces.

Sheet wash erosion was also found on terraced fields. Figure 6, Table 2, and Table 3 show hydrological and sedimentological results of rainfall simulation tests. These results differed depending on what section of a

TABLE 2 Hydrological and erosional response in different sectors (see also Figure 6).

Talus at the foot of terrace wall	Level soil	Anova (P)
Time to runoff (seconds)	301	629	0.278
Runoff (mm/h)	36.7	18.5	0.043
Runoff coefficient (%)	49.7	17.7	0.003
Wetting front (cm)	12.7	19.1	0.254
Sediment concentration (g/L)	0.77	0.41	0.078
Erosion rate (g/m ² /h)	25.0	10.2	0.030

TABLE 3 Hydrological and erosional response on abandoned terraces with different grazing intensity (see also Figure 6).

Heavily grazed	Lightly grazed	Anova (P)
Time to runoff (seconds)	398	645	0.314
Runoff (mm/h)	35.1	16.2	0.008
Runoff coefficient (%)	41.4	15.7	0.003
Wetting front (cm)	9.8	21.1	0.008
Sediment concentration (g/L)	0.82	0.33	0.002
Erosion rate (g/m ² /h)	27.1	7.1	0.000

highest runoff values (runoff coefficient 41.4%) in the study area. On these plots, runoff began 398 seconds after the rainfall event had started. On lightly grazed plots, runoff began much later (after 645 seconds) and the runoff coefficient was moderate (15.7%). The erosional response also depended on the use of the terraces. The highest sediment concentrations (27.1 g/m²/h) were found on intensively grazed terraces.
