Sand dune management problems and techniques, Spain.

Source: Journal of Coastal Research, 36(sp1) : 325-332

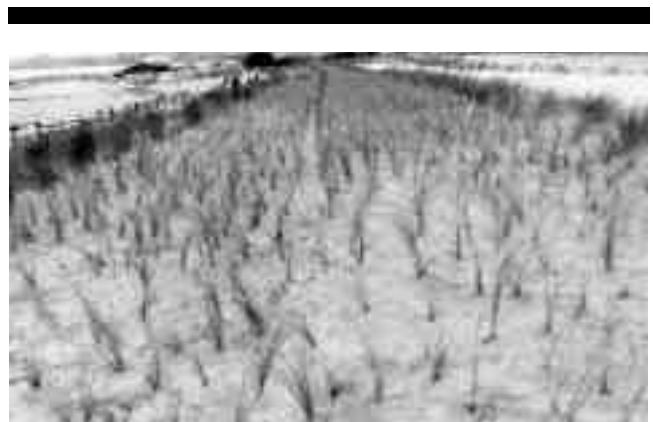
Figure 5. Fencing and transplanted vegetation in Somo spit (Cantabrian, Spain).

Figures 3 and 4 show aerial views of Somo spit before and after dune restoration. In Figure 5 a detailed perspective of fencing and transplanted vegetation is displayed.
