Avian Electrocutions in Western Rajasthan, India

Source: Journal of Raptor Research, 47(4) : 352-364

AVIAN ELECTROCUTIONS IN WESTERN RAJASTHAN, INDIA

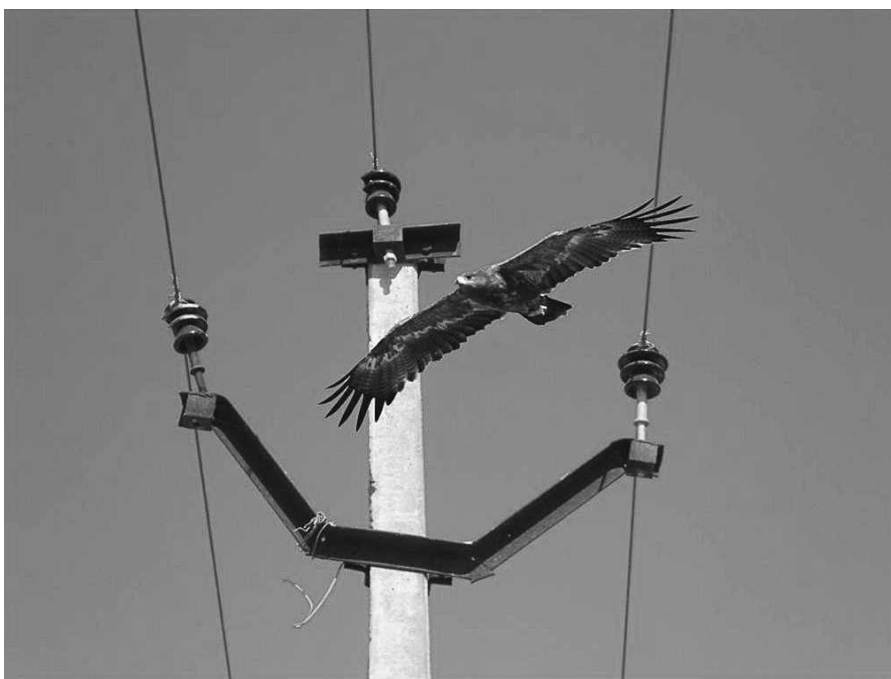
Figure 1. Typical 11-kV concrete pole with a grounded metal cross-arm. A Steppe Eagle (*Aquila nipalensis*), a common raptor in Rajasthan, India, with a wingspan of 165–190 cm, provides a reference for relative size.

grounded metal rebar, and affixed with metal cross-arms and pole-top insulator supports (Fig. 1). Because the rebar lattice within the concrete is conductive and grounded, the metal cross-arms attached to the pole are indirectly grounded. This creates pole configurations that are functionally similar to metal poles, where electrocution risk is substantially higher than on wooden poles (e.g., Harness 1998, Janss and Ferrer 1999, Garrido and Fernández-Cruz 2003).

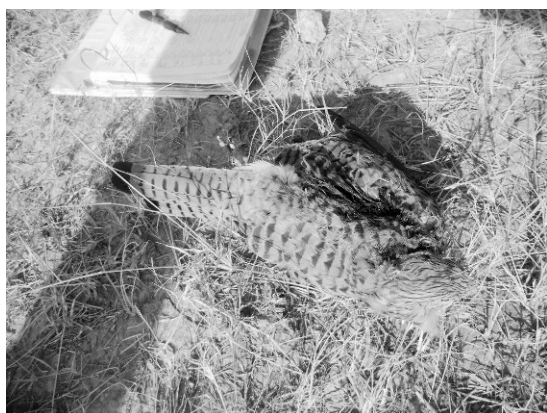
Figure 6. Eurasian Kestrel (*Falco tinnunculus*) with electric burn marks visible on the left scapulars, found beneath an energized utility pole in Rajasthan, India.
