Relationships Between Landsliding and Land Use in the Likhu Khola Drainage Basin, Middle Hills, Nepal

Authors: Gerrard, John, and Gardner, Rita

Source: Mountain Research and Development, 22(1) : 48-55

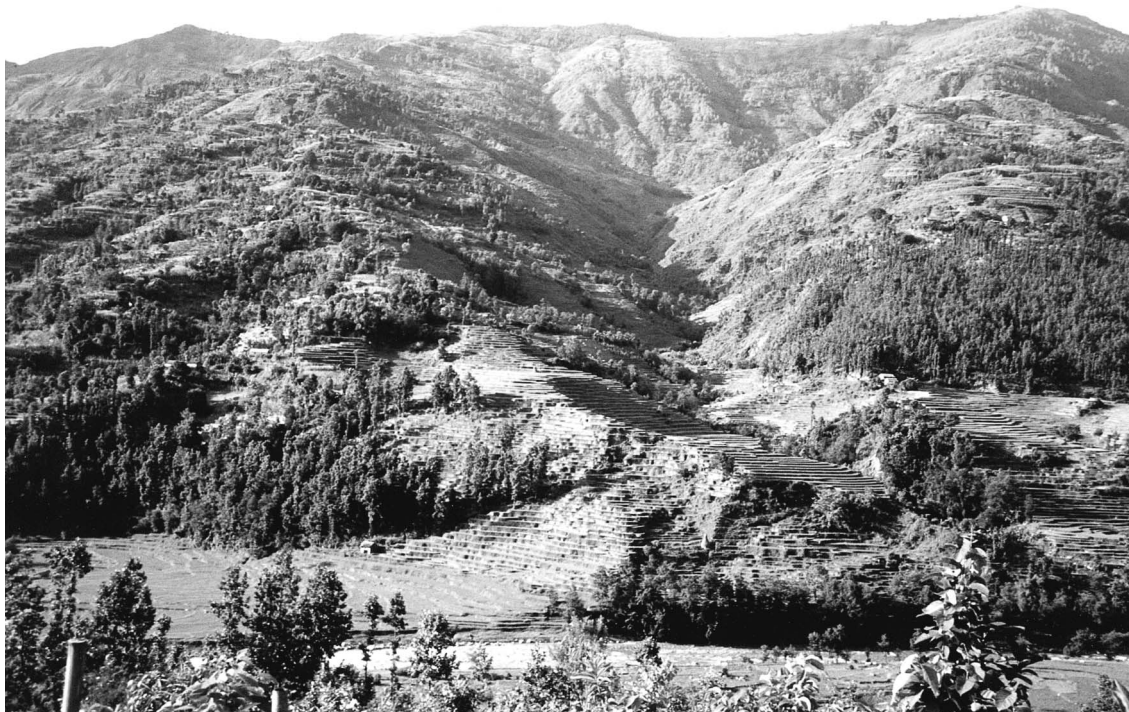
FIGURE 3 General view of the Dee subcatchment of the Likhu Khola (visible in the foreground), with *khet* terraces on the lower slopes and patches of woodland and *bari* terraces on the higher slopes. A few landslide scars are visible. (Photo by John Gerrard)

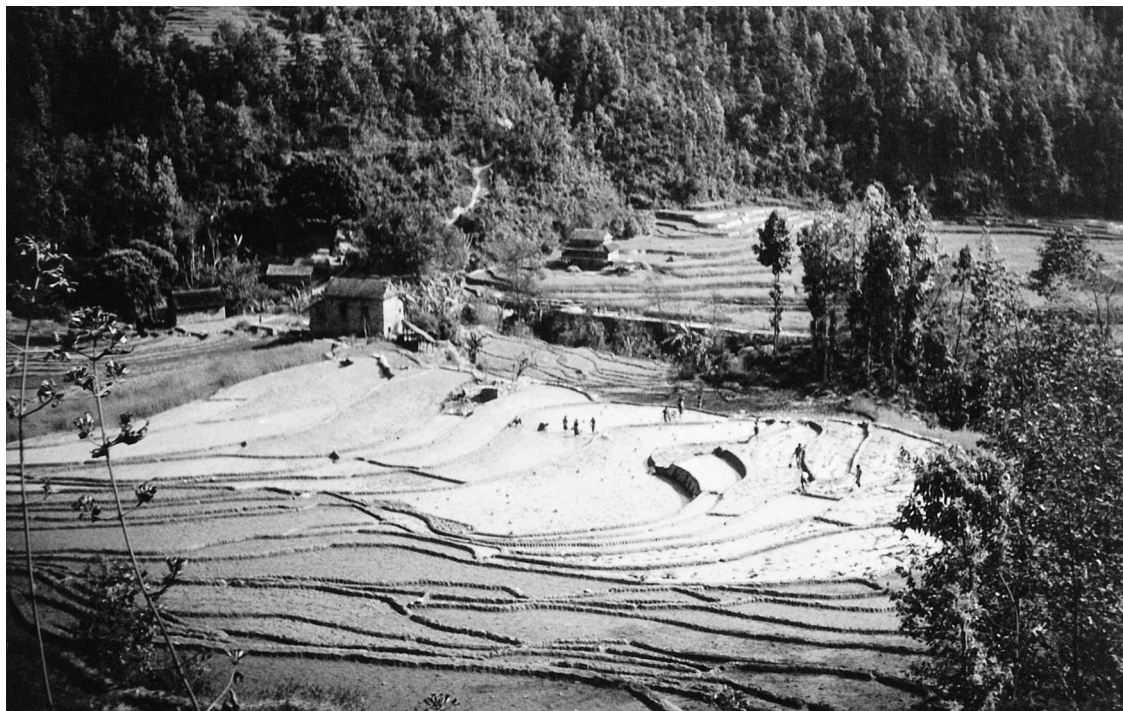
FIGURE 4 Rice transplanting on *khet* terraces low down on the valley side. Remnants of *sal* woodland in the background, in various states of degradation. (Photo by John Gerrard)
