Source: Mountain Research and Development, 21(1) : 69-76

# Marginal Lands and Erosion in Terraced Fields in the Mediterranean Mountains

A Case Study in the Camero Viejo (Northwestern Iberian System, Spain)

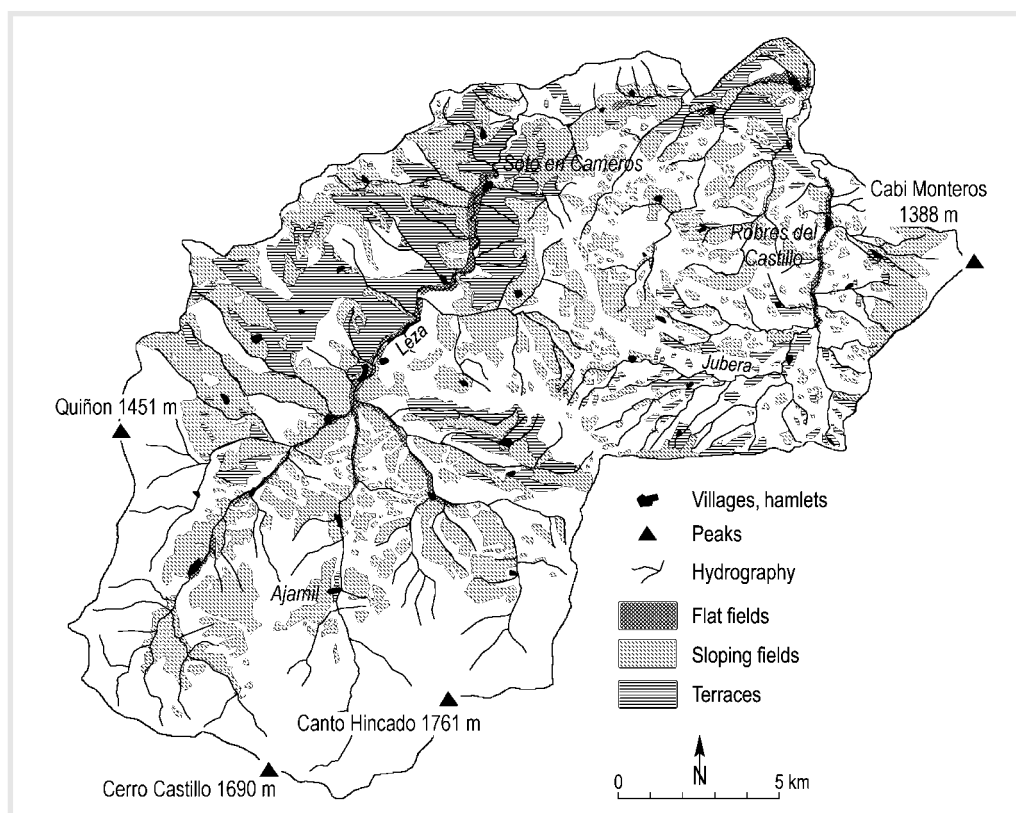
**FIGURE 2** Historical farmland and types of fields in the high valleys of the Leza and Jubera (Camero Viejo). The map was drawn on the basis of aerial photographs (1956 and 1977) and was adapted by means of a GIS.

Depending on the inclination of their fields, farmers in the Camero Viejo used different cultivation methods. In 1956, flat fields represented only 3% of the total farmed area (Figure 2). They were well fertilized and irrigated. On slopes near villages, terraces were built to preserve the soil, support the infiltration of water, and increase yields. Terraces represented 28% of the total cultivated area (4412 ha). The rest of the farmed area (69%) consisted of sloping fields. Some of these fields were worked permanently (one year with cereals, the next in fallow) while others were cultivated sporadically (in times of great population growth), with long fallow periods.

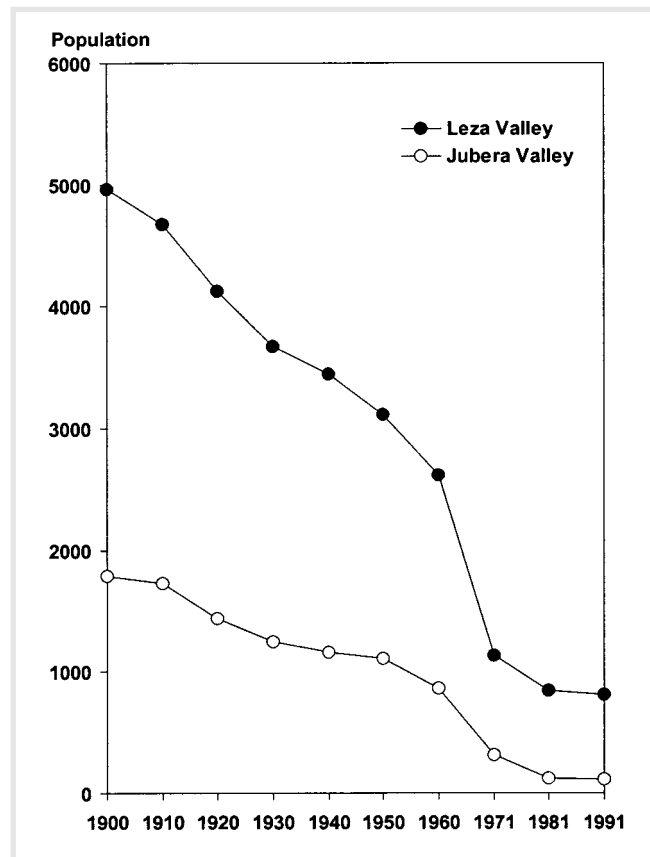
**FIGURE 3** Demographic trends in the Camero Viejo (1900–1991).

Figure 3 shows the demographic trends in the two valleys in the study area. The 6754 inhabitants registered in 1900 represented a population density of 17

inhabitants/km<sup>2</sup>. In 1995, the population decreased to 927 inhabitants (2.3 inhabitants/km<sup>2</sup>), which constitutes a loss of 86.2%.

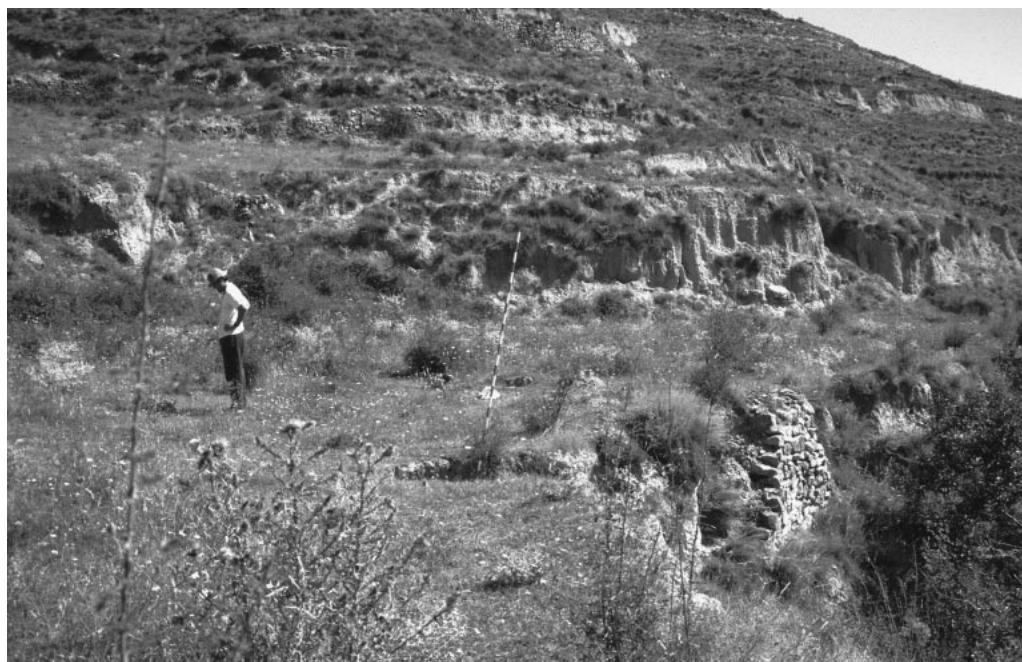
**FIGURE 4** Erosion and spread of scrub on high terraces abandoned since the 1940s or 1950s. The 20–25° slope is concave. The terraces are located at a considerable distance from the village of Terroba, Leza Valley. (Photo by L. Ortigosa)

Previously cultivated land was definitively abandoned and started being recolonized by scrub (Figure 4). Some abandoned fields and hillslopes were afforested with *Pinus sylvestris* for the control of hydro-

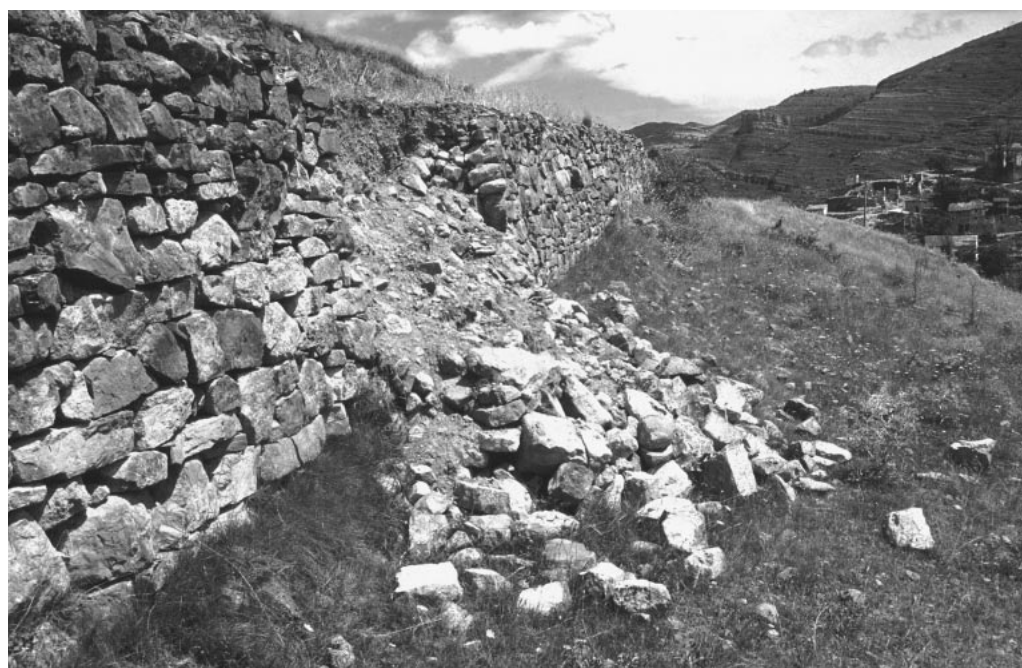
**FIGURE 5** Collapse of a terrace wall at the foot of a hill near a village resulting from hydrological pressure higher up (Soto en Cameros, Leza Valley). Fields in this gently sloping area were only abandoned within the last 10 years. (Photo by L. Ortigosa)

The most important erosion process observed on terraced fields was the collapse of terrace walls as a consequence of massive soil movement (small landslides; see Figure 5). Landslides generate an arcuate surface failure and leave the small scarp of the terrace unprotected and susceptible to erosion. On average, each slide was found to move 3.31 m<sup>3</sup> of soil and terrace wall. The volume of soil moved was calculated to be 38.80 m<sup>3</sup>/100 m of wall.

increasing the volume of accumulated soil and its tendency to slide down the slope. However, the most influential factor in this erosion process seems to be the slope's hydrological function. The highest landslide rate (72.8 m<sup>3</sup>/100 m of terrace wall) was observed on concave slopes, particularly on the lower part of hillslopes (Table 1). Terraces located in these areas receive water from the upper part of the hillslopes. Moreover, their deep and loam-sandy soils retain more moisture. The more a soil's weight increases due to its absorption of water, the greater the likelihood is that a landslide will be triggered (Arnáez et al 1992).

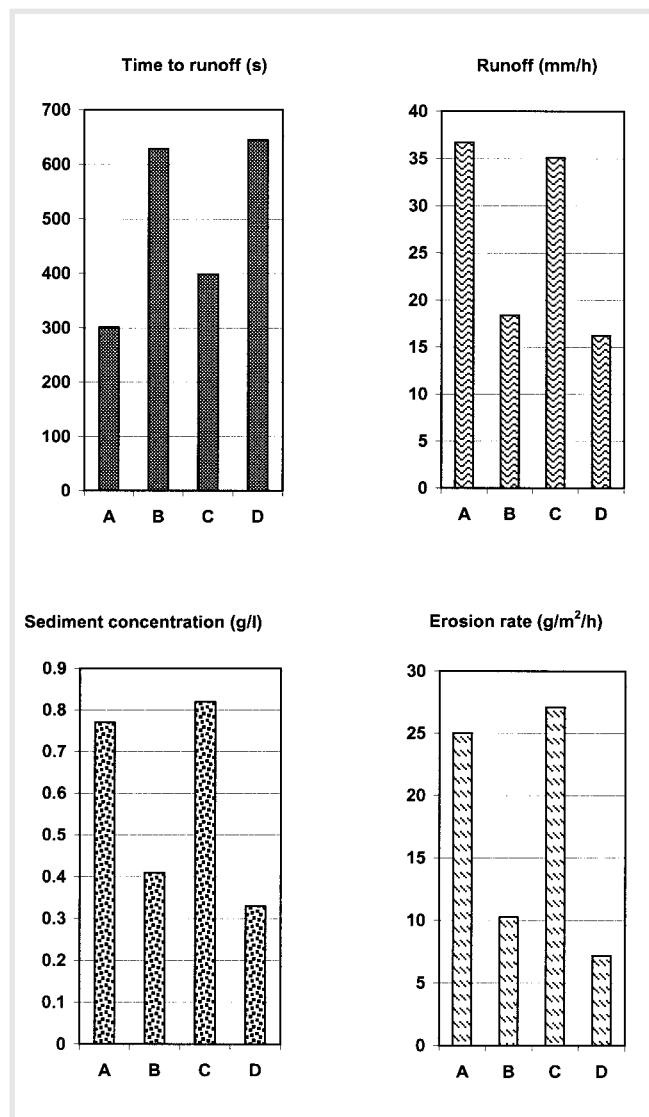
**FIGURE 6** Runoff and erosion on abandoned terraces. A, talus at the foot of terrace walls; B, level soil (cultivated field); C, heavily grazed terraces; D, lightly grazed terraces.

Sheet wash erosion was also found on terraced fields. Figure 6, Table 2, and Table 3 show hydrological and sedimentological results of rainfall simulation tests. These results differed depending on what section of a

terrace (Figure 7) was affected and how the field was used. The talus at the foot of a terrace wall (accumulation of material that has been eroded from fields above) produced high runoff coefficient values (49.7%) and had low wetting front values (12.7 cm as an average). These areas were very prone to erosion: the erosion rate obtained by means of the rainfall simulation test was 25 g/m<sup>2</sup>/h. This hydromorphological behavior was caused by the talus gradient and the scarce plant cover in this section of terraces. Where the soil was level on a terrace, erosion rates were more moderate (Table 2).

highest runoff values (runoff coefficient 41.4%) in the study area. On these plots, runoff began 398 seconds after the rainfall event had started. On lightly grazed plots, runoff began much later (after 645 seconds) and the runoff coefficient was moderate (15.7%). The erosional response also depended on the use of the terraces. The highest sediment concentrations (27.1 g/m<sup>2</sup>/h) were found on intensively grazed terraces.

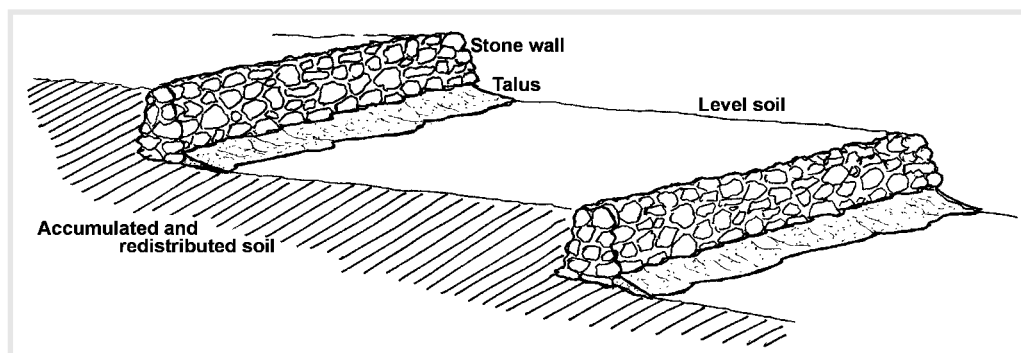
**FIGURE 7** Sectors of an abandoned terrace. (Drawing by Karl Herweg)
