Sand dune management problems and techniques, Spain.

Source: Journal of Coastal Research, 36(sp1) : 325-332

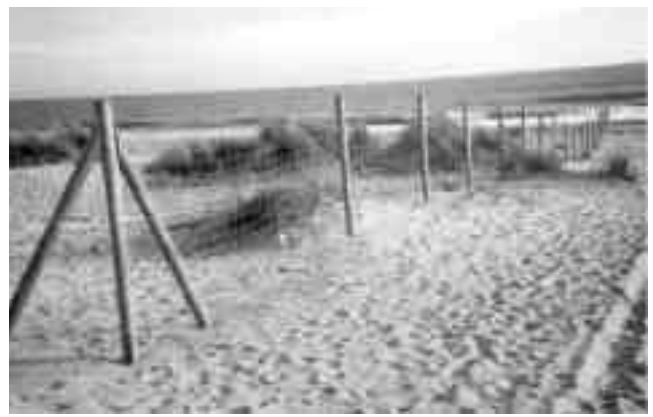
Figure 15. Dune fencing and revegetation in Isla Cristina beach (Huelva, Spain)

Fig.13 shows typical dune blow-outs in Isla Cristina beach. Fig.14 depicts an illustrative grazing scene. Fig.15 shows dune fencing and revegetation.

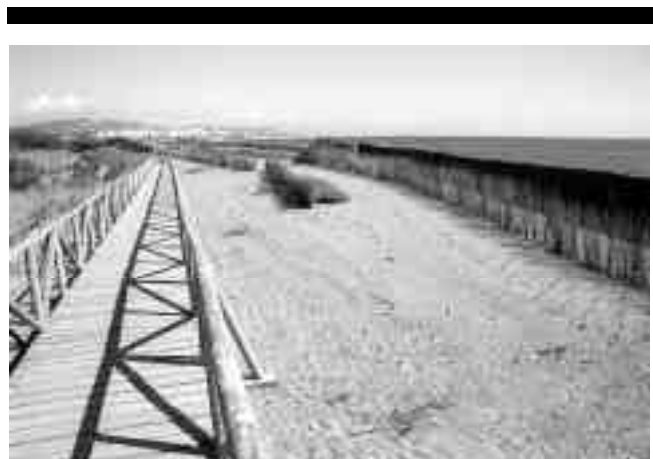
Figure 20. A detailed view of Guadalquítón dune restoration (Cádiz, Spain)

The dune restoration project was only a part of an integrated plan to improve coastal zone management aspects at the Guadiaro estuary, such as river flushing recovery, garbage cleaning, water quality improvement, wetland restoration, fencing of sensitive areas, public access improvement, sea bird observatories, beach nourishment and dune reinforcement. New sand trapping methods were experimented with as well as native transplanted vegetation under critical climatic conditions (yearly run-off is less than 250 mm)
