## RESTORATION OF A COASTAL WETLAND AT PRISONERS HARBOR, SANTA CRUZ ISLAND, CHANNEL ISLANDS NATIONAL PARK, CALIFORNIA

**ABSTRACT.**—Prisoners Harbor of Santa Cruz Island, California, was historically the site of a 4.86-ha coastal wetland and riparian system—the largest on the California Channel Islands. The site was occupied by native people for 3000 years until the 1830s. During the late 1800s, ranchers filled about half of the wetland area to build livestock corrals and other facilities. They also rerouted the main stream channel, Cañada del Puerto, and built a stone wall and earthen berm along its west bank. This disconnected the stream from its floodplain and inadvertently caused erosion of a Native American archeological site. The National Park Service developed a wetland and riparian restoration design for Prisoners Harbor based on topographic and hydrologic analyses and on relationships between vegetation community and depth to water table estimated from neighboring reference wetlands. In 2011, Channel Islands National Park and The Nature Conservancy restored 1.25 ha of coastal wetland and reconnected the stream to its floodplain by removing the earthen berm. This restorati

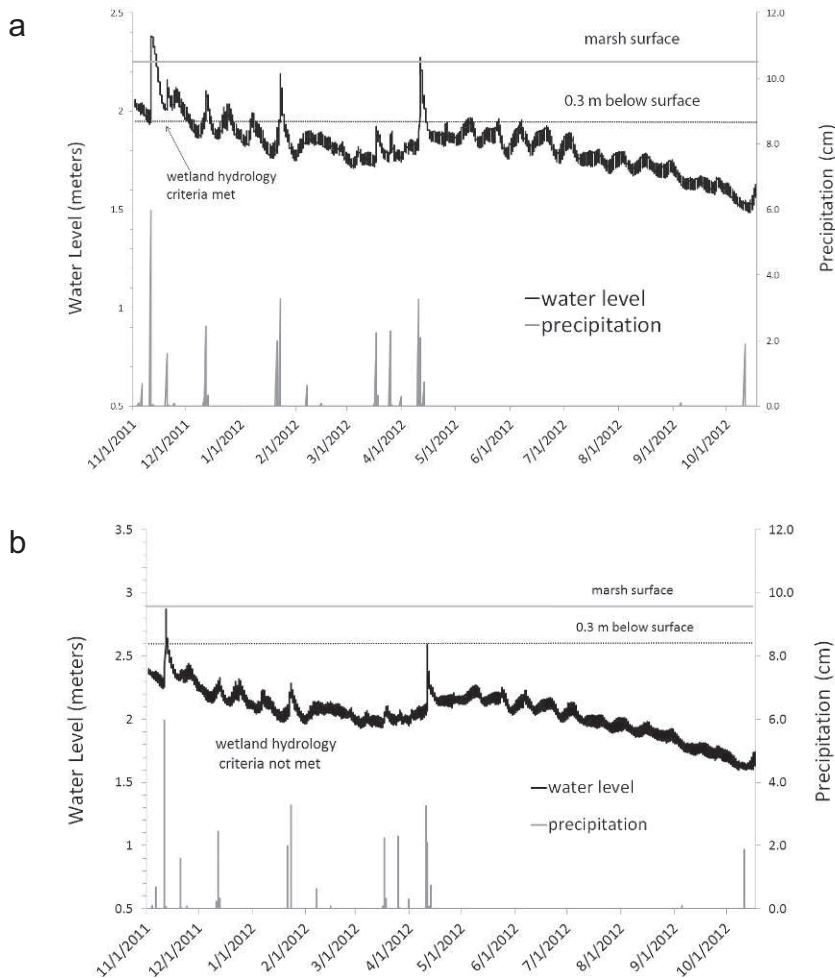
Fig. 3. Postrestoration water-level response to precipitation during November 2011–October 2012: a, well 6 (shallow marsh); b, well 9 (floodplain west of stream channel, former location of earthen berm).

Figure 3 shows how water levels at well 6 (shallow marsh) and well 9 (the former berm location) responded to precipitation during the first year after construction. According to

the federal technical standard for wetland hydrology, wetland areas must be ponded or have a water table within 0.3 m of the ground surface for 14 or more consecutive days during the growing season, at a minimum frequency of 5 years in 10 (United States Army Corps of Engineers 2005). The dashed lines on the graphs in Fig. 3 represent 0.3 m below

the ground surface. Well 6 data show that the shallow marsh met the high-water table duration requirement of the wetland hydrology standard in the relatively wet month of November 2011—the only time this occurred during the 2011–2012 wet season. The water table again rose to within 0.3 m of the marsh surface following rain events in December,

January, and April but not long enough to meet the 14-day duration requirement. A second shallow marsh monitoring site at well 7 produced the same results. Drought conditions were so severe during the 2012–2013 wet season that these shallow marsh wells were dry (no data) much of the time, and neither location had a water table within 0.3 m of the surface. The hydrograph for well 9, located at

an upland floodplain site between the stream channel and the restored wetland area, shows that the water table fluctuated in a pattern similar to well 6 in the first year after restoration. Although the water table rose briefly to within 0.3 m of the ground surface on 2 occasions during this period, the water table is generally deeper than at well 6 by design, and this site did not come close to meeting the

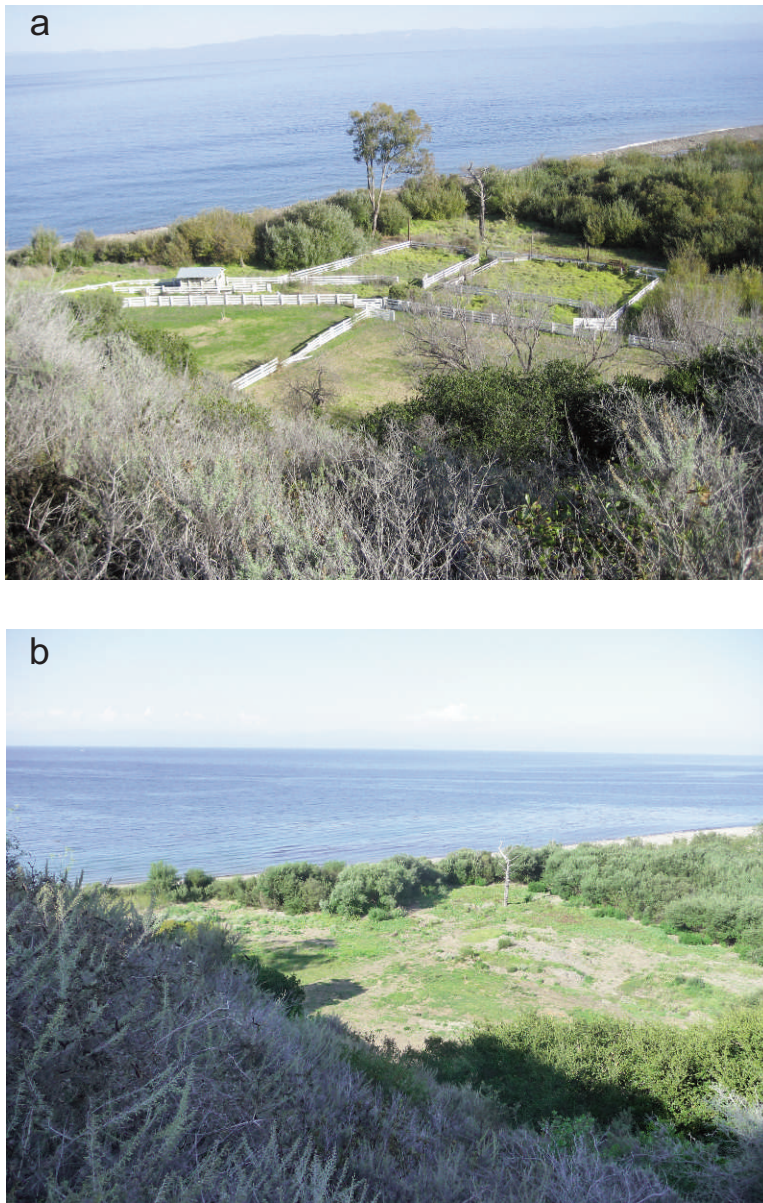
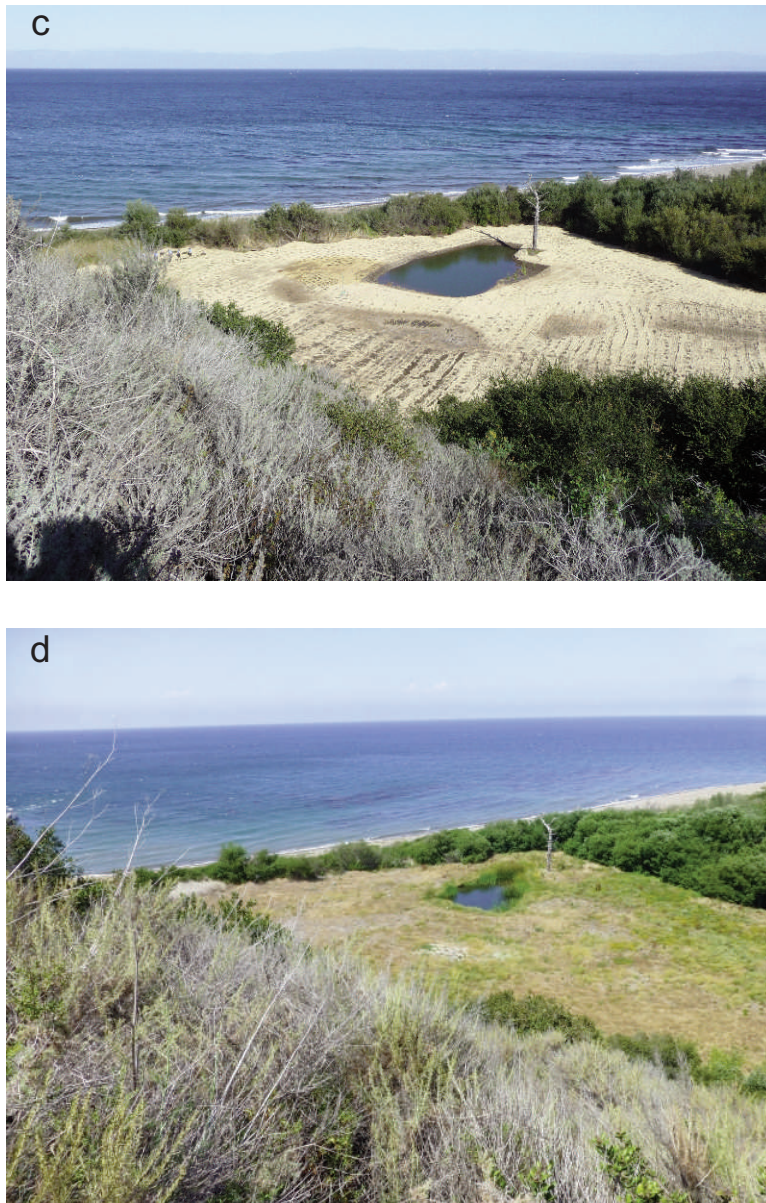
Fig. 4. Continued.

Fig. 4. Prisoners Harbor restoration area looking northeast: **a**, prior to project implementation in January 2010; **b**, prior to excavation in September 2011; **c**, immediately after native plant installation in December 2012; **d**, 18 months after project implementation in June 2013.

Table 1 shows the results for  $1 \times 1\text{-m}$  quadrat vegetation monitoring in 2012 compared to 2013. Of the 8 herbaceous species planted, abundance (% frequency) of one species, *Baccharis douglasii*, increased significantly from 1.3% to 4.4% (chi-square value  $P = 0.01$ ). There was no significant change in *D. spicata*, *Juncus mexicanus*, *S. californicus*, *Schoenoplectus maritimus*, and *Schoenoplectus pungens*. *Juncus patens* declined in abundance significantly, and *Juncus xiphioides* was not observed during 2013 monitoring (chi-square value  $P = 0.02$  and  $P = 0.00$ , respectively). Photomonitoring also documented vegetation change on a landscape scale over this period (Fig. 4).
