Use of Sonic Tomography to Detect and Quantify Wood Decay in Living Trees

Source: Applications in Plant Sciences, 4(12)

USE OF SONIC TOMOGRAPHY TO DETECT AND QUANTIFY WOOD DECAY IN LIVING TREES¹

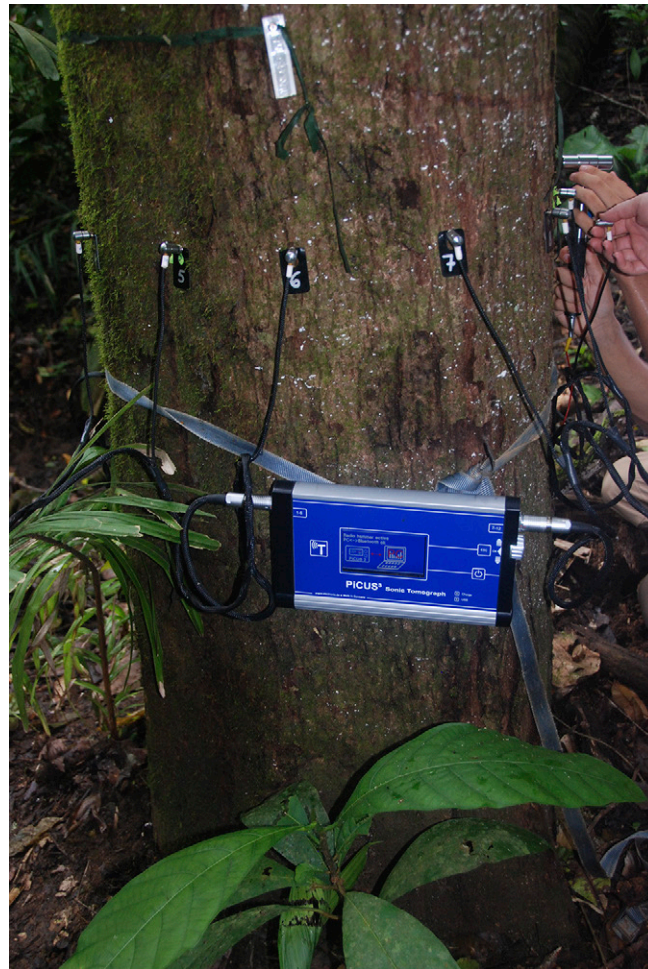
Fig. A1-1. The PiCUS 3 Sonic Tomograph attached to a tree with sensor cables.

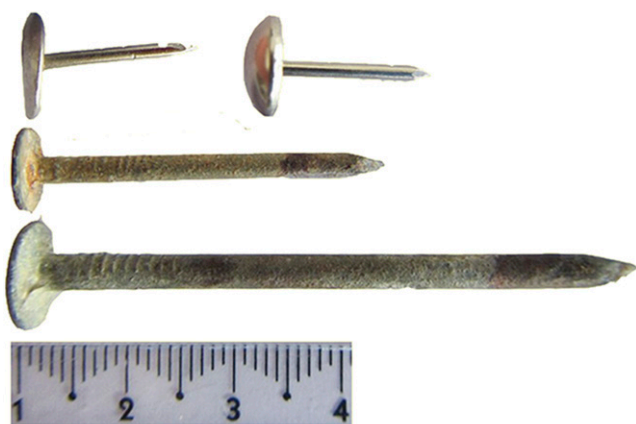
Fig. A3-2. Examples of nickel upholstery nail (top, with head intact [right] or flattened for better sensor contact [left]) for thin-barked tree species, and larger steel roofing nails (middle and bottom) used for thick-barked tree species.

2. Nails must be magnetic (i.e., steel or nickel, but not aluminum) and have a broad, flat head (Fig. A3-2). For thin-barked trees, we use nickel upholstery nails (National Hardware V7730 N279-174) and flatten the heads with a mallet. For thicker-barked trees, we use short steel roofing nails (but with large heads) that penetrate to the wood. It is best to have a number of nail sizes available and use the smallest nail practical to minimize damage to trees; each nail just needs to pass through the bark to make solid contact with wood.
