Effects of a Natural Dam-Break Flood on Geomorphology and Vegetation on the Elwha River, Washington, U.S.A

Source: Northwest Science, 82(sp1) : 210-223

Effects of a Natural Dam-Break Flood on Geomorphology and Vegetation on the Elwha River, Washington, U.S.A.

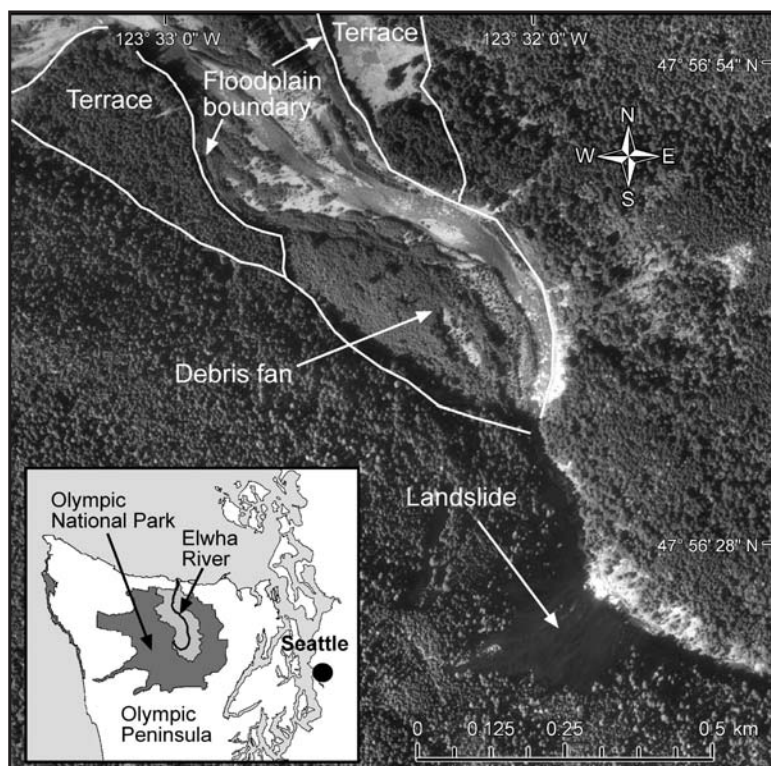
Figure 1. Geysers Valley aerial photograph (2002) showing locations of (1) landslide that likely triggered dam-break flood of 1967, (2) location of dam-break flood deposits, and (3) boundaries of the contemporary floodplain and terraces. Inset shows location of the Elwha River on the Olympic Peninsula in Washington State, USA.

The 72 km-long Elwha River flows northward out of the Olympic Mountains to the Strait of Juan de Fuca on Washington State’s Olympic Peninsula (Figure 1), draining an area of approximately 830 km² (see Duda et al. 2008 for more information on climate and hydrology of the watershed). Geysers Valley, an unregulated alluvial reach upstream of the upper dam between rkm 28 and rkm 32, may be the best model of pre-dam geomorphology for the area inundated by the upper dam on the Elwha River (Gilbert and Link 1995, DOI 1996). However, floodplain morphology and disturbance regimes are undocumented and there is little information upon which to base a strategy for restoration of floodplain forests. One of the most significant events to occur

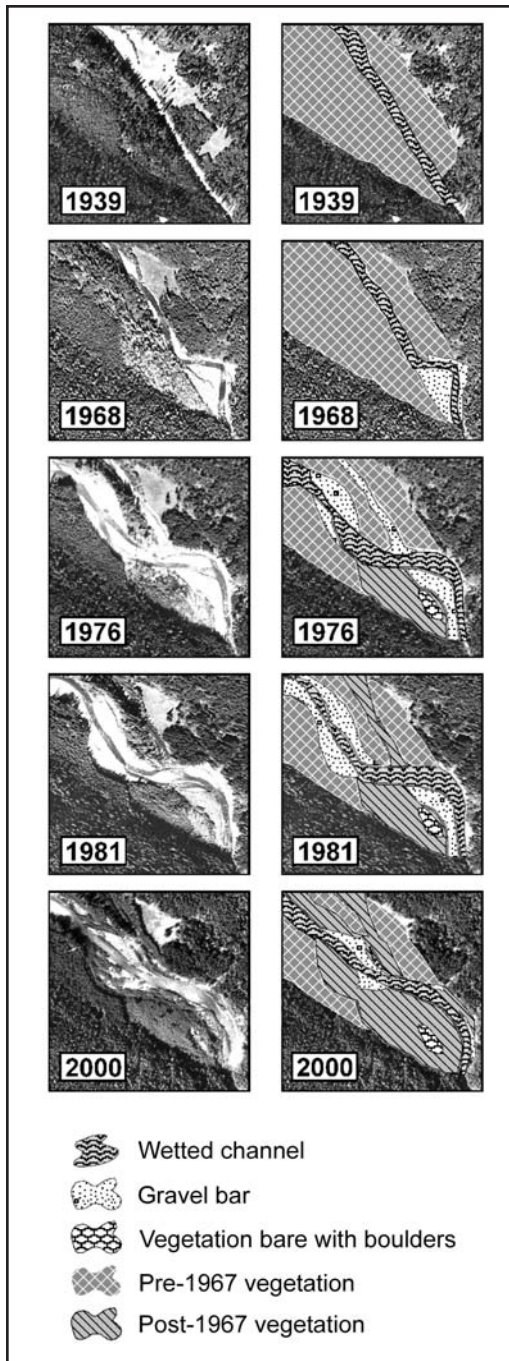
Figure 2. Aerial photograph time series of the study site illustrating straight channel prior to the dam break flood (1939), channel shift eastwards after the dam-break flood (1967), and subsequent vegetation and channel changes. The non-forested patch in the center of the upper edge of each photograph is a persistent meadow on a terrace.

Prior to the dam-break flood of 1967 the Elwha River flowed in a straight channel through the study reach, bordered by mature forest on both banks and aligned with the canyon upstream (Figure 2). In the year after the dam-break flood (1968), the flood deposit evidently filled the straight channel and forced the main channel more than 100 meters to the east. The forest on the floodplain to the west of the channel remained standing, but most trees appeared dead. By 1976, the channel had moved farther to the east, exposing a new surface deposited at the eastern edge of the 1967 flood deposits. The channel continued to erode eastward into the terrace of glacial sediments after 1976 and by 1981 had deposited a second new surface to the east of the 1967 flood deposits. By the year 2000, the study site attained the configuration mapped during this study.

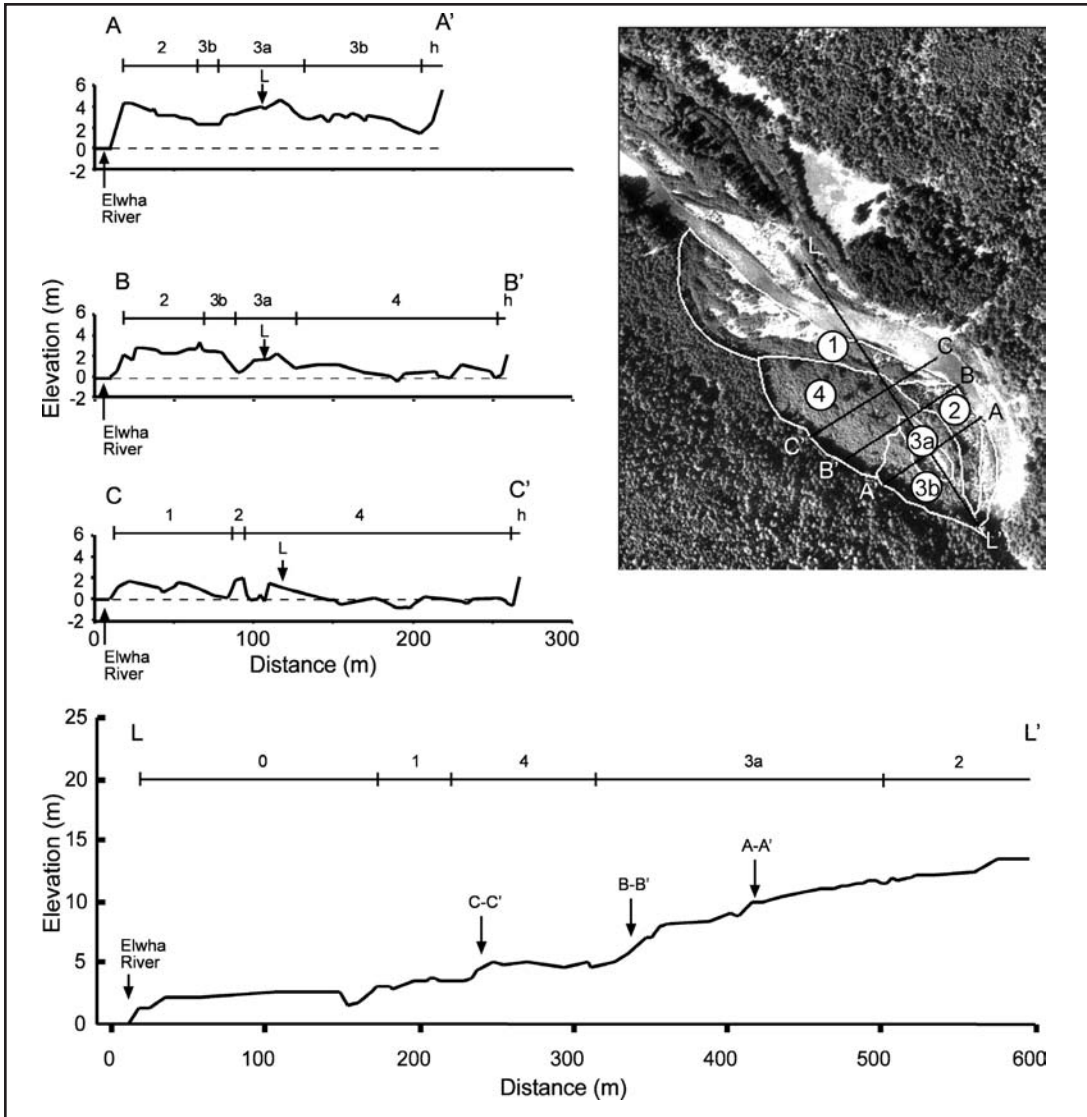
Figure 3. Cross sections (A-A', B-B', C-C') and longitudinal profile (L-L') of dam-break flood deposits located at the upstream end of Geyser Valley, Elwha River, Washington. Line above each profile illustrates locations of geomorphic surfaces. Surface 0 is the contemporary gravel bar. Surface 1 is the most recent dam-break flood deposit (dating to 1984). Surface 2 is an intermediate age dam-break flood deposit (dating to 1977). Surfaces 3a, 3b, and 4 are from the 1967 dam-break flood. Transect locations are shown on aerial photograph at upper right.

Our survey identified five major surfaces within the fan area, excluding the contemporary gravel bars of the Elwha River (Figure 3). Based on ages of the vegetation plots (Figure 4), all surfaces post-date the 1967 dam-break flood. Surfaces 3a, 3b, and 4 date approximately to the 1967 dam-break flood, with first tree establishment no later than 1971, 1970, and 1969, respectively (Table 1). The coarse boulders of surface 3a indicate a region of high energy flow oriented along the fan's long axis, and in approximate alignment with the canyon immediately upstream. There was little fine-grained sediment within this deposit, forming a substrate of large boulders with large interstitial spaces. The peak elevation of the surface was approximately 4 m above the present day river bed, or more than 2 m above contemporary bankfull floods (Figures 3 and 5). Surface 3b surrounded the upstream portion of the boulder field, and consisted of boulders within a matrix of finer gravels and sand. The elevation of surface 3b was 1 to 2 m lower than the main boulder field at transect A-A', or 2 to 3 m above the present-day river bed. Partially vegetated overflow channels that are

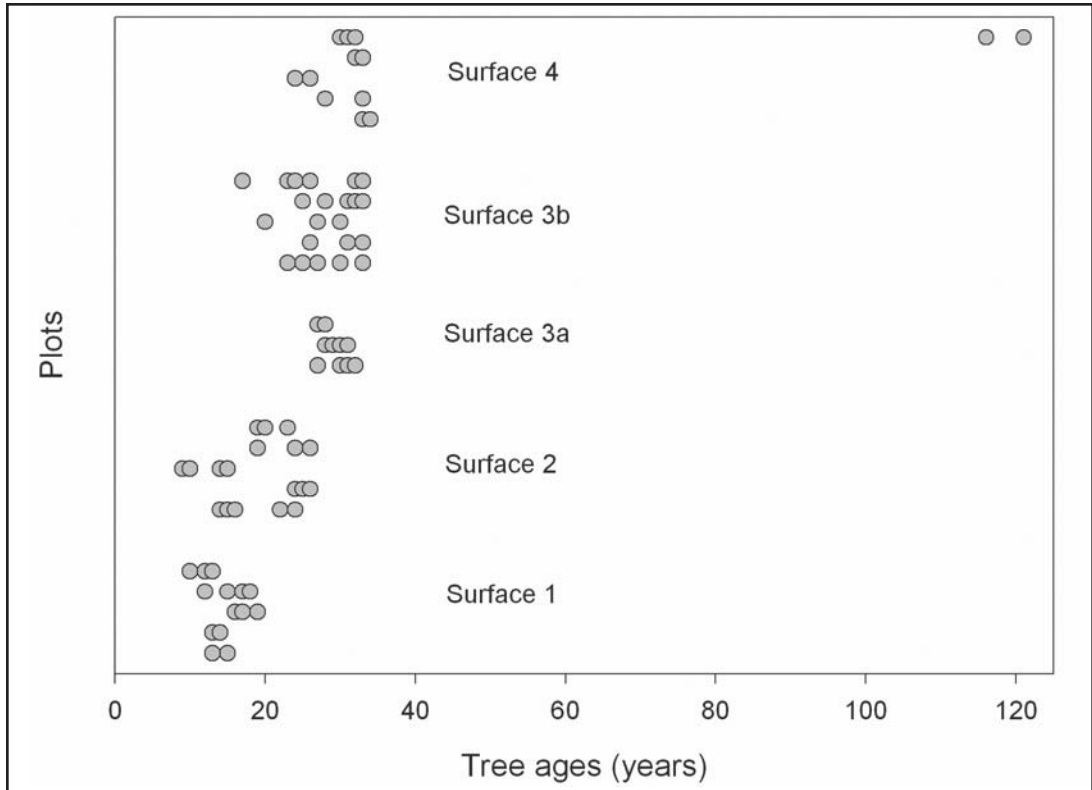
Figure 4. Ages of trees within plots, grouped by geomorphic surface. Each horizontal line of points represents one plot.

Trees began to establish on all surfaces one to four years after surface creation (Table 1). There has been a prolonged period of tree recruitment, especially on surfaces 3b and 2 (Figure 4). Present day tree species composition was generally
