Authors: Espizua, Lydia Elena, and Bengochea, Jorge Daniel

Source: Mountain Research and Development, 22(2) : 177-185

# Landslide Hazard and Risk Zonation Mapping in the Río Grande Basin, Central Andes of Mendoza, Argentina

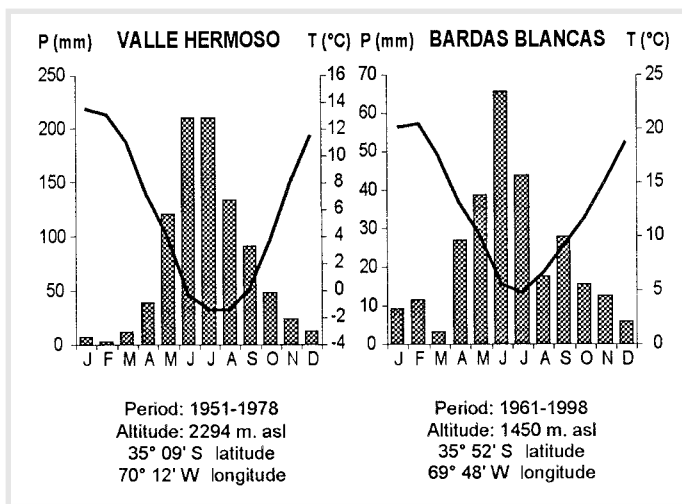
**FIGURE 2** Monthly mean precipitation and temperature in Valle Hermoso and Bardas Blancas meteorological stations.

There are 2 meteorological stations in the zone, with interrupted records: (1) Valle Hermoso (35°09'S, 70°12'W) at 2294 m, and (2) Bardas Blancas (35°52'S, 69°48'W) at 1450 m. The mean monthly precipitation and temperature records show 2 well-defined periods, one in winter and the other in summer (Figure 2). The monthly mean maximum precipitation coincides with the monthly mean minimum temperature. In Valle Hermoso the mean monthly temperature from June to August is below 0°C. At this station the higher monthly precipitation occurs in the winter as snow, whereas in Bardas Blancas it can be snow or rain and occurs from May to June. Annual mean precipitation varies from 400 mm in Bardas Blancas to 940 mm in Valle Hermoso.

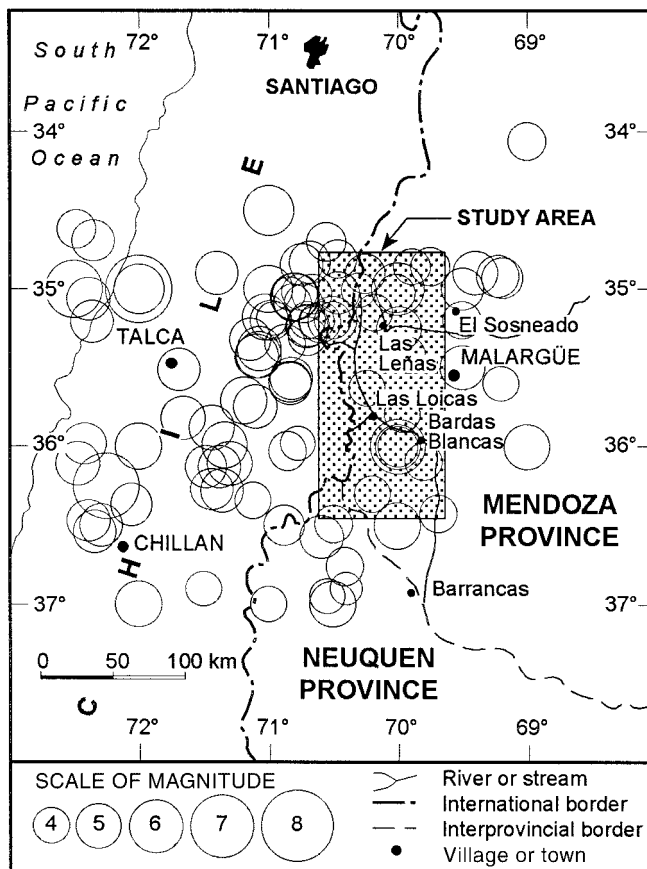
**FIGURE 3** Location of earthquakes (epicenters and magnitudes).

sity of Chile. Ninety earthquakes with magnitudes greater than 4 have occurred in the area. Figure 3 shows the location of the epicenters and magnitudes in the study area and the surrounding zones; the figure shows that there is an increase in the number of earthquakes and in their magnitudes toward the west.

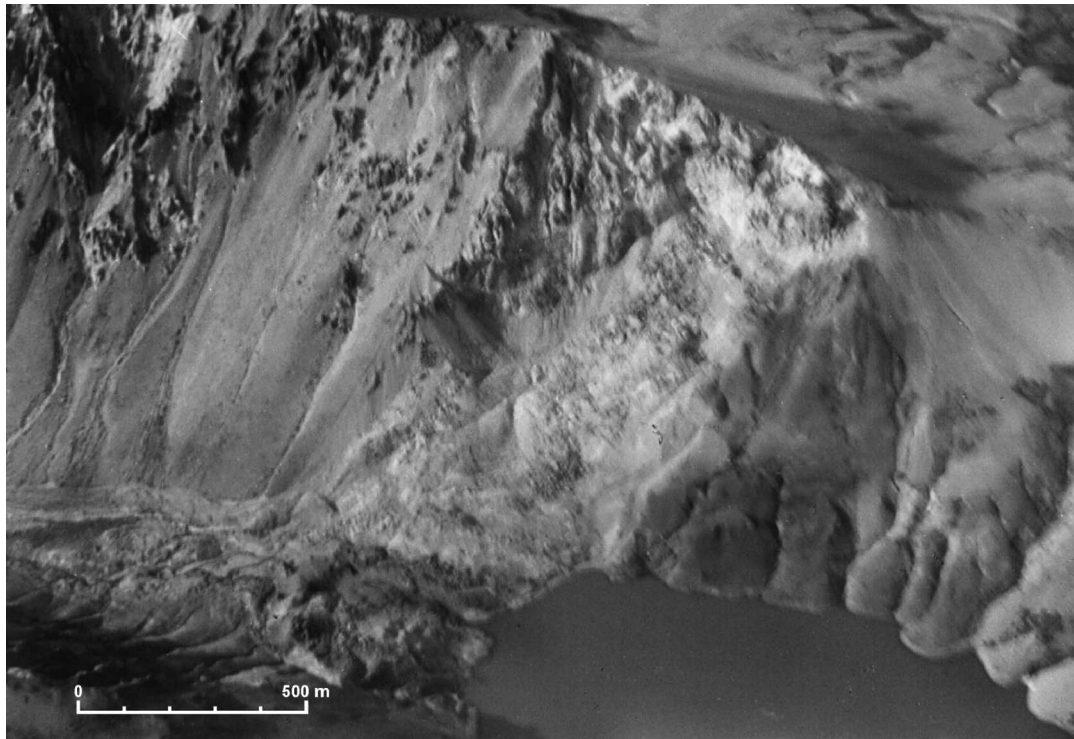
**FIGURE 4** South aerial view of a landslide and the resulting dam at the headwaters of the Cajón Bayo creek in the Río Pehuenche basin. (Photo by Luis Lenzano and Carlos Aguado)

In the study area it was possible to detect a reactivated landslide (slump) at the headwaters of the Cajón Bayo creek at the Río Pehuenche basin. Tuffs of the lower Tihuelitense (lower Quaternary age) are characterized by outcrops about 300–400 m thick, in subhorizontal position, with andesitic composition arising from eruptions of Volcano Campanario. A small 600-m-long landslide that deviated the creek about 50 m to the north can be observed in the 1963 aerial photos. In the satellite image of March 1985, no change was detected in the sector. Instead, on the 1986 images, a 1500-m-long lake that formed upstream from the landslide was detected (Figure 5; slump B39). In March 1992 the region was observed from a plane. A reactivated slide had occurred in the same sector as the one before, but this time it was more important, and the mass movements crossed the valley floor and extended far up the opposite wall. A lake was formed after the landslide obstructed the Cajón Bayo valley floor in 1986 (Figure 4). In March 1992, minor drainage of the lake through the base of the mass was also observed. This characteristic, and the prevailing lithology (friable tuffs), a steep slope, and the presence of snow ablation water, are negative factors that may affect stability. It is quite probable that at some time the natural dam will break. Were the water mass to drain suddenly, catastrophic downstream flooding would affect the Pehuenche road (Provincial Route 224) and the locality of Las Loicas.

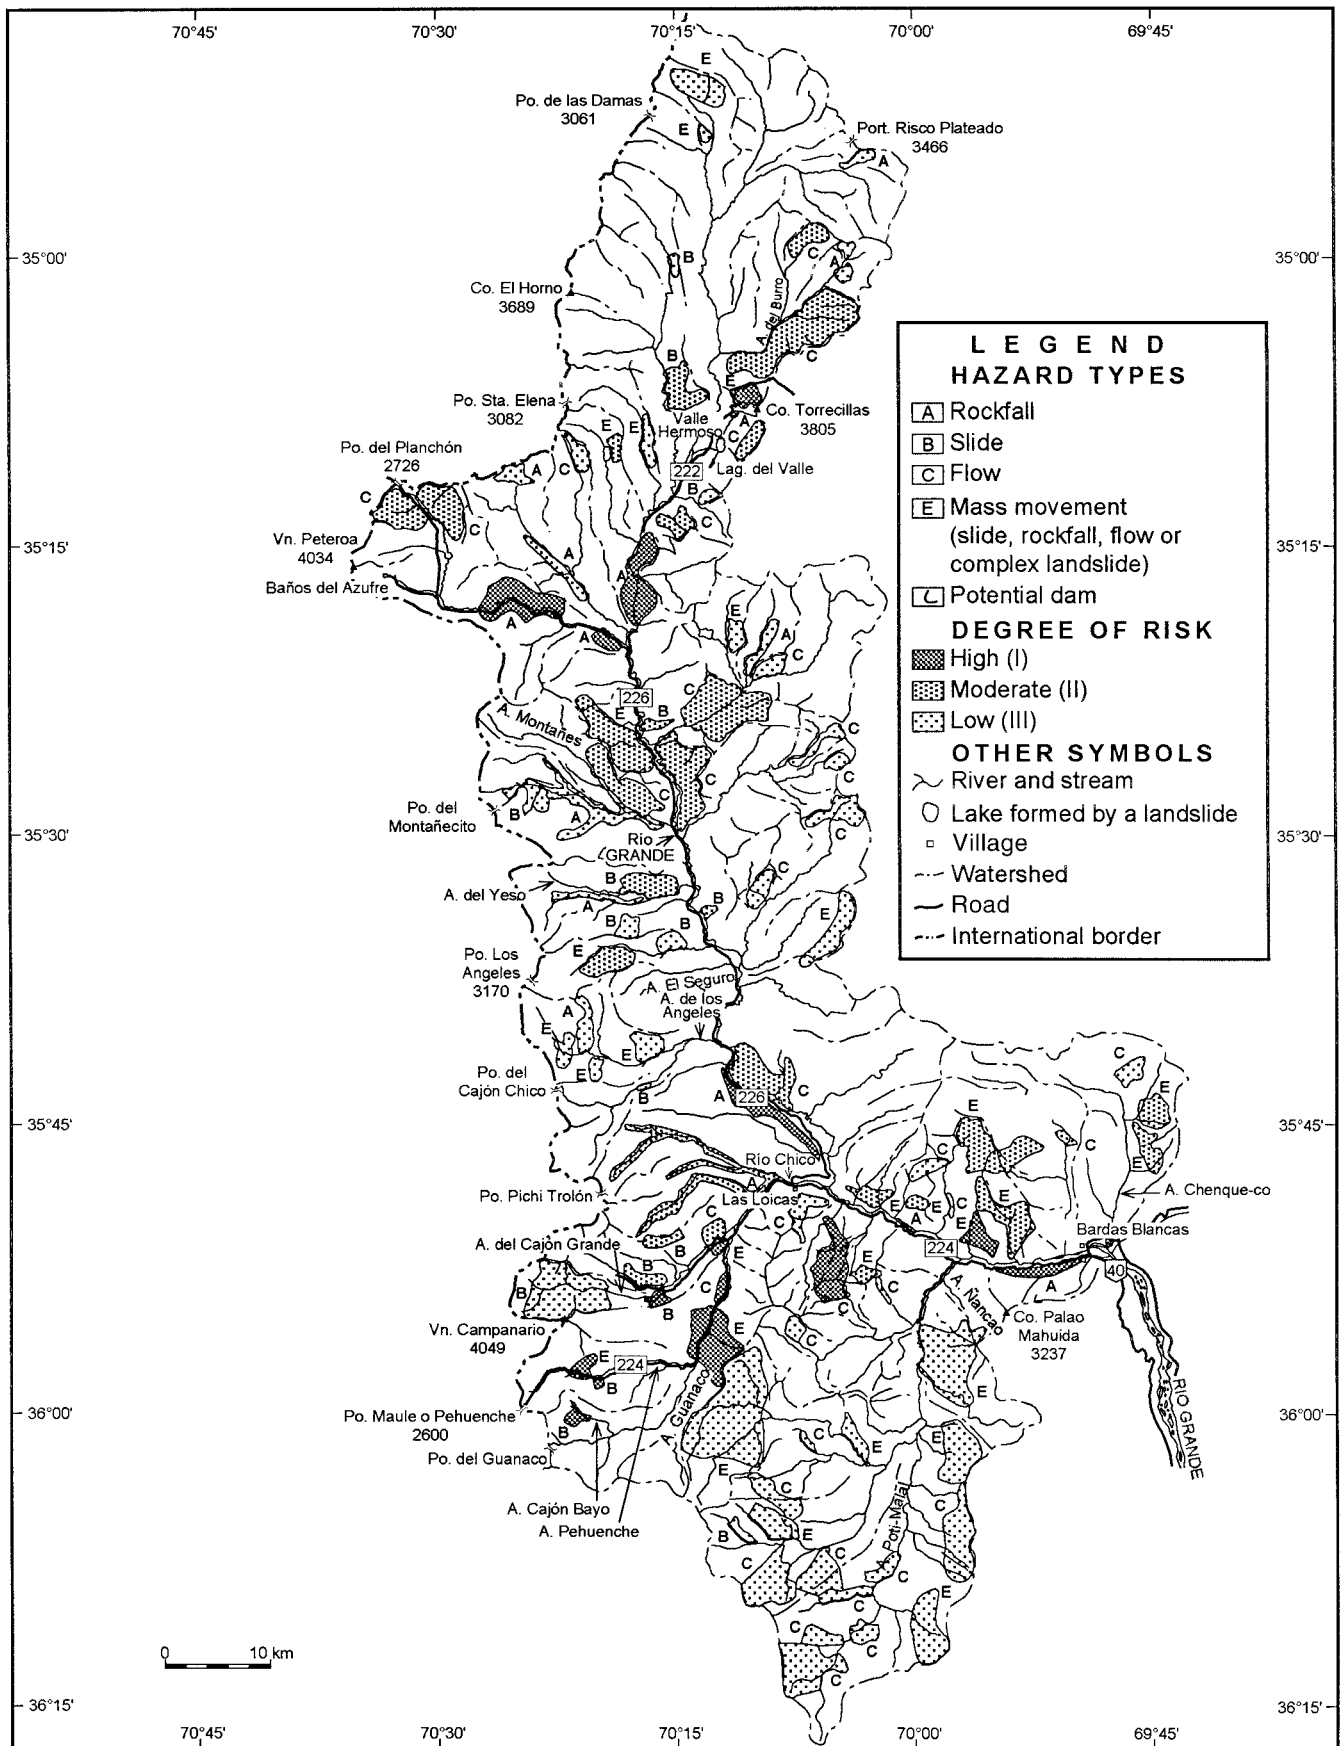
**FIGURE 6** Map of landslide hazards and risk zonation in the Río Grande basin.

We prepared 2 maps. The distribution and classification of landslides are shown on the first map (inventory map; Figure 5). The second—a landslide hazard and risk zonation map (Figure 6)—was prepared taking into account the zones subject to landslide hazard and the degree of loss to a given element or set of elements at risk in the region because of the occurrence of a particular phenomenon of a given magnitude (Coburn et al 1994).

A landslide risk map was obtained showing the hazards and elements at risk according to UNDRO/UNESCO (See Coburn et al 1994) definitions. The risk map shows that the major hazards and the greatest potential risk are concentrated along the Río Grande valley and its tributaries where the roads, routes, and settlements are located. Three risk degrees were distinguished as follows (Figure 6):

- *Degree I (high risk)*. This is the category with the highest degree of hazard and risk, where rockfalls, flows, or slides that could occur would affect Provincial routes 222 and 224, roads, bridges, or small, populated centers. Rockfalls are probably the most frequently observed mass movements in mountain areas. The areas where rockfalls occur are subject to events of lesser magnitude that occur more frequently; therefore, construction should be avoided.

- *Degree II (moderate risk)*. This category covers areas vulnerable to the potential occurrence of landslides, but the threat to infrastructure in the area is not as great because the hazard zones are far away. Through field observations in March 1996, it was possible to detect the occurrence of a debris flow that flowed from the headwaters of Arroyo Chenque-Co after a heavy rainstorm (Degrees II and III; Figure 6). Highway No. 40 and a small bridge were damaged (Degree I; Figure 6).

- *Degree III (low risk)*. The occurrence of a potential landslide is relatively remote, and the expected damage to the infrastructure is very slight.
- *Potential dam*. The potential occurrence of a specific hazard induced by large mass movements that could cross the valley floor up to the opposite slope, thus damming a river or a creek, was considered as a slide hazard zone. In case the dam is broken, a catastrophic flood could occur, posing high risk to inhabited areas and infrastructure located downstream.
