Landslide Hazard and Risk Zonation Mapping in the Río Grande Basin, Central Andes of Mendoza, Argentina

Source: Mountain Research and Development, 22(2) : 177-185

This paper presents an inventory of landslides and hazard and risk zonation mapping along the Río Grande basin in the Central Andes of Mendoza. The mapping was based on field work combined

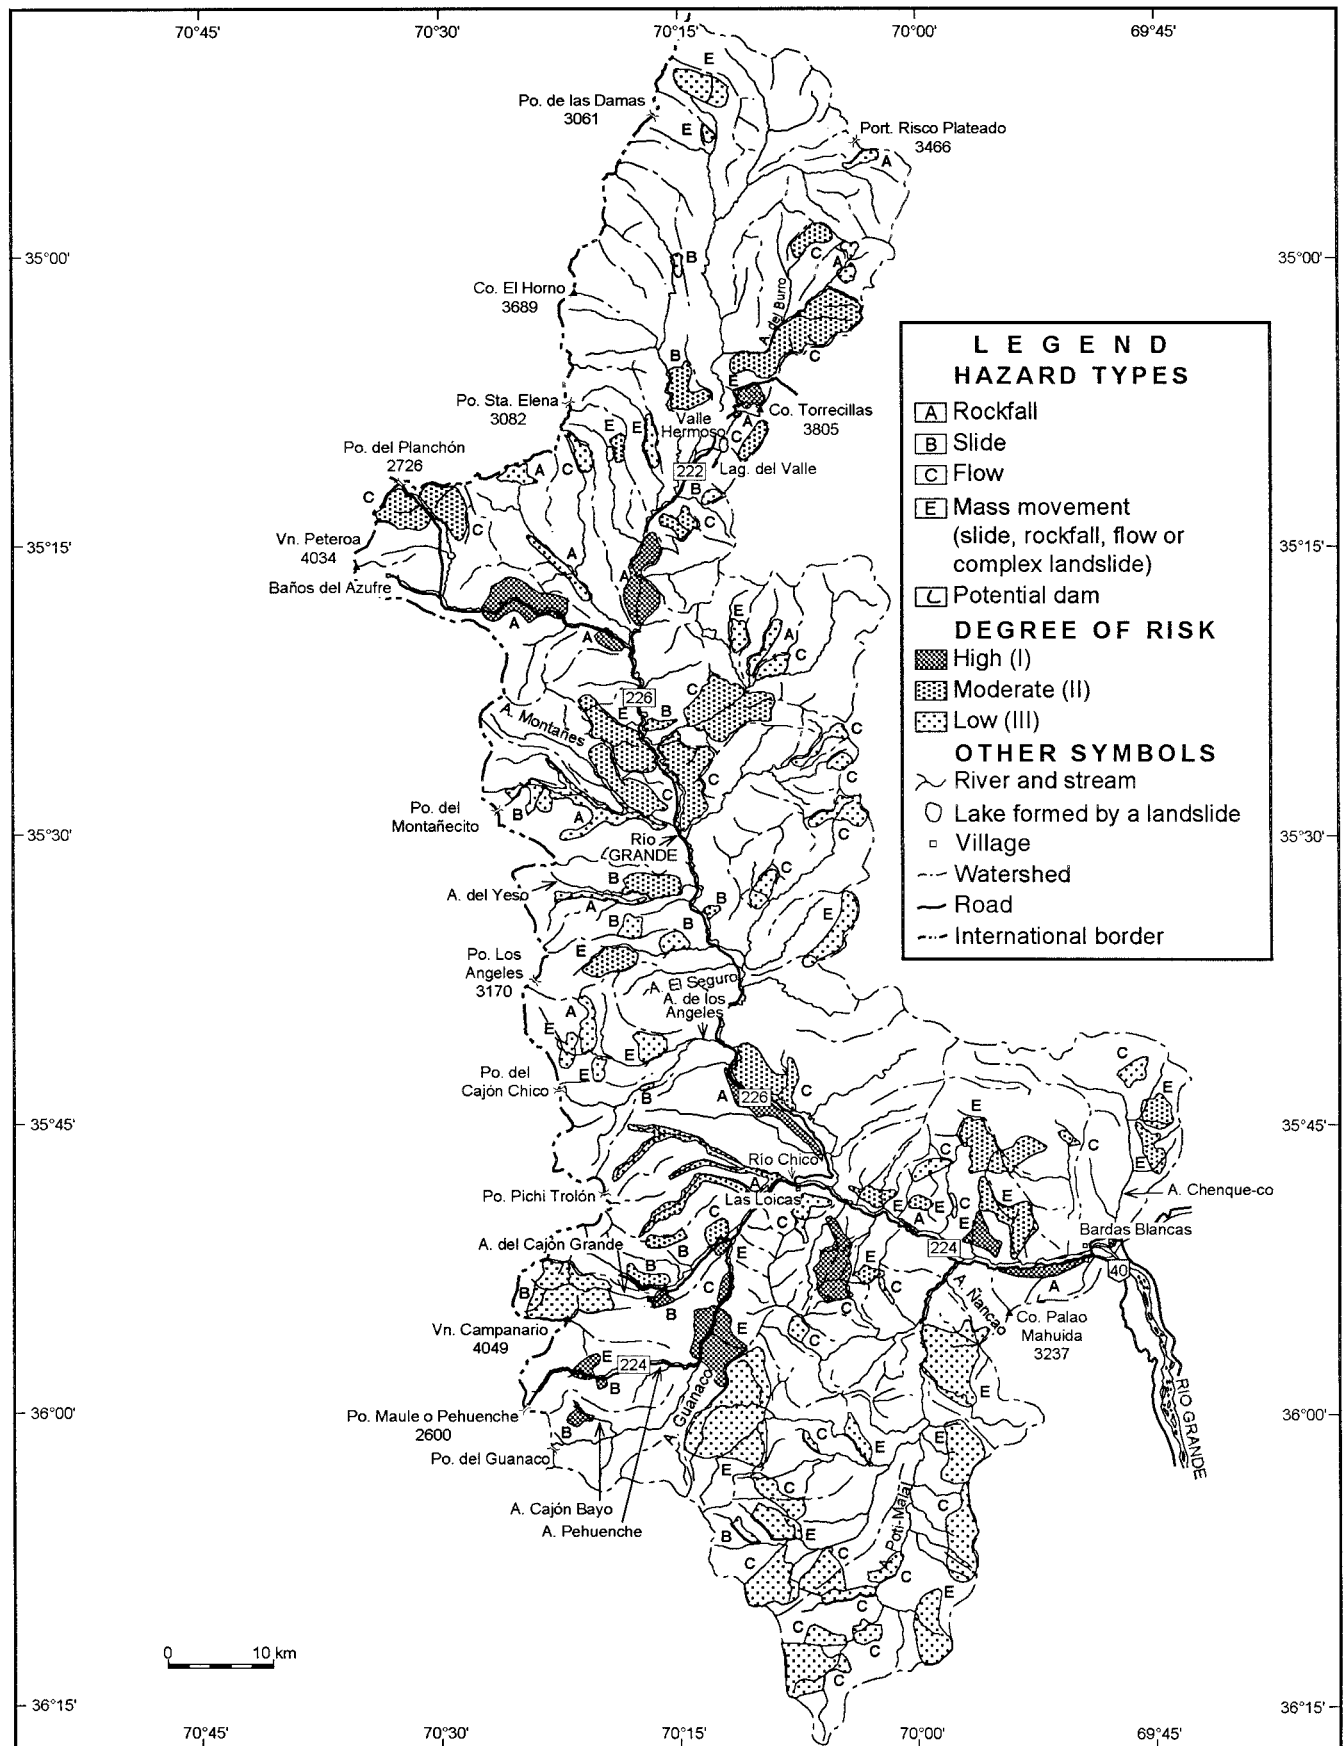
FIGURE 6 Map of landslide hazards and risk zonation in the Río Grande basin.

We prepared 2 maps. The distribution and classification of landslides are shown on the first map (inventory map; Figure 5). The second—a landslide hazard and risk zonation map (Figure 6)—was prepared taking into account the zones subject to landslide hazard and the degree of loss to a given element or set of elements at risk in the region because of the occurrence of a particular phenomenon of a given magnitude (Coburn et al 1994).

A landslide risk map was obtained showing the hazards and elements at risk according to UNDRO/UNESCO (See Coburn et al 1994) definitions. The risk map shows that the major hazards and the greatest potential risk are concentrated along the Río Grande valley and its tributaries where the roads, routes, and settlements are located. Three risk degrees were distinguished as follows (Figure 6):

- *Degree I (high risk)*. This is the category with the highest degree of hazard and risk, where rockfalls, flows, or slides that could occur would affect Provincial routes 222 and 224, roads, bridges, or small, populated centers. Rockfalls are probably the most frequently observed mass movements in mountain areas. The areas where rockfalls occur are subject to events of lesser magnitude that occur more frequently; therefore, construction should be avoided.

- *Degree II (moderate risk)*. This category covers areas vulnerable to the potential occurrence of landslides, but the threat to infrastructure in the area is not as great because the hazard zones are far away. Through field observations in March 1996, it was possible to detect the occurrence of a debris flow that flowed from the headwaters of Arroyo Chenque-Co after a heavy rainstorm (Degrees II and III; Figure 6). Highway No. 40 and a small bridge were damaged (Degree I; Figure 6).

- *Degree III (low risk)*. The occurrence of a potential landslide is relatively remote, and the expected damage to the infrastructure is very slight.
- *Potential dam*. The potential occurrence of a specific hazard induced by large mass movements that could cross the valley floor up to the opposite slope, thus damming a river or a creek, was considered as a slide hazard zone. In case the dam is broken, a catastrophic flood could occur, posing high risk to inhabited areas and infrastructure located downstream.
