A Lichens-Mediated Mechanism for Environmental Biodeterioration

Authors: Thakur, Monika, Shrikhandia, SP Pourush, and Kumar, Vinod

Source: Air, Soil and Water Research, 15(1)

TYPE: Review

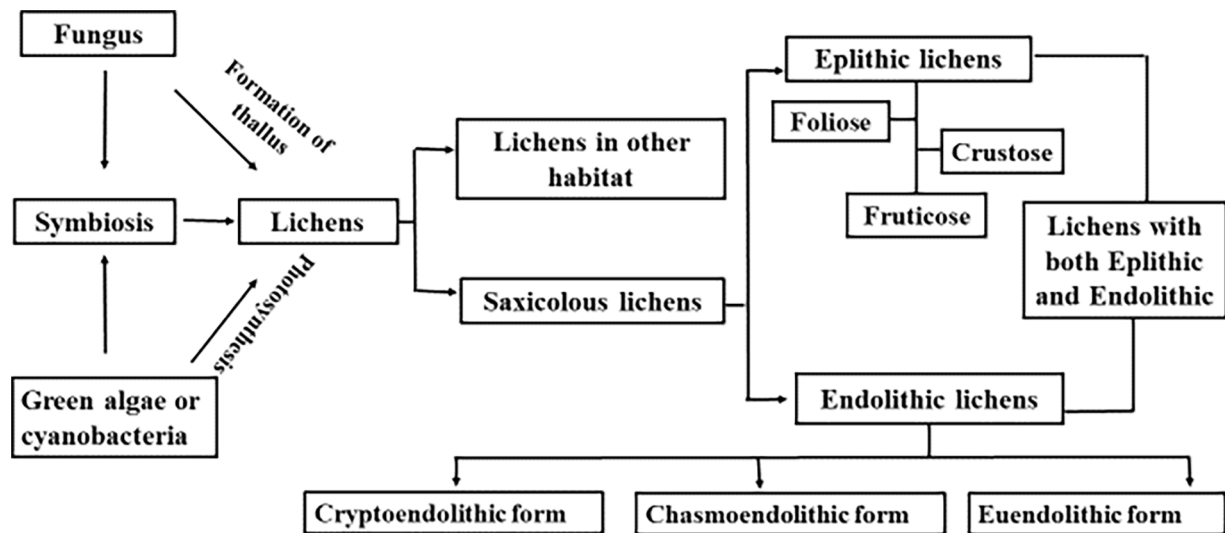
Figure 1. Diagrammatic representation of lichens based on habitat variation.

epilithic lichens that exist on the rock's surface and endolithic lichens that reside inside the rock. Euendolithic forms aggressively bore into rocks, while cryptoendolithic forms occupied structural cavities and chasmoendolithic forms resided in fissures and cracks within rocks (Figure 1).

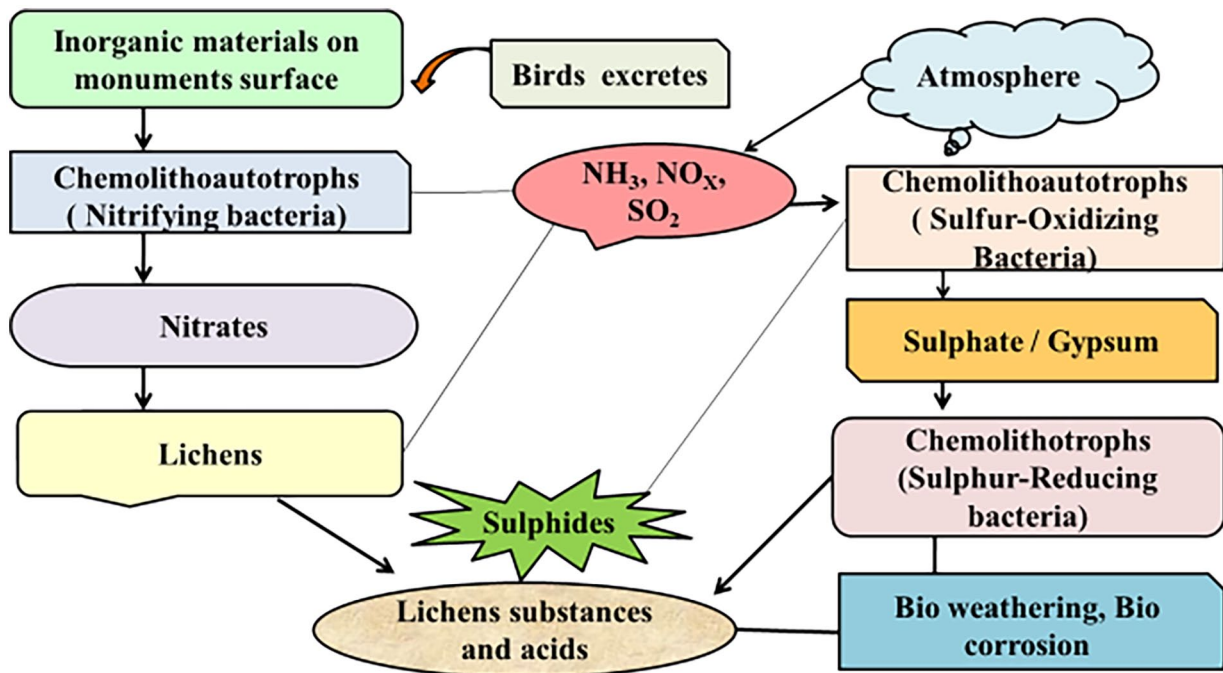
Figure 2. Diagrammatic representation of lichens mediated biodeterioration of monuments.

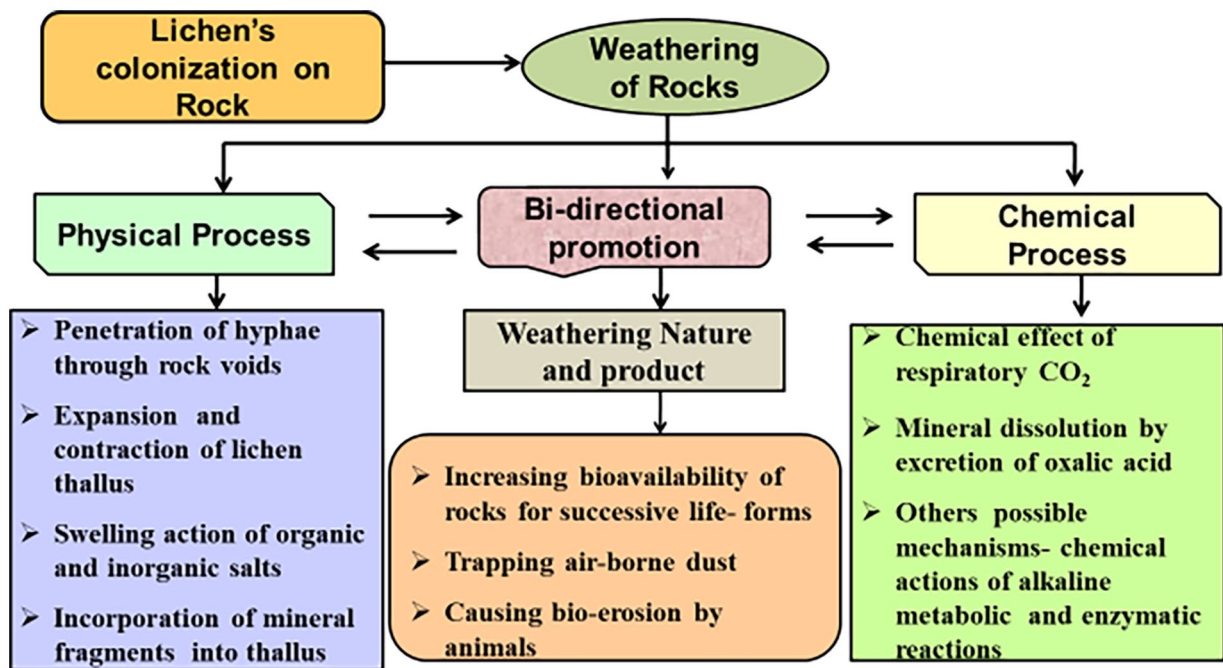
Figure 3. Diagrammatic representation of lichens effects on monuments soil formation.
