## **Sand dune management problems and techniques, Spain.**

Authors: Gómez-Pina, Gregorio, Muñoz-Pérez, Juan J., Ramírez, Jose L., and Ley, Carlos

Source: Journal of Coastal Research, 36(sp1) : 325-332

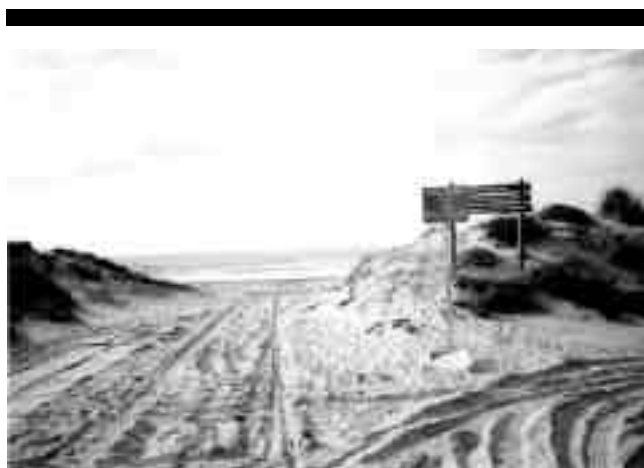
Figure 1. Typical dune breaching in La Bota (Huelva, Spain), Gómez-Pina 1997

Figures from GÓMEZ-PINA(1999) are representative of dune degradation in La Bota beach (Huelva). Figure 1 shows a typical dune breach caused by off-road vehicles and human trampling. Figure 2 depicts the existing public road, crossing the foredunes longitudinally. The removal of this road is part of a very ambitious integrated dune management project being carried out by the National Spanish Coast Directorate, Ministry of Environment.

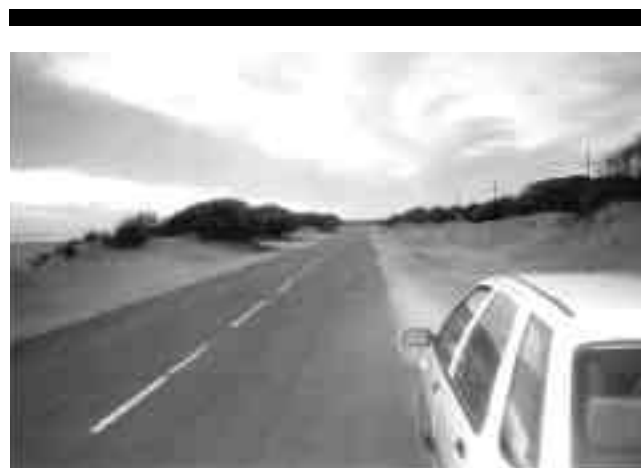
Figure 2. Existing road alongside La Bota beach (Huelva, Spain), Gómez-Pina 1997.

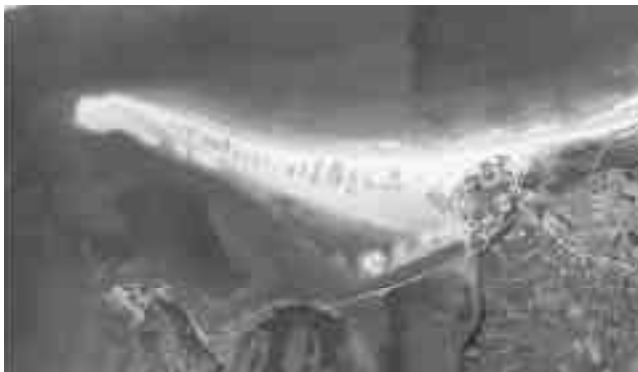
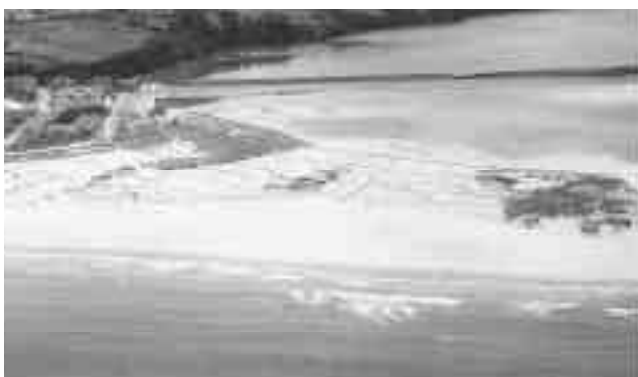
Figure 3. An aerial view of Somo spit (Cantabrian, Spain) before dune restoration.

Figure 4. An aerial view of Somo spit (Cantabrian, Spain) after dune restoration.

Since 1992 dune restoration works have been carried out in several phases consisting of the reinforcement of the deteriorated dune system by using willow sand trappers in conjunction with transplanted vegetation (*ammophila arenaria*) from the neighbouring dune plant nursery. Fencing was used in sensitive areas to reduce the effects of human trampling. Elevated dune walkovers for access to the beach were conveniently placed near parking areas, beachfront subdivisions and public facilities to avoid damage to the dunes from pedestrian traffic. Finally, information posters were placed in adequate locations to make beach visitors aware of the importance of the dunes and the restoration works in place.

Figures 3 and 4 show aerial views of Somo spit before and after dune restoration. In Figure 5 a detailed perspective of fencing and transplanted vegetation is displayed.

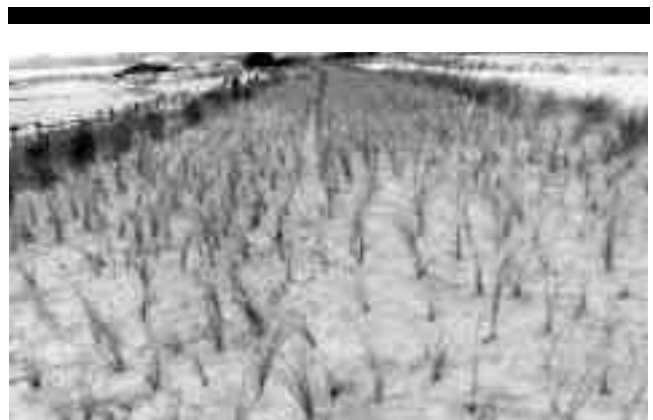
Figure 5. Fencing and transplanted vegetation in Somo spit (Cantabrian, Spain).

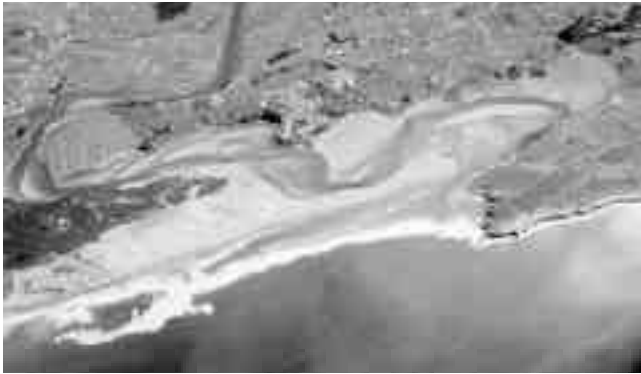
Figure 6. An aerial view of Liencres spit (Cantabrian, Spain) after breaching.

Figure 6 depicts an aerial view of Liencres spit after dune breaching. In Figure 7 sand accumulation caused by willow fences can be seen. Elevated dune walkovers and fencing are shown in Figure 8.

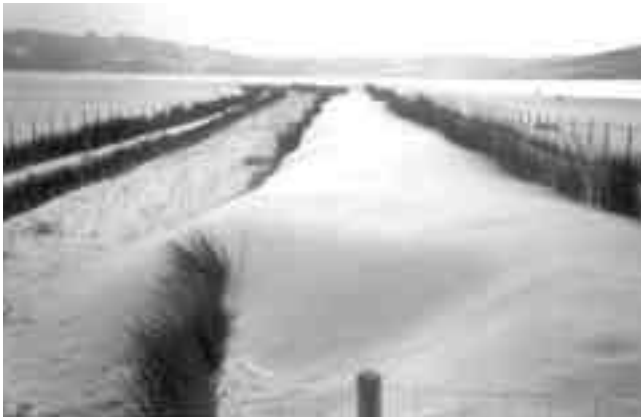
Figure 7. A detail of dune restoration in Liencres spit (Cantabrian, Spain)

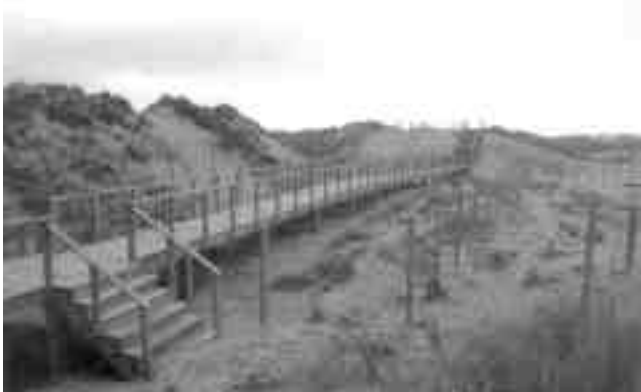
Figure 8. Dune walkover and fencing in Liencres spit (Cantabrian, Spain)

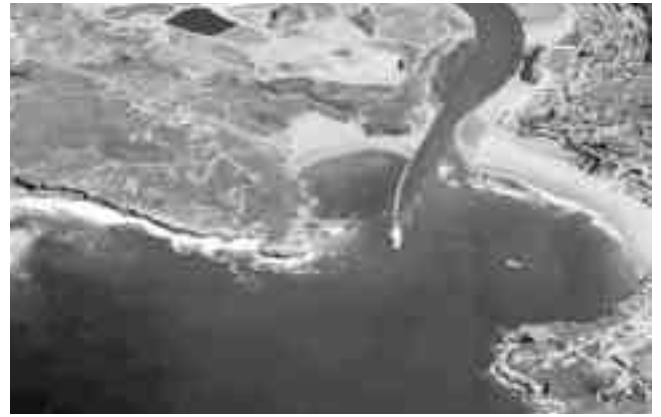
Figure 9. An aerial view of Cuchía beach (Cantabrian, Spain)

As a result of former sand mining, human trampling and disorderly garbage dumping in Cuchía beach, coppice mounds and foredunes lost all kind of dune vegetation presenting a very degrading state. After cleaning operations, foredunes were restored with adequate dredging from the neighbouring inner harbour in Suances estuary ("ría"). Finally, willow sand trappers together with transplanted vegetation were used to stabilise the foredune surface.

Figure 9 shows an aerial view of Cuchía beach and Suances estuary. A panoramic of Cuchía beach after rehabilitation is depicted in Figure 10.

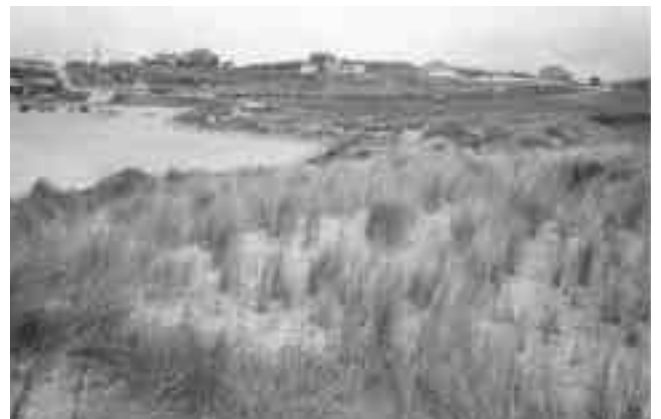
Figure 10. Cuchía beach (Cantabrian, Spain) after dune restoration

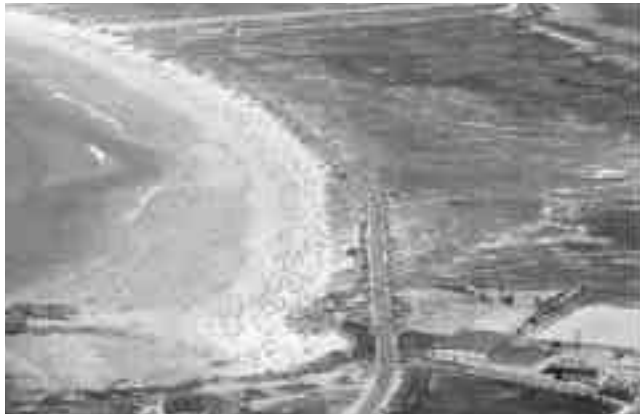
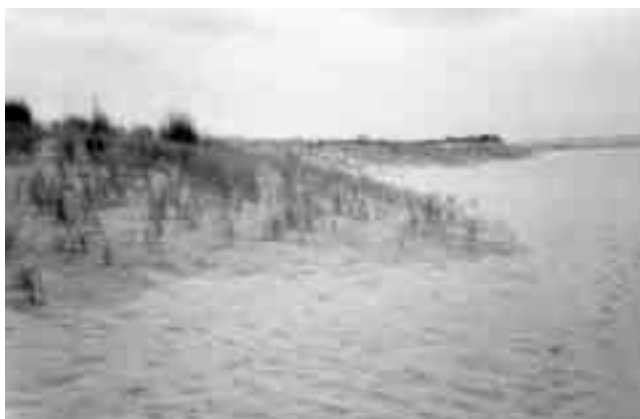
Figure 11. La Lanzada beach (Pontevedra, Spain) before dune restoration

Figure 12. La Lanzada beach (Pontevedra, Spain) after dune restoration

Figures 11 and 12 show aerial views of La Lanzada beach before and after dune restoration.

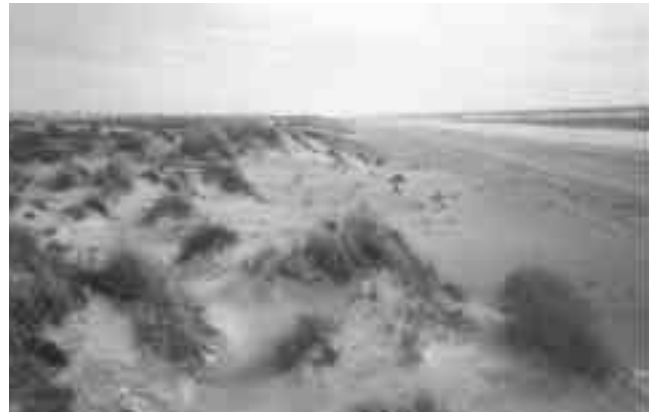
Figure 13. Dune blow-outs in Isla Cristina beach (Huelva, Spain)

Fig.13 shows typical dune blow-outs in Isla Cristina beach. Fig.14 depicts an illustrative grazing scene. Fig.15 shows dune fencing and revegetation.

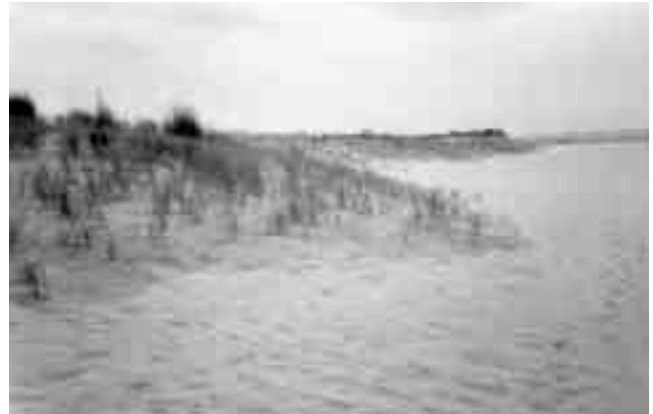
Figure 14. Grazing in Isla Cristina beach (Spain).

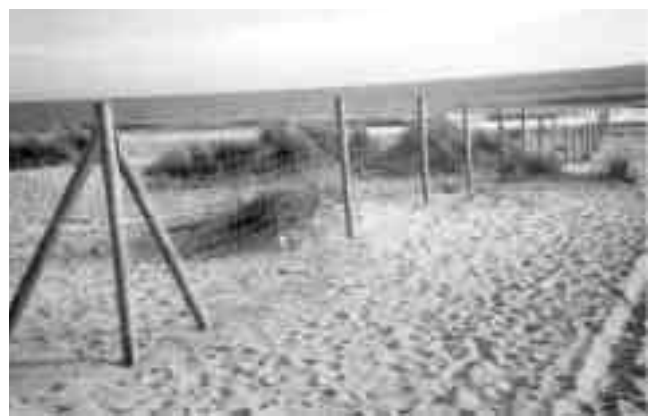
Figure 15. Dune fencing and revegetation in Isla Cristina beach (Huelva, Spain)

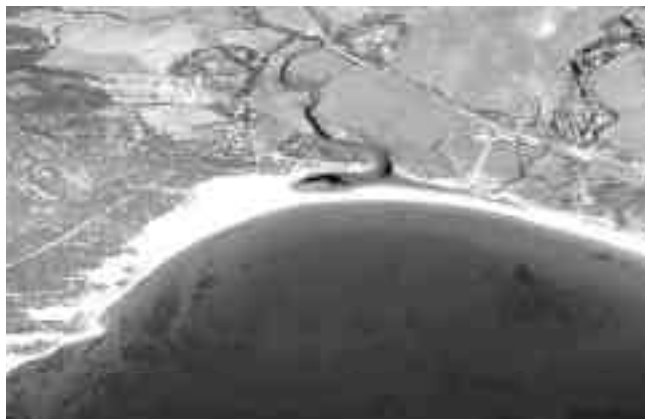
Figure 16. An aerial view of Valdevaqueros cove (Cádiz, Spain)

The special characteristics of these mobile dunes together with their natural and scenic values confer to Valdevaqueros cove a great attraction. The frequent local Levante wind regimes give rise to high wind speeds of up to 100 km/hr. The high longitudinal aeolian transport is responsible for building up a huge dune at the northern beach side. Wind conditions and low rainfall, together with the direct burden caused by dune visitors, make it difficult to establish permanent vegetation on the dune. As a result the dune became unstable, showing a continuous massive movement towards an adjacent pine grove.

Figure 16 depicts an aerial view of Valdevaqueros cove. Figure 17 shows backdune restoration near the adjacent pine grove. Figure 18 shows foredune accretion after restoration.

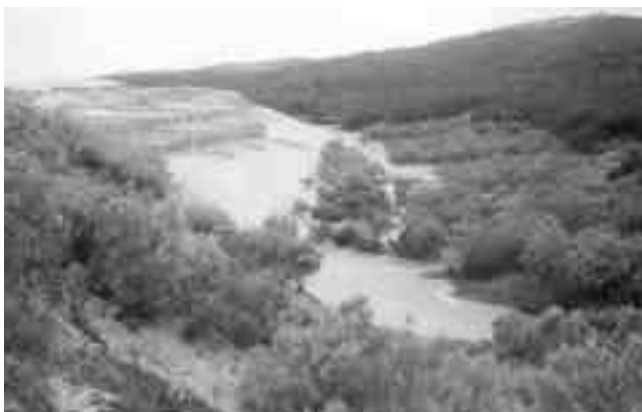
Figure 17. A view of Valdevaqueros backdune restoration (Cádiz, Spain)

Dune restoration works started with the reshaping of the dune profile in order to obtain a better aerodynamic stability complemented with the experimental use of longitudinal willow sand fences to decrease erosive surface patterns. Also experimental transplanted vegetation techniques were used along certain potentially stable areas.

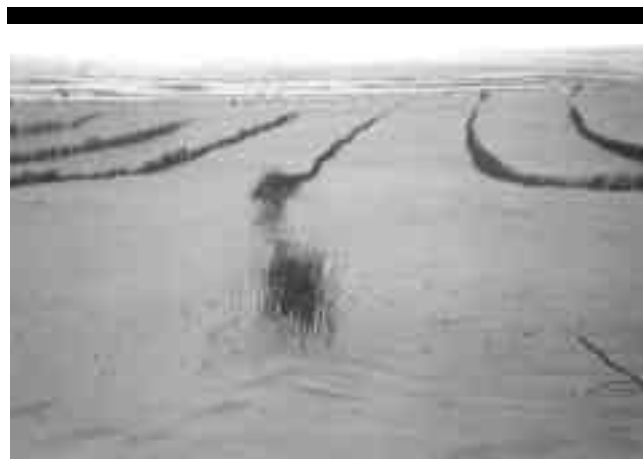
Figure 18. A view of Valdevaqueros accreted foredune after restoration (Cádiz, Spain)

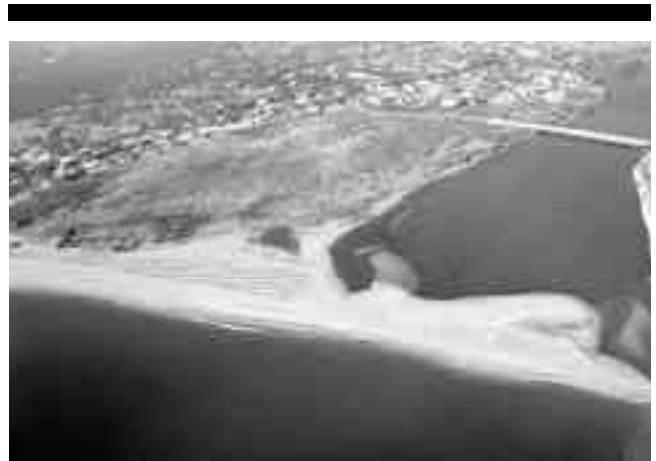
Figure 19. An aerial view of Guadalquítón estuary after restoration (Cádiz, Spain)

Guadalquítón beach (Fig. 19) is located in the Guadiaro river estuary on the Mediterranean sea, under the influence of the waters from the Gibraltar strait. Coastal dunes near the Mediterranean sea are, in general, less developed than Atlantic dunes due, among other factors, to the almost absence of tides in the Mediterranean sea. Extensive Mediterranean dune areas were totally altered and destroyed in the course of enormous tourist urbanisation projects during the 1960s-1970s (e.g. the beautiful barrier island of La Manga in Cartagena, GÓMEZ-PINA 1999). Furthermore, littoral drift interruption by harbour and marinas contributed to the acceleration of dune degradational processes. Although the case of Guadalquítón beach did not escape from this problem its conditions at the time of undertaking the restoration project were not as irreversible as in other Mediterranean beaches.

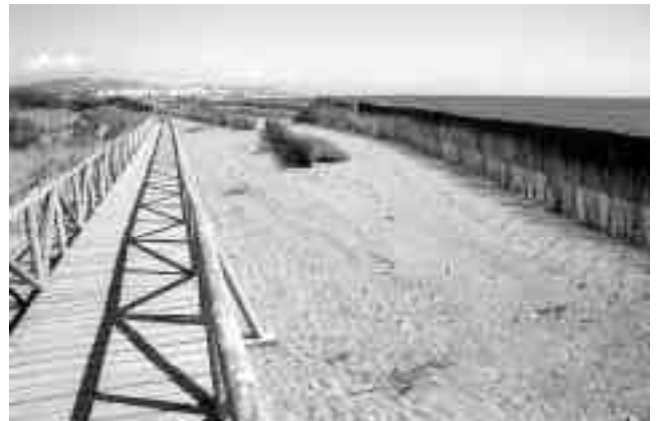
Figure 20. A detailed view of Guadalquítón dune restoration (Cádiz, Spain)

The dune restoration project was only a part of an integrated plan to improve coastal zone management aspects at the Guadiaro estuary, such as river flushing recovery, garbage cleaning, water quality improvement, wetland restoration, fencing of sensitive areas, public access improvement, sea bird observatories, beach nourishment and dune reinforcement. New sand trapping methods were experimented with as well as native transplanted vegetation under critical climatic conditions (yearly run-off is less than 250 mm)
