# Contamination of Household Open Wells in an Urban Area of Trivandrum, Kerala State, India: A Spatial Analysis of Health Risk Using Geographic Information System

**OBJECTIVE:** To assess the sanitary condition and water quality of household wells and to depict it spatially using Geographic Information System (GIS) in an urban area of Trivandrum, Kerala state, India.

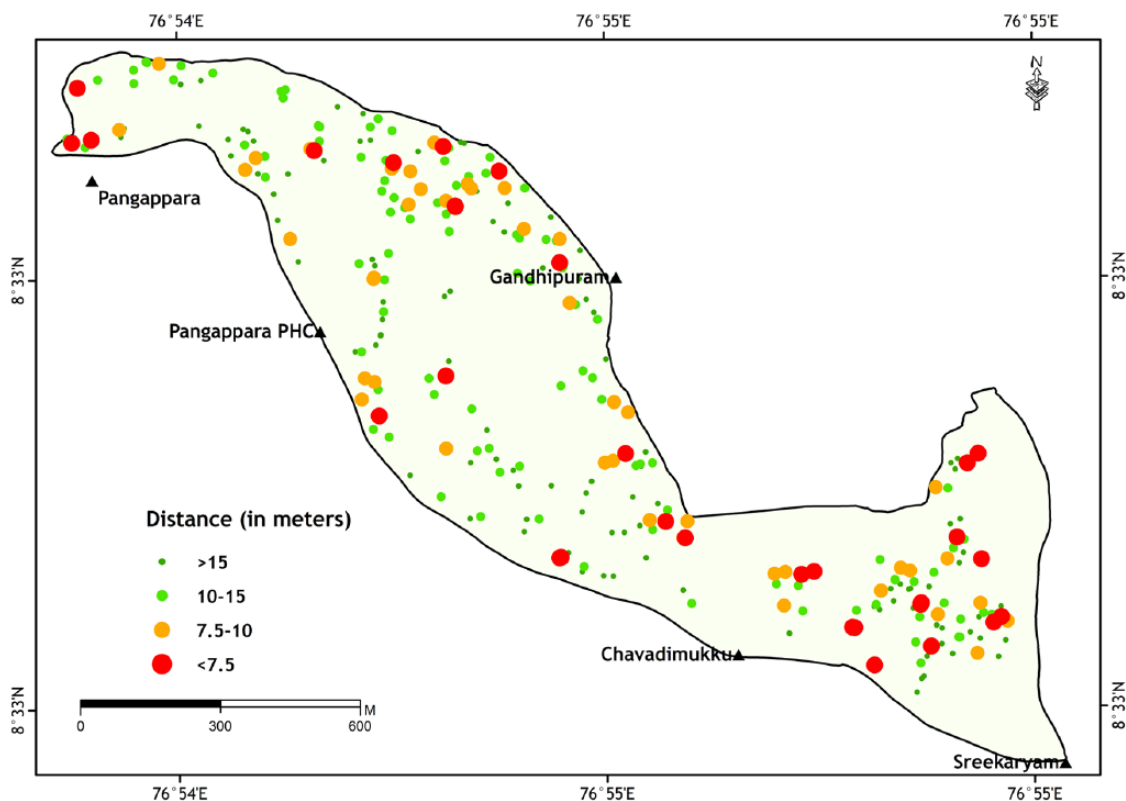
**Figure 2.** Map showing the distance of each well from the nearest septic tank. Larger dots depict a well with a septic tank nearer.

using DGPS, which showed a median of 13.40 ± 12.77 m, with a minimum of 1 m and maximum of 139 m. Here, the septic tank may be of the adjacent household, not necessarily within the same household boundary. This was then mapped, as shown in Figure 2. The sanitary survey results are depicted in Table 1.

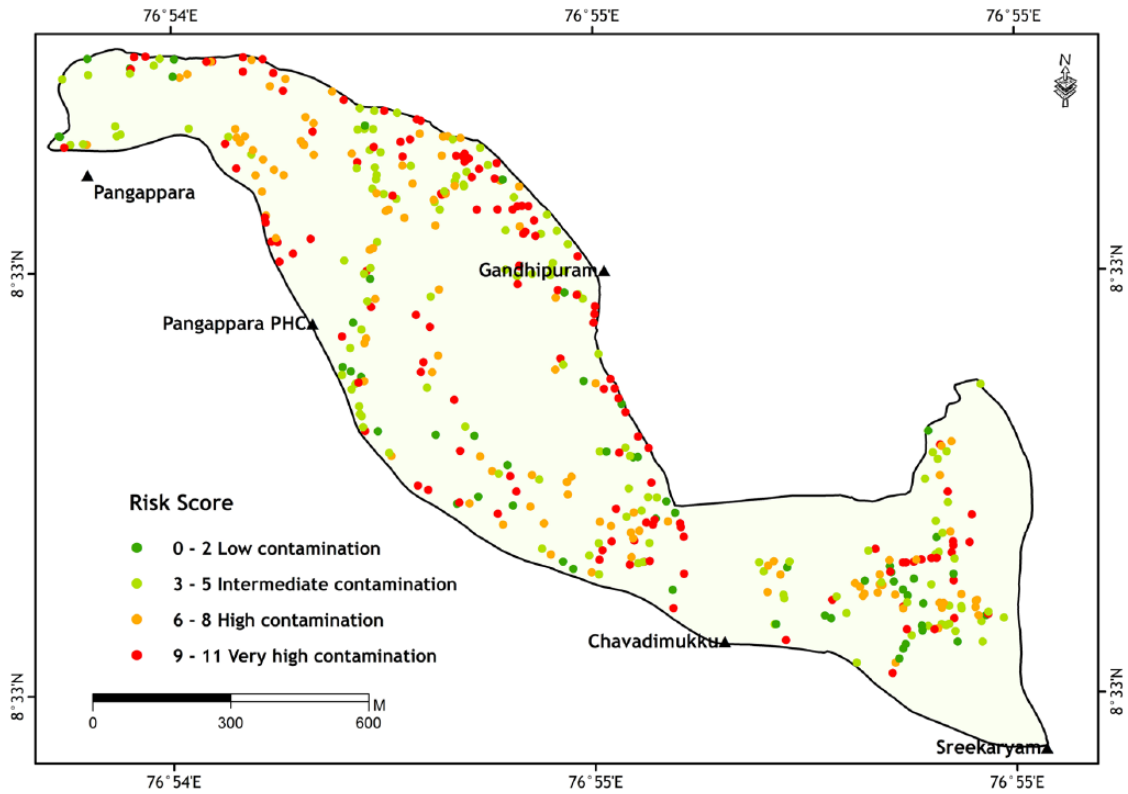
The net contamination score from the survey was used to predict the contamination risk for each of the well. Most of the wells (39%) in the area had intermediate risk for contamination, followed by high risk (31%) of contamination (Table 2 and Figure 3).

**Figure 3.** Spatial distribution of contamination risk score of each well in the study area. Red dots denote the wells with highest risk of contamination, and green dots the least risk.

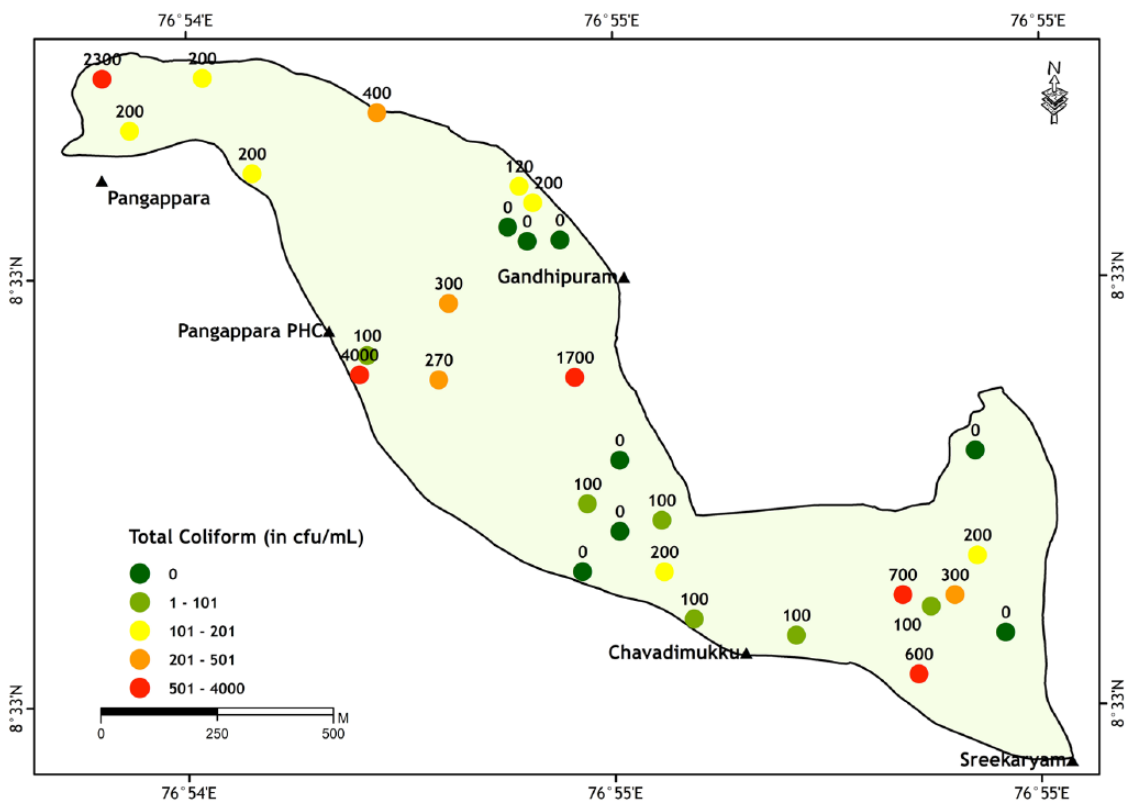
Out of the 30 samples that collected for bacteriological analysis, 22 were positive for Coliforms (both Total Coliforms and Fecal Coliforms), as mapped in Figure 4. The chemical analysis of open well water revealed the low pH or acidic nature of the groundwater (Median: 5, 40) as compared with the BIS for drinking water. The groundwater pH pattern of the area was mapped using GIS and is given as Figure 5.

**Figure 4.** Distribution of coliform contamination in the sampled wells (n = 30). Red dots are the wells with highest coliform load. Dark green dots denote wells free of coliforms.

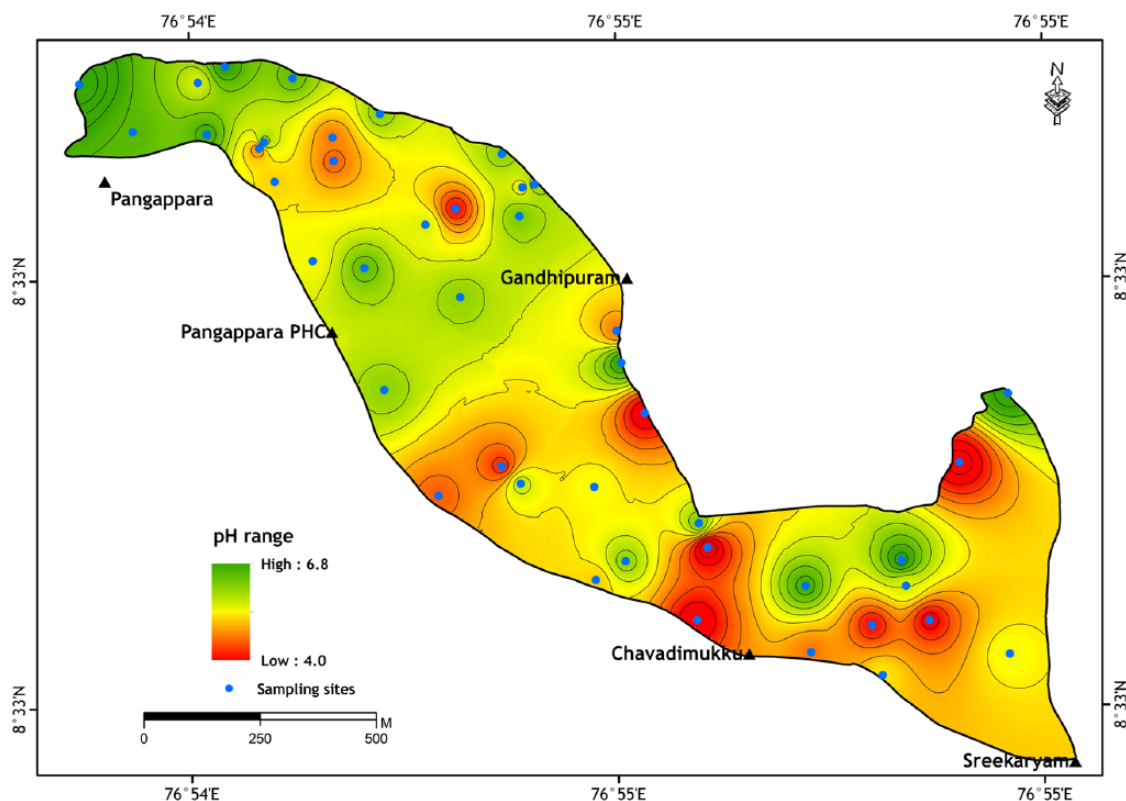
**Figure 5.** Spatial distribution of well water pH of the study area. Green color depicts a pH close to the normal recommended range and orange to red shows highly acidic well water.
