Processes Controlling Development of Erosional Hot Spots on a Beach Nourishment Project

L. Benedet[†‡], C.W. Finkl[†§], and W.M. Hartog[‡]

BENEDET, L.; FINKL, C.W., and HARTOG, W.M., 2007. Processes controlling development of erosional hot spots on a beach nourishment project. *Journal of Coastal Research,* 23(1), 33–48. West Palm Beach (Florida), ISSN 0749-0208.

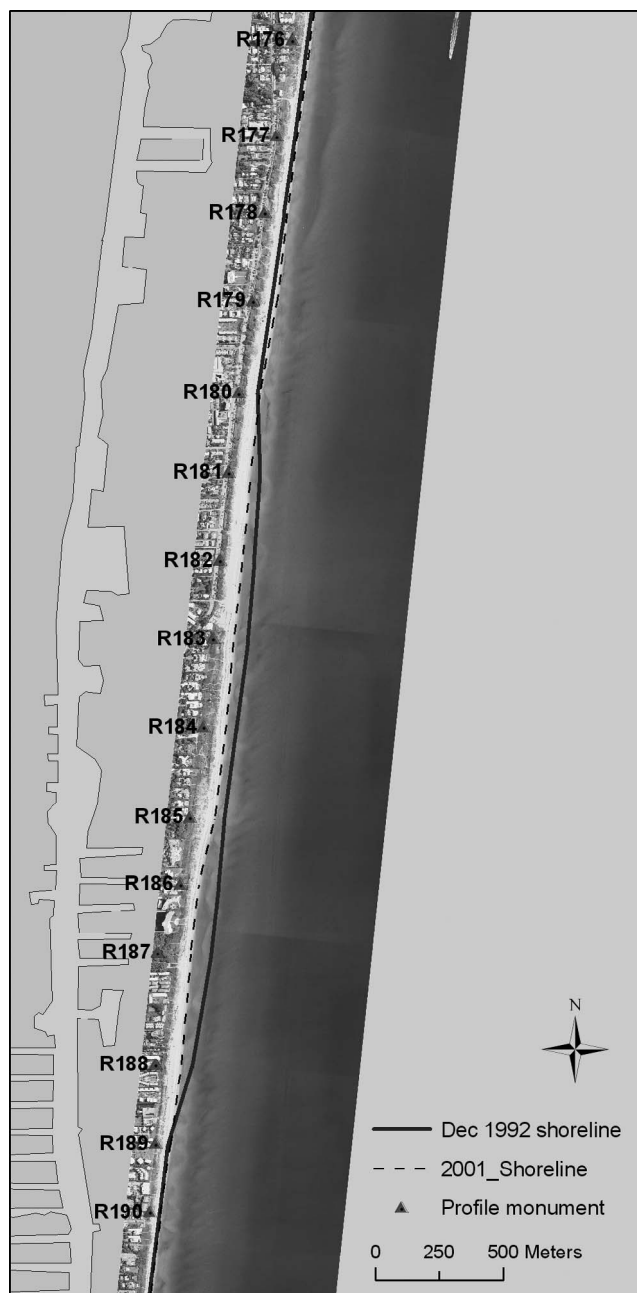
Figure 2.   Shoreline positions overlaid on georectified aerial photography obtained in 2001. The 1992 shorelines shown were surveyed immediately after construction of the 1992 nourishment project (December 1992), and June 2001 is the last complete survey of the project area prior to the construction of the fourth consecutive nourishment project in April 2002. **For color version of this figure, see page 128.**

Deviations between postconstruction shorelines and the 2001 shoreline (Figure 2) increase on the downdrift segment of the fill (between monuments R186 and R187), indicating more erosion than on other fill segments. Crescentic bars, which are the most persistent type of bar morphology observed at the project area, have horns between bars not attached to the beach near the downdrift end of the fill, whereas on the other areas irregularly spaced crescentic bars with horns attached to the beach occur, suggesting a morphodynamic relationship between erosion rates and surfzone morphology. Shoreline and volume change from the postconstruction survey (December 1992) to the last survey (June 2001) reached -80 m between R186 and R187, about -40 m between R184 and R185, and about -60 m at R183 (Figure 3). The updrift beach segment (R175 to R180) showed an average accretion of 11 m, while the downdrift beach (R189 to R191)

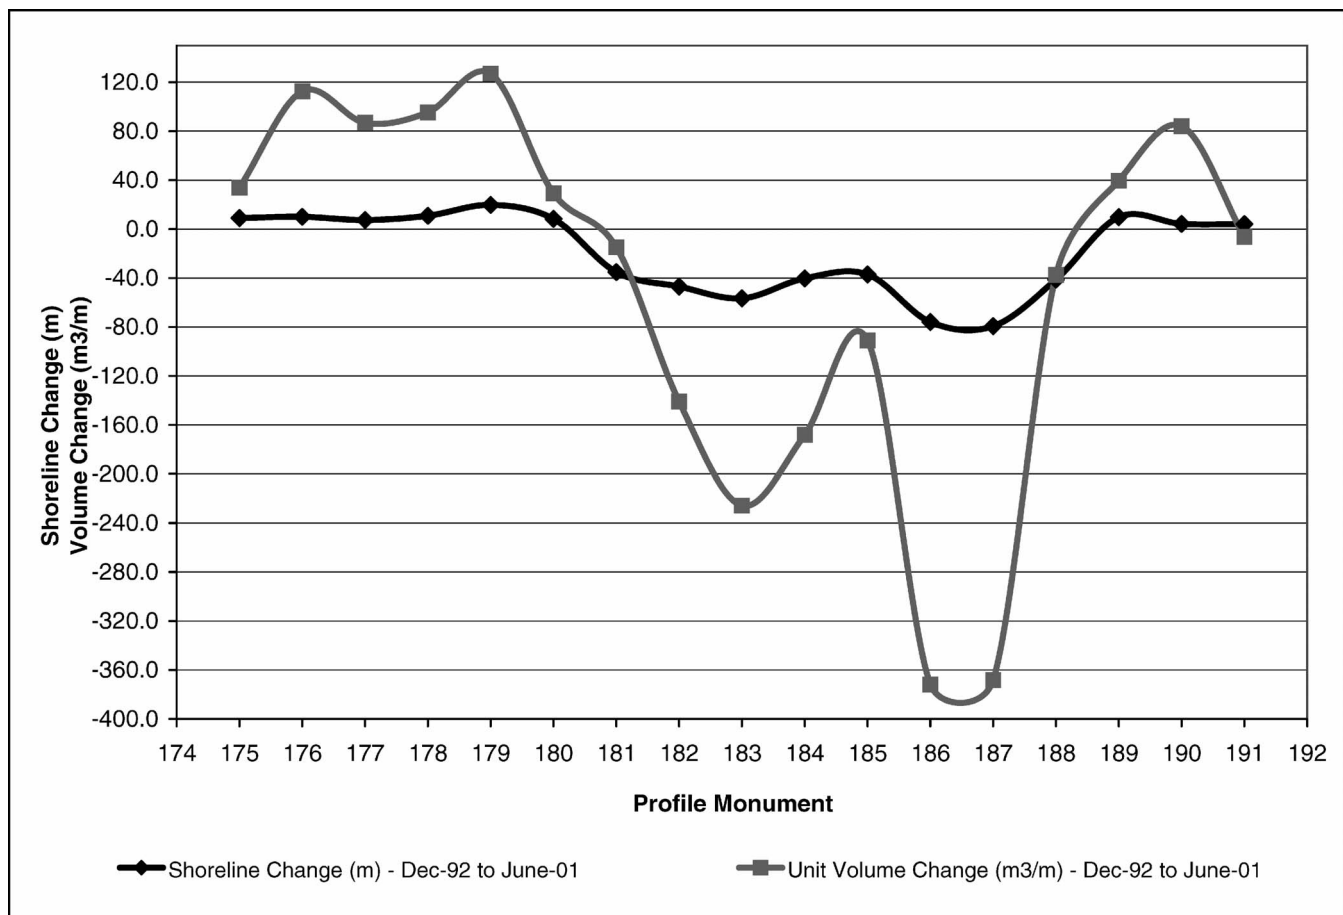
Volume changes to the -7.5-m depth contour (offshore limit of the profile surveys) between 1992 and 2001 show a general trend similar to the shoreline changes (Figure 3). Total volumetric changes were estimated by multiplying the unit volume change by the distance between profile monuments. Between 1992 and 2001, a cumulative volume of about 448,000 m³ was lost from the fill limits; of this volume, 177,000 m³ (about 40%) eroded from the beach segment between profile monuments R186 and R187.

Figure 3. Shoreline changes (m) and volume changes (m³ m⁻¹) from the postconstruction survey (December 1992) to the last survey of the entire study area (June 2001).

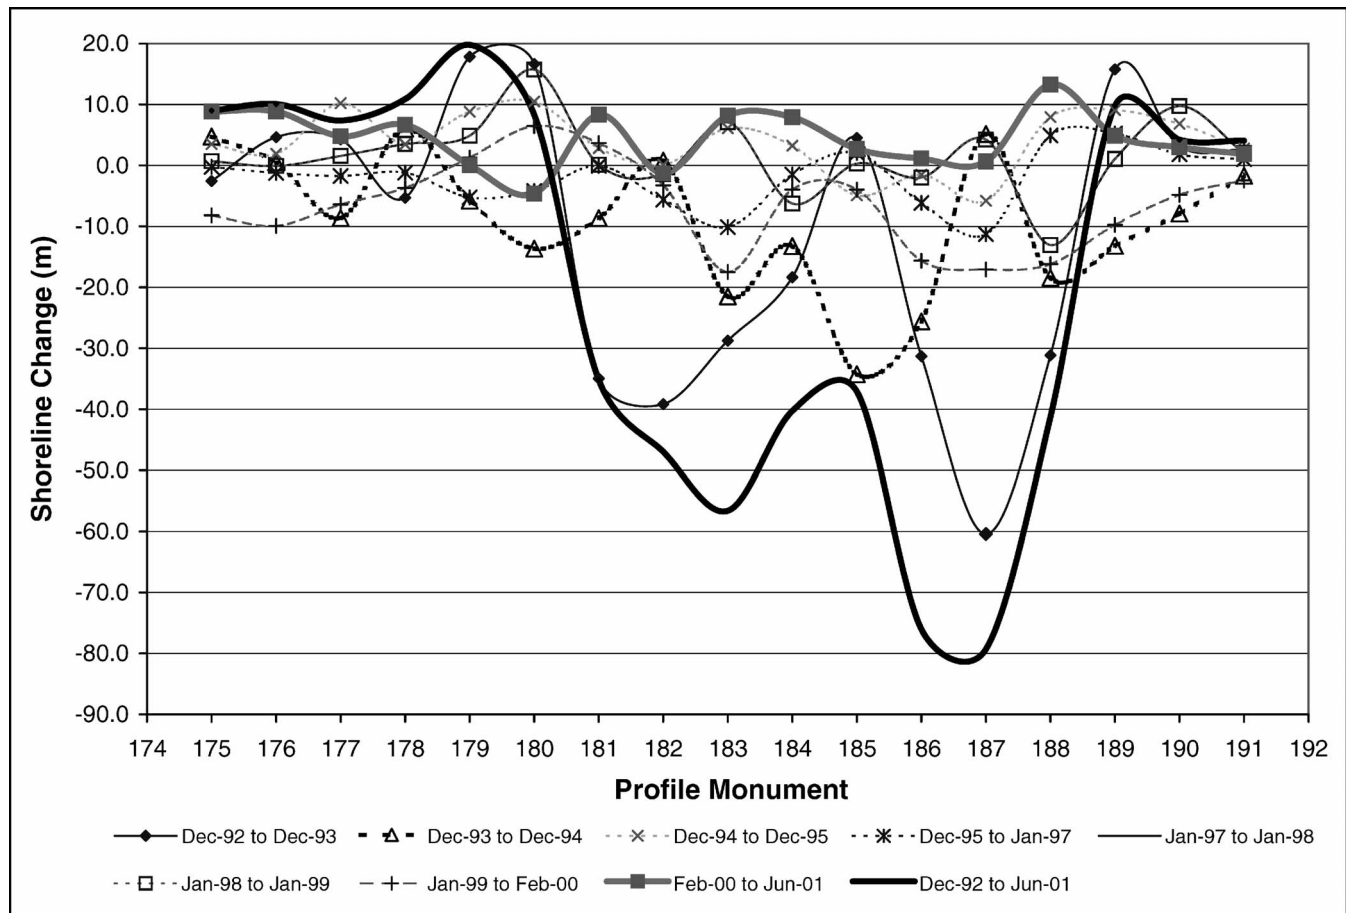
Monuments that eroded relatively more than the rest of the fill, shown in Figures 4 and 5, include R183, R186, and R187. The shoreline on R186 and R187 retreated almost every year except for two periods (1993–1994 and 1998–1999) (Figure 4). Greater shoreline retreat also occurred near R183 for most of the time except for 1993–1994, 1998–1999, and 2000–2001 where accretion occurred (Figure 4).

Figure 4. Shoreline changes calculated between annual survey intervals for the Delray Beach project area contrasted with the total changes from December 1992 to January 2001 (thicker black line).

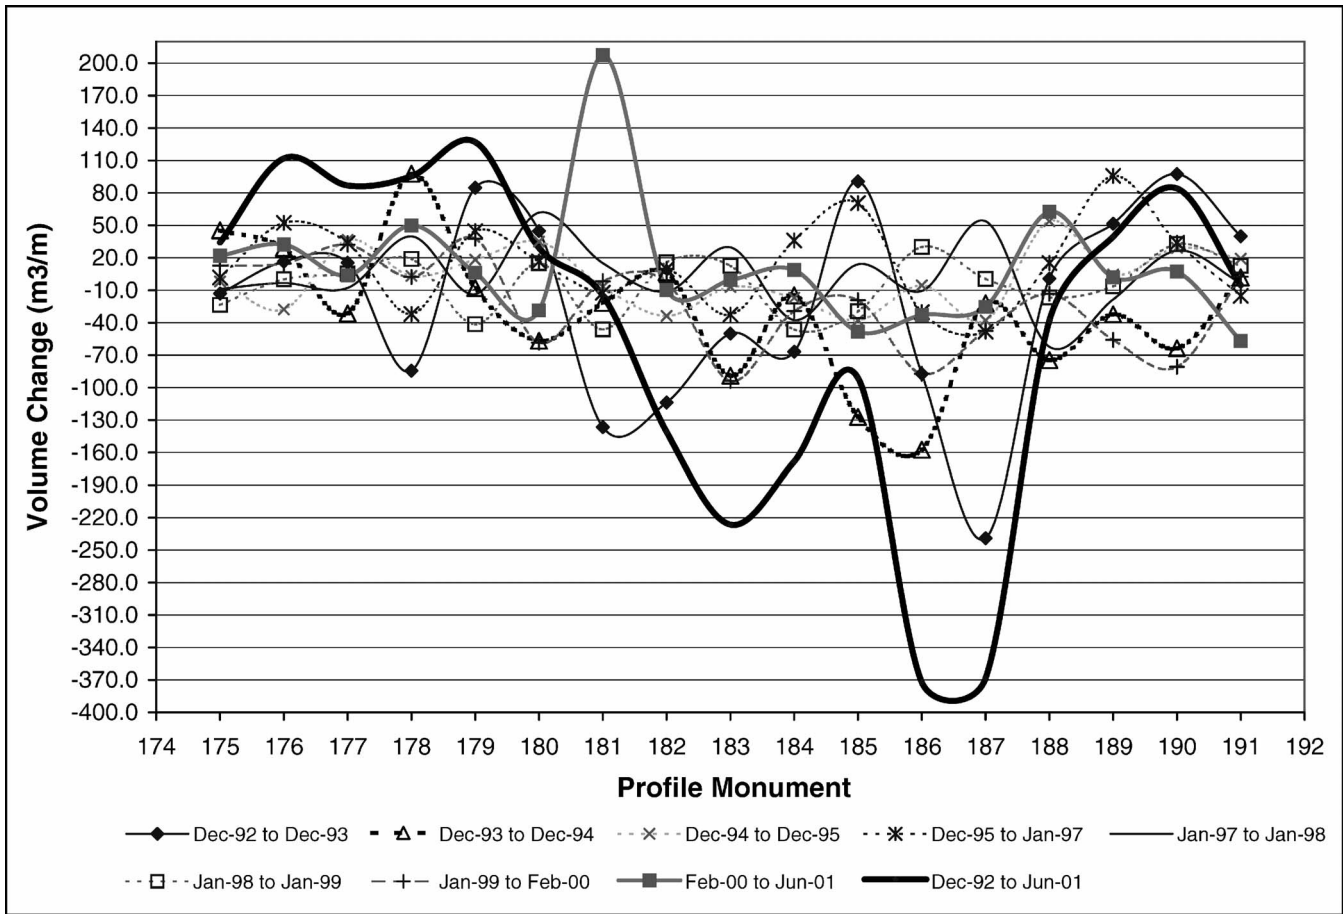
Volume losses of R183, R186, and R187 were also greater than the rest of the project for most years but for two (January 1997 to January 1999) when accretion occurred on these locations. Relatively small volume gains were observed in the updrift and downdrift segments throughout most of the monitoring period simultaneous to erosion of the beach fill, indicating some alongshore spreading of fill sediments. Further analysis of beach profiles shows that accretion of about 200 m³ m⁻¹ observed at profile R181 between 2000 and 2001 period (see Figure 5) was mostly due to sedimentation in the inner and outer bar systems; thus, although a large volumetric gain occurred, very little shoreline change was observed in this area during the same time period (see Figure 4).

Figure 5. Volume changes per unit length of beach (m³ m⁻¹) calculated between annual survey intervals for the Delray Beach project area contrasted with the total changes from December 1992 to January 2001 (thicker black line).

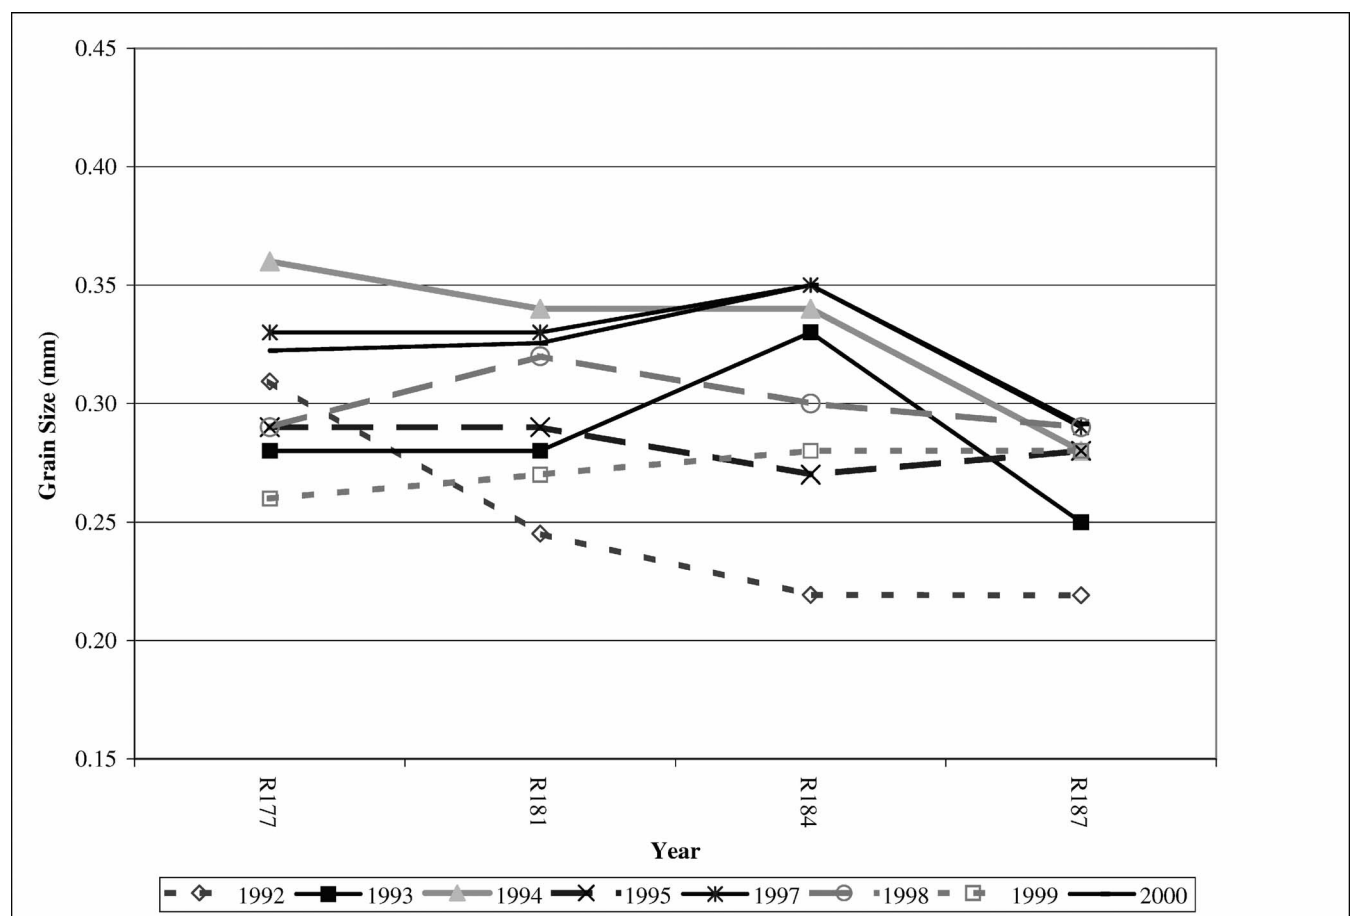
Figure 6. Alongshore distribution of grain size along the project area at selected profile monuments surveyed on an annual basis.

monitored years. Beach sediments at monuments R184 and R187 were finer than beach sediments at monuments located farther to the north (R177, R181) during the first postconstruction survey conducted February 1992 (Figure 6); however, about 10 months later (December 1993), the grain-size difference between R177 and R187 was minimal, 0.28 mm *vs.* 0.25 mm, respectively, and the grain size at R184 is coarser than anywhere else in the beach (0.33 mm), indicating rapid mixing of fill sediments with preexisting sediments. The absence of large alongshore variations in beach grain size that are persistent in time within the beach fill area indicates that grain-size distribution is not a major parameter controlling EHS development, since the higher erosion in the EHS segment occurs throughout the monitoring period.

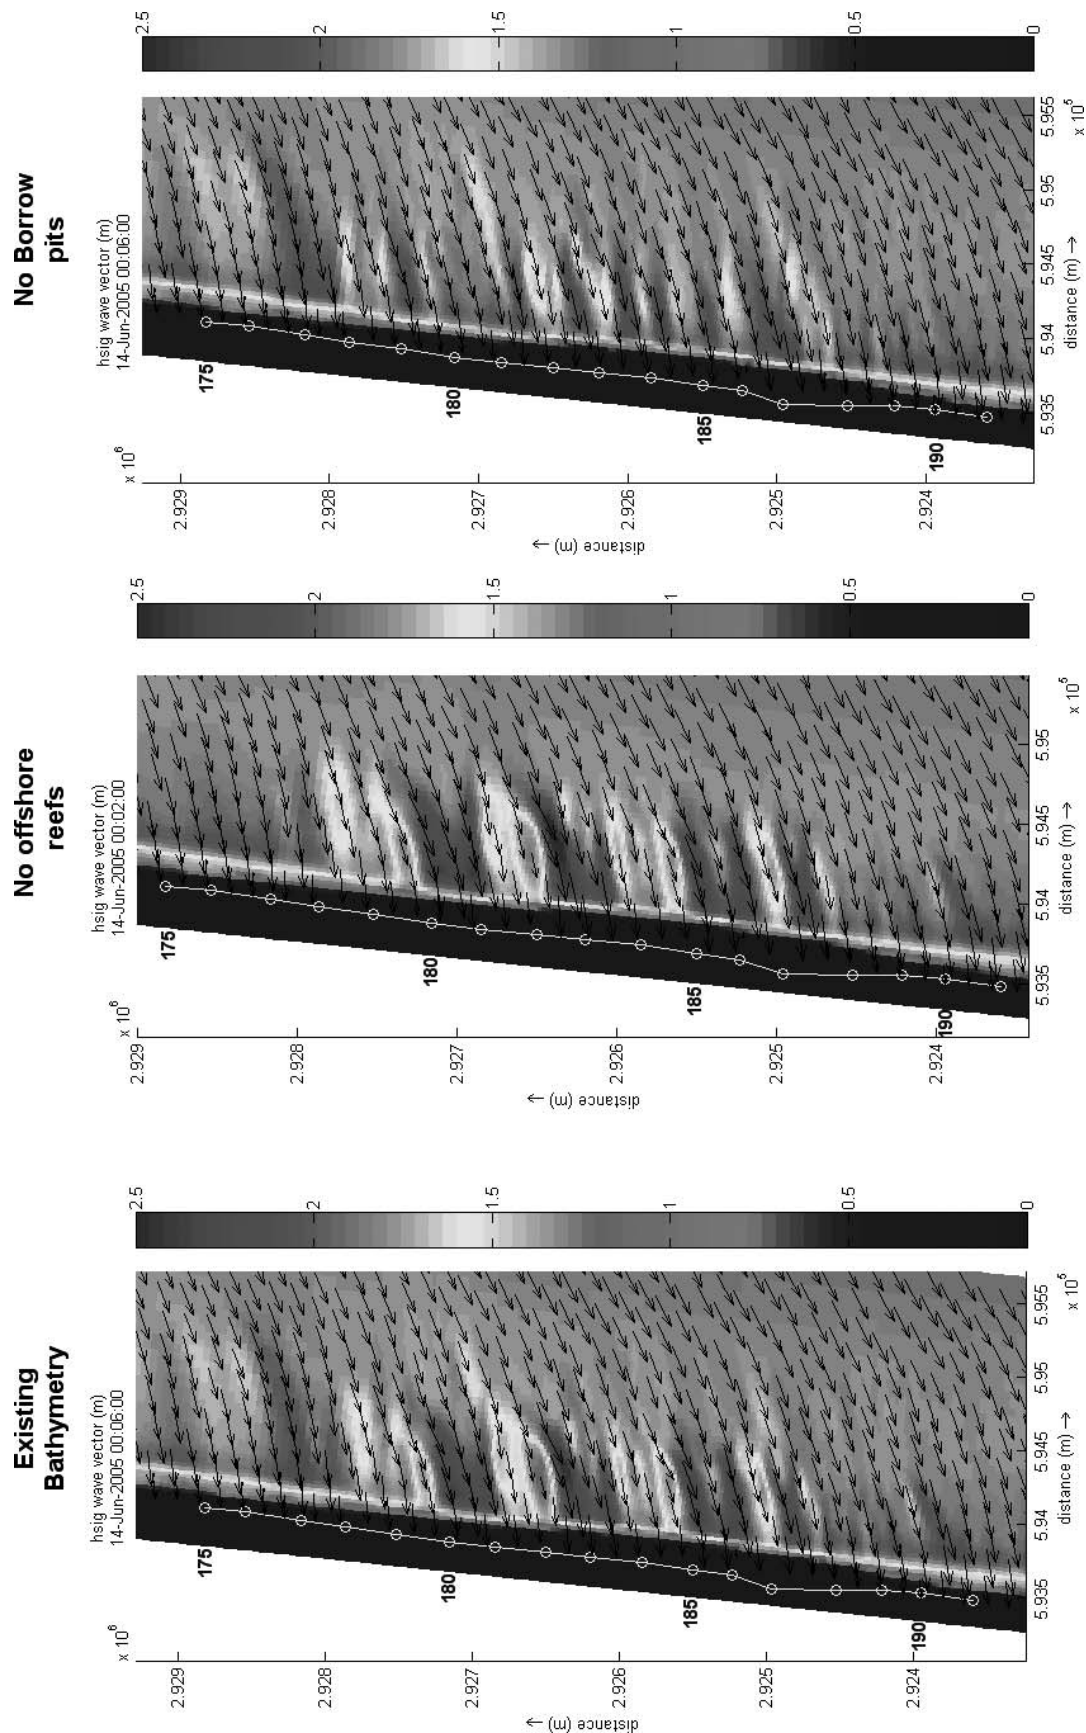
Up to 1 m alongshore variability in wave height (50% of the input boundary wave condition) is observed in the simulation that used original bathymetry (see left plot on Figure 7). When the offshore shore-parallel barrier coral reefs are removed (artificially created bathymetry) a pattern of alongshore variability in wave heights, similar to the simulation with the original 2002 bathymetry, is observed (see middle plot in Figure 7). When the borrow pits are removed, the alongshore variability in wave heights is smoothed out and the most prominent wave shadow and wave focusing zones disappear (see right plot on Figure 7 compared to middle and left plot).

For quantitative analysis, wave heights along a shore-parallel grid line located about 600 m offshore were evaluated using the results shown in Figure 7. This analysis indicated that the offshore barrier coral reefs slightly reduce nearshore wave heights at wave focusing locations (generally less than 10% of the boundary wave height). Compared to the effects produced by the borrow areas, the effects of the shore-parallel barrier coral reefs are minor along the study area. Although significant, gradients in nearshore wave height may not be directly linked to the development of the hot spot on the south end of the project (between R186 and R187) because the locations of the major wave focusing and wave shadow zones do not coincide with this hot spot location. The other erosional area (R183 to R184), however, occurs in a zone where high variability in alongshore wave height is observed.

Figure 7. Results from SWAN simulations for northeast waves (60° angle of approach) with H_o of 2 m and T_p of 11.5 s and 5° wave energy distribution. The left plot was conducted with existing postconstruction bathymetry, the offshore shore-parallel reefs were removed in the middle plot, while the offshore borrows are removed in the right plot. Alongshore patterns in wave height are similar between the left plot (existing condition) and the middle plot (reefs removed). Once the borrow pits are removed (right plot), the alongshore variability in wave heights is smoothed out as the most prominent wave shadow and wave focusing zones disappear. Variations in wave height are, however, relatively small in the hot spot area (R186 and R187). **For color version of this figure, see page 129.**

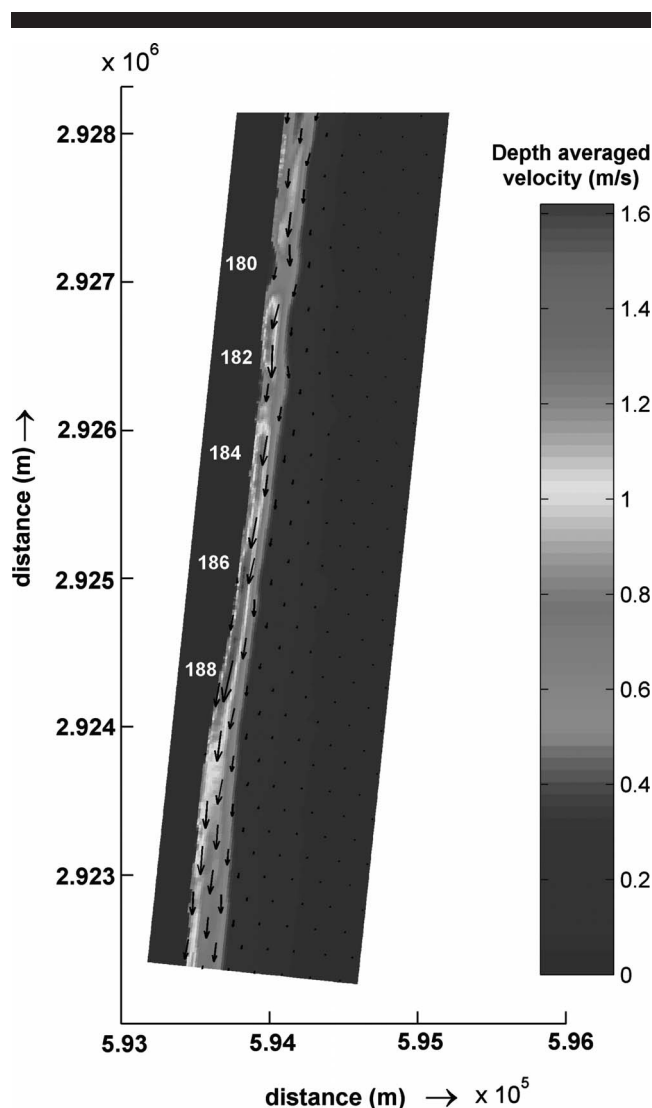
Simulation results show that current velocities at the surf zone are higher near the end of the fill, where they reach about 1.6 m s^{-1} compared to currents generally less than 1

Figure 9. Results from current simulations during a strong northeast wave event (2 m H_s, 11.5 s T_p and 60° approach). The hydrodynamic model was forced by the output from a spectral wave model. Tides and a representative wind condition were also included. The input bathymetric grid was obtained about 67 mo after the 2002 nourishment project (which had similar dimensions to the 1992 nourishment project). Note that current velocities are higher near the end of the fill where they reach about 1.6 m/s when compared to currents of generally less than 1 m/s throughout the rest of the study area. **For color version of this figure, see page 130.**

m s^{-1} throughout the rest of the study area (Figure 9). Smaller areas with stronger current velocities (1.0 to 1.4 m s^{-1}) are observed within the nourished area (near R182 and R184, Figure 9) as a result of combined effects of approaching wave angle and gradients in wave height induced by nearshore features (sand borrows). Alongshore current velocities of similar magnitude (1.5 m s^{-1}) were measured by RENIERS *et al.* (2002) at Duck, North Carolina, during the Delilah experiment, under similar wave conditions, corroborating velocity simulation results reported here. Figure 9 shows that, in ad-

Alongshore current accelerations are observed on the south end of the project (EHS segment between R186 and R187). Increased current velocities in this area are attributed to fill-induced changes in shoreline orientation and may cause the higher erosion rates observed in this beach segment. Since this effect is a function of fill-induced shoreline orientation it is generally expected to decrease with time as the nourishment planform adjusts to smoother curvature and the project increases in length (eroded sediments from the project area deposit in adjacent shorelines). Although volumetric losses from the EHS area are significantly higher during the first 2 years after construction as a result of alongshore adjustments of a locally advanced shoreline segment, higher than average erosion rates persist in the south end of the fill even after the fill adjustment years (Table 3). As shown in Figure 2, about eight and a half years after project construction, the change in shoreline orientation in the downdrift (south) end of the project persists (from about 6° north–south throughout most of the fill to 10°–15° northeast–southwest in the south end), although translated to the updrift (to the north). Sediments eroded from the project area did not deposit on the subaerial beach immediately downdrift of the nourished area, and, instead of adjusting to a semistraight shoreline, the area with increased orientation in the end of the project migrated north (updrift) while roughly maintaining its angle. Because the EHS in the south end of the fill (between R187 and R186) is located halfway between the area with increased curvature observed after construction (December 1992) and in June 2001, it is reasonable to assume that higher current velocities and an increasing sediment transport predominated in this area during most of the project lifetime, thus leading to persistent higher erosion of this area.
