Avian Electrocutions on Incorrectly Retrofitted Power Poles

Authors: Dwyer, James F., Harness, Richard E., and Eccleston, Duncan

Source: Journal of Raptor Research, 51(3) : 293-304

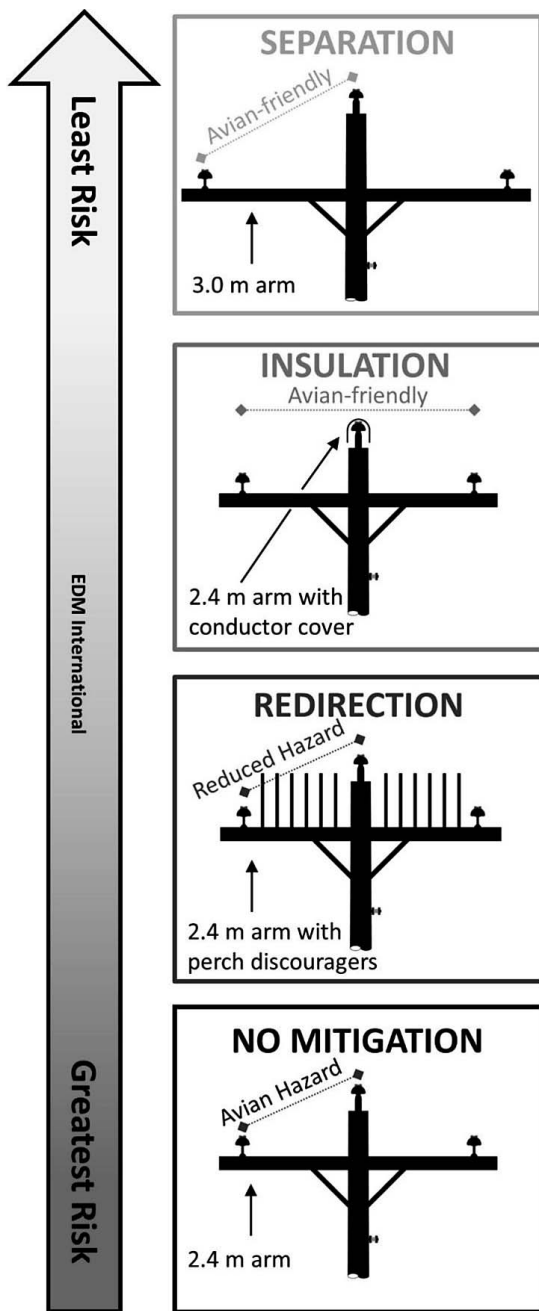
Figure 1. Avian electrocution risk is highest on poles with no mitigation, and lowest on poles with avian-friendly retrofitting achieved through insulation or separation.

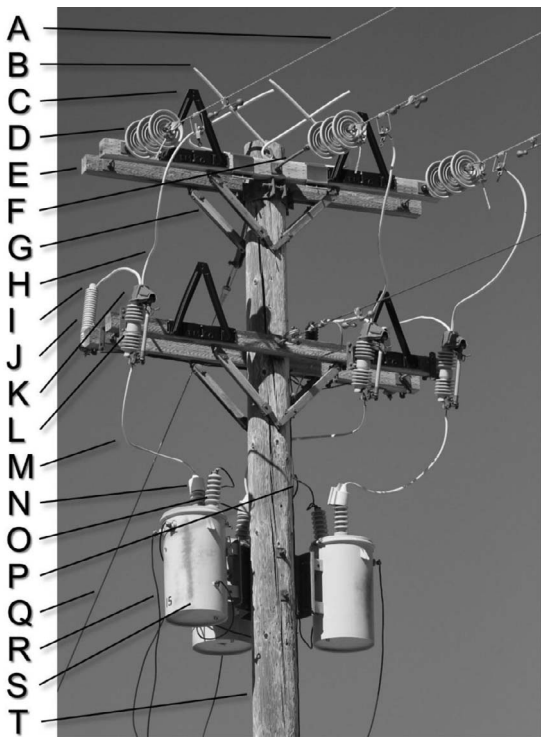
Figure 2. Common power pole (pole) components useful in understanding retrofitting mistakes for birds electrocuted between January 2013 and December 2015 on poles described as retrofitted, in Arizona, Colorado, Idaho, New Mexico, Utah, and Wyoming, U.S.A. See APLIC (2006), Dwyer et al. (2013), and APLIC (2015) for additional illustrations. See Table 1 for component names.
