Rapid, Remote Assessment of Hurricane Matthew Impacts
Using 4D Structure-from-Motion Photogrammetry:
Supplemental Material

SUPPLEMENTAL MATERIAL

This is supplemental material to accompany the manuscript titled “Rapid, Remote Assessment of Hurricane Matthew Impacts Using 4D Structure-from-Motion Photogrammetry” by Sherwood *et al.* The supplement provides information about the independent ground-truth points surveyed by the U.S. Geological Survey field crew on October 13 and 14, 2016. The team consisted of J. Bernier, B.J. Reynolds, and N. Zaremba. They identified twelve points on features that were likely to be visible in the aerial photos and that did not appear to have moved since the storm. The points included corners of asphalt and concrete slabs, the ends of exposed water pipes, the end of a wall, a dune scarp, a nearly-buried fire hydrant, and the trunk of a downed palm tree. The points were located by setting up a RTK GNSS (real-time kinematic global navigation satellite surveying system) consisting of a base station with an Ashtech Proflex 800 base station with Thales choke-ring antenna and an Ashtech Proflex 800 receiver with an Ashtech GNSS antenna that was placed on a

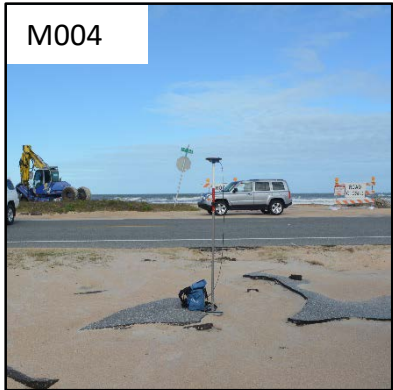
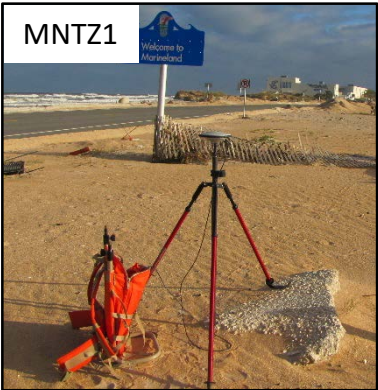
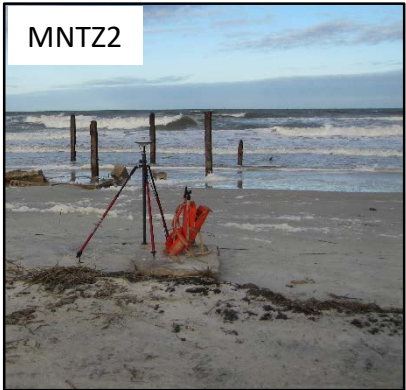
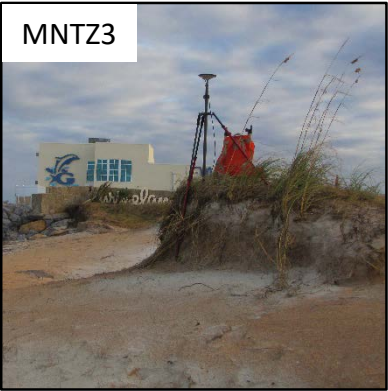
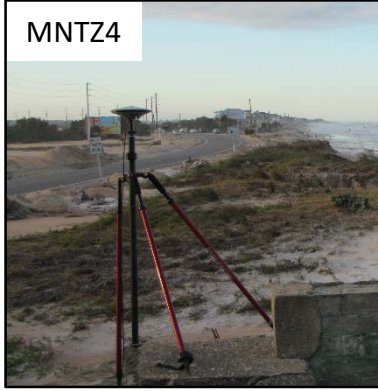
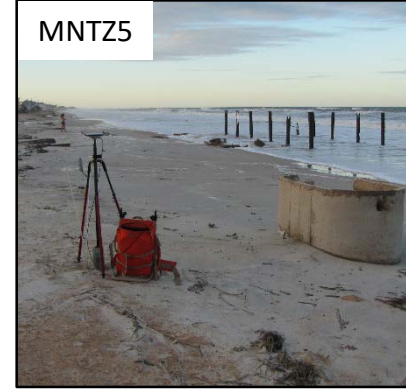
Figure S1. Representative images of the ground-truth features

Table S1 lists the surveyed points and coordinates in the NAD83(2011), Geoid12a reference frame. Figure S1 contains photos of the features; additional photos were used to help locate the features in the oblique aerial images. Table S2 lists the coordinates of the ground-truth points in Universal Transverse Mercator (UTM) Northing and Easting (meters, zone 17 North) in the NAD83 reference frame (Geoid12a). Vertical coordinates were meters referenced to North American Vertical Datum of 1988 (NAVD88). The short descriptions in column two indicate whether the point has questionable horizontal positioning (h?), vertical positioning (v?), or both (h, v?). Table S2 also lists the estimated location of the features determined by locating them in the oblique images and extracting their coordinates according to the 4D SfM reconstruction, and the associated differences. The summary rows at the bottom of the table list the mean difference, standard deviation of the differences, root-mean-squared differences, and minimum and maximum absolute differences. Tables S3 and S4 contain the same information for subsets of the features: in Table S3, features with questionable vertical control have been removed, and in Table S4, features with questionable horizontal control have been removed. Vertical positioning was considered compromised when the feature was prominent relative to its immediate surroundings, and small errors in the horizontal position could have led to substantial vertical differences. Horizontal positioning was considered compromised if the feature was indistinct or difficult to locate precisely in the oblique photos.
