# The Protection/Hardening of California's Coast: Times Are Changing

Source: Journal of Coastal Research, 35(5): 1051-1061

## The Protection/Hardening of California's Coast: Times Are Changing

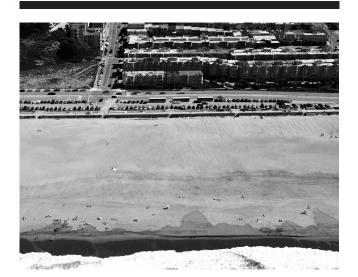
Figure 4. The O'Shaughnessy Seawall along San Francisco's Ocean Beach is one of the oldest in California and was designed and built to withstand every potential type of failure. (Photo courtesy of Kenneth and Gabrielle Adelman, California Coastal Records Project.)

The O'Shaughnessy seawall along Ocean Beach in San Francisco was arguably one of the earliest, largest, and best engineered structures built along the California shoreline in the last century. O'Shaughnessy, the city engineer for San Francisco, considered every possible way in which a seawall might fail and then designed the wall to withstand all of those possibilities. The 1407-m-long (4600-ft-long) structure was completed in 1929 and has effectively protected the Great Highway ever since (Figure 4). The wall extends about 6 m (20 ft) above and below sea level, was built in freestanding sections such that failure of one part would not compromise the adjacent sections, and has a drainage system to deal with overtopping and runoff. An additional factor in the long-term survival of this massive wall was its construction on the back beach, such that it has not been regularly exposed to the impacts of large waves. It was built for a total cost of \$600,000 at that time (or \$425/m; \$130/ft) and was extended southward about a decade ago at a cost of just over \$38,260/m (\$11,700/linear ft, in 2018 dollars). Constructing the original 1407 m of seawall today would cost about \$53 million.

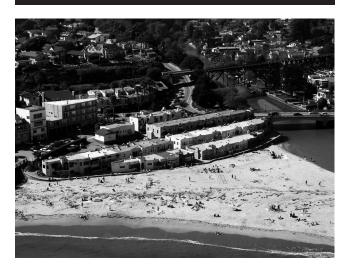
Figure 6. The Venetian Court condominiums, built essentially on the beach in Capitola in 1923, are repeatedly flooded by the combination of storm waves and high tides.

The beachfront village of Capitola on the northern Monterey Bay shoreline began as a summer tent camp (Camp Capitola) on the low floodplain at the mouth of Soquel Creek. Development followed with a large hotel built just landward of the beach between 1895 and 1897. The hotel was soon protected by a masonry seawall, part of which is still standing today (Figure 5). Timber bulkheads were also built in the early 1900s to support a number of oceanfront businesses behind the beach and lagoon. Two decades later in 1923, the first reported condominiums on the California coast, the Venetian Courts, were constructed on the beach at Capitola (Figure 6). The condominiums were elevated just a few feet off the sand and were offered minimal protection from waves and storm surge by a low concrete seawall that still stands. These condominiums, as well as the back beach businesses and downtown streets, are frequently flooded by high tides and wave surge

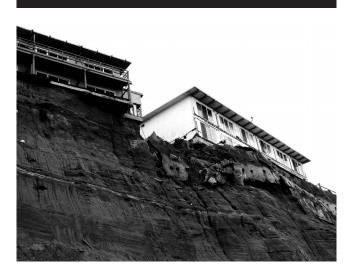
Figure 13. These apartment buildings in Pacifica were built on a high eroding bluff in the early 1970s, and despite efforts to protect them, they were declared unsafe to occupy and then demolished in 2016.

Marin County, the Pacifica Esplanade in San Mateo County (Figure 13), Carpinteria in Ventura County, West Newport Beach in Orange County, and Encinitas in San Diego County are all examples where portions of or entire neighborhoods have been lost to coastal erosion (Griggs, 2015). Documenting these lost neighborhoods and those that are in the process of disappearing today is important in providing a longer term perspective of what California faces as a state.
