Source: Mountain Research and Development, 31(2) : 112-121

# The 2005 Pakistan Earthquake Revisited: Methods for Integrated Landslide Assessment

Karen Sudmeier-Rieux\*, Michel Jaboyedoff, Alain Breguet, and Jérôme Dubois

University of Lausanne, Faculty of Geosciences and Environment, Institute of Geomatics and Risk Analysis, Amphipôle 330, CH-1015 Lausanne, Switzerland

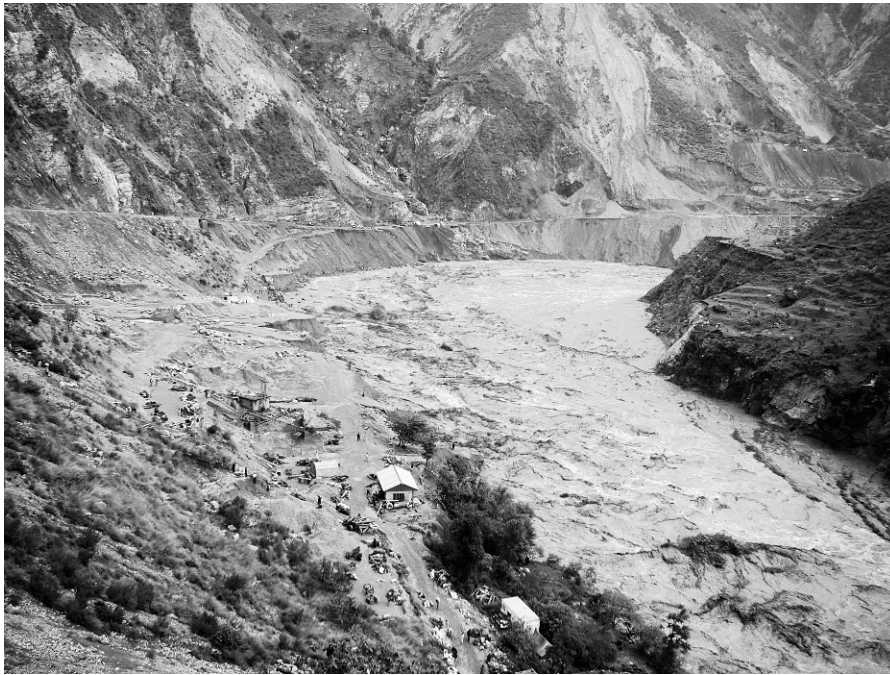
**FIGURE 1** Neelum River and road near quarry north of Muzaffarabad. (Photo by Rauf Qureshi, 2010)

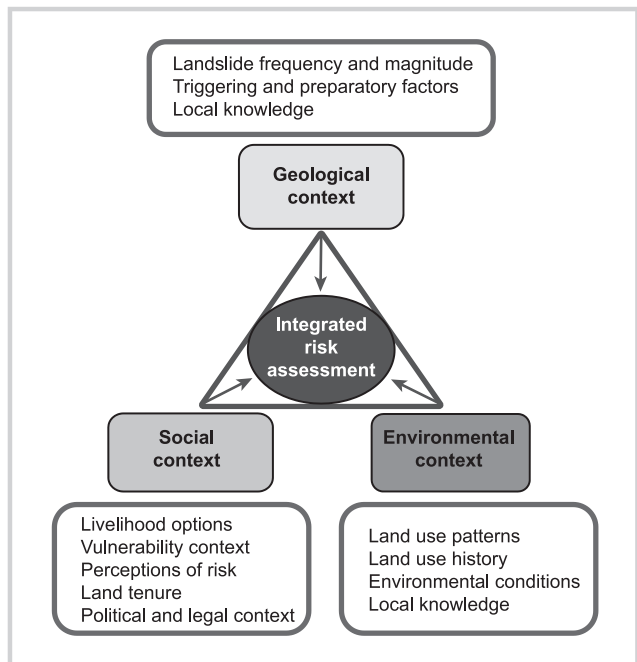
**FIGURE 2** Conceptual framework for integrated landslide risk assessment. (Modified from Leroi et al 2005)

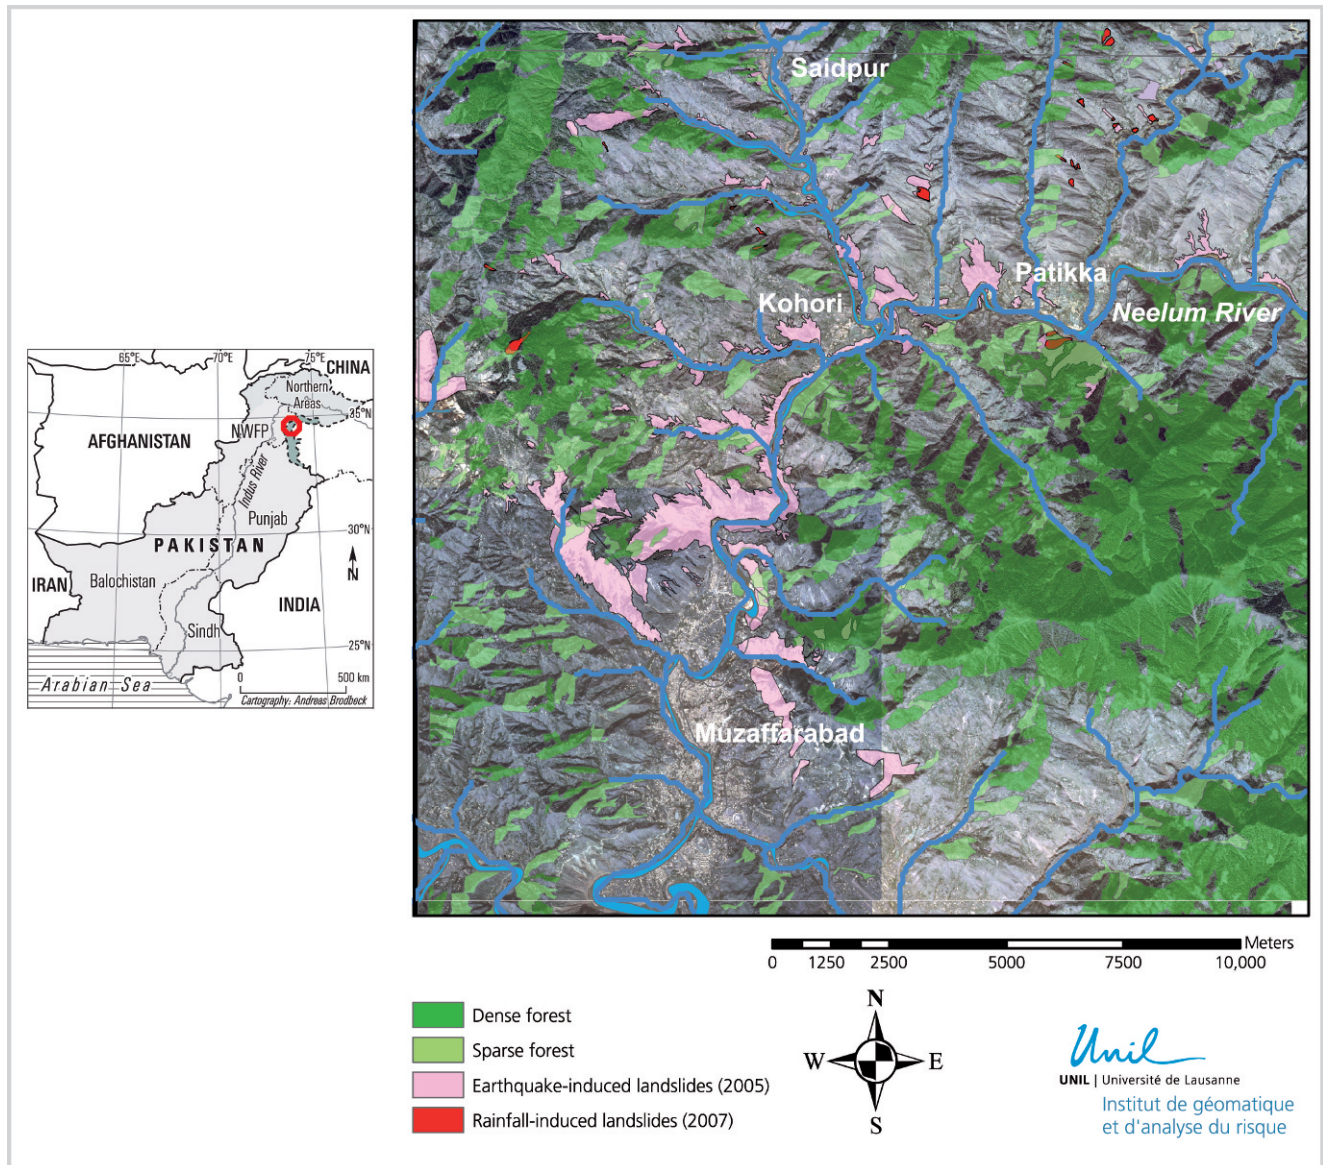
**FIGURE 3** Map of earthquake- and rainfall-induced landslides, and forest cover in Neelum Valley, AJK, Pakistan. (Map by Jérôme Dubois and Alain Breguet, University of Lausanne, 2011)

km<sup>2</sup> (AJK Planning Dept 2005)—was chosen because of its 2 very distinct river banks and because this was the location of the earthquake epicenter (34.493°N, 73.629°E) (Owen et al 2008). The lower Neelum River Valley is a west-east-oriented steep V-shaped valley with an estimated slope range of 35–65°, an average width of 15 km, and an altitude range of 800–3000 m (Figure 3).

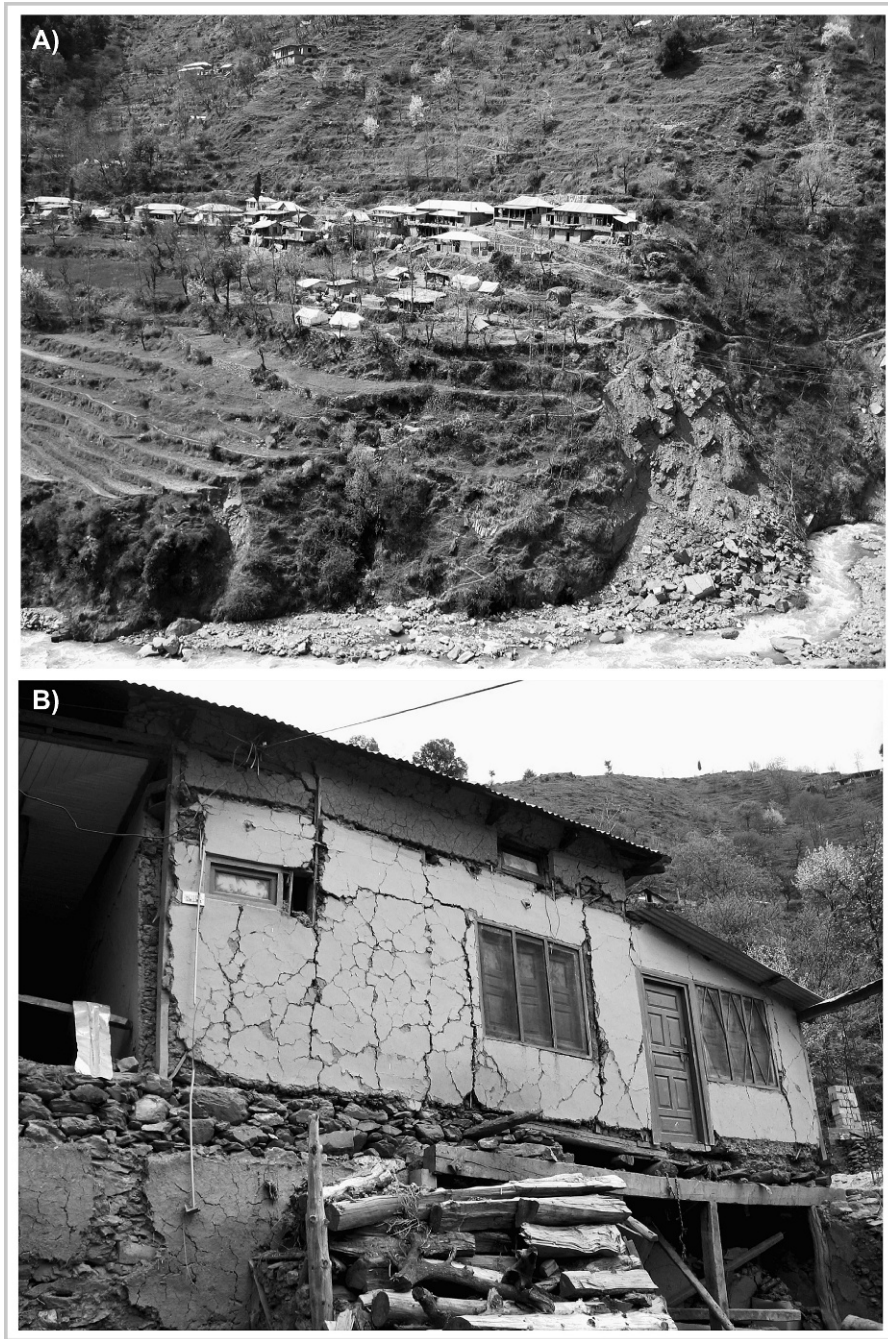
**FIGURE 4** (A) Neogran hamlet, Saidpur village. A rainfall-induced landslide killed 1 child on her way to school in 2007. (B) Damaged house in Saidpur village after 2005 earthquake. Example of modern cinderblock house that was more prone to collapse compared with traditional houses. (Photos by Karen Sudmeier-Rieux, 2007)

crops are maize, wheat, rice, walnuts, and fruits. The second village, Kohori (population 5000 before the earthquake), supplements its farming income considerably through shopkeeping. Kohori was more severely destroyed than Saidpur, most likely due to the higher frequency of cinderblock construction versus the traditional *katcha* houses, constructed from logs and mud in Saidpur (Figure 4B).
