Journal of Coastal Research 21 1 79-111 West Palm Beach, Florida January 2005

Panorama of the History of Coastal Protection

Roger H. Charlier[†], Marie Claire P. Chaineux[‡], and Selim Morcos§

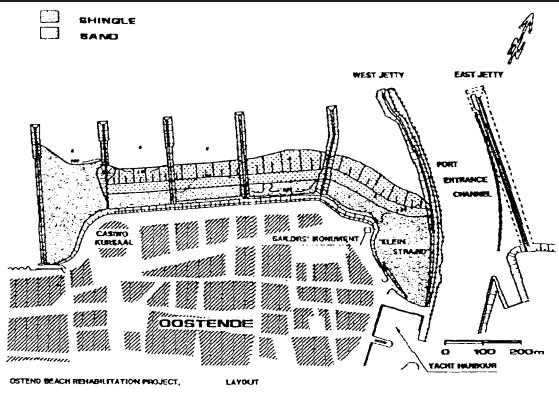
Figure 2. Layout of the beach rehabilitation project at Oostende, Belgium.

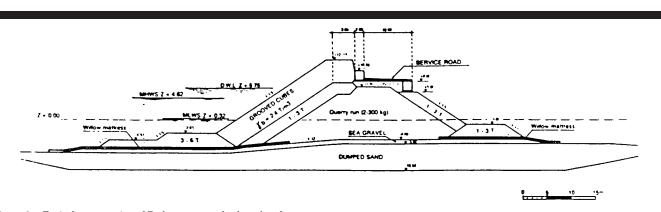
$Figure \ 3. \quad Typical \ cross-section \ of \ Zeebrugge \ outer \ harbour \ breakwaters.$

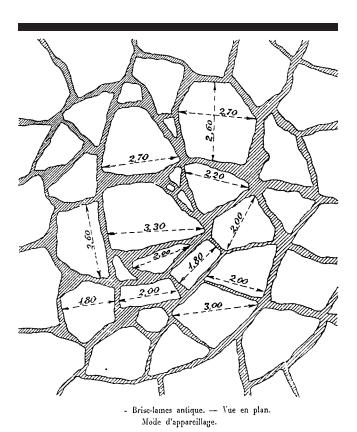
Figure 5. Upper surface view of the Great Ancient Breakwater. After Jondet, 1916.

the ancient great breakwater, surrounding west and north Abu Bakar Rock, constituted a formidable coastal defense, de facto closing the ancient harbor. The upper side of the offshore dyke shows a seaward slope of 3 to 4 cm (\pm 1 to 1.4 inches); the median line is free of masonry and constitutes a trench roughly a meter (3.28 ft) wide whose depth seems to equal, in the mean, half of the dyke's height. Jondet surmises that this trench was used to place military defense works (Jondet, 1912). A line of interrupted external submerged ruins, 200 m (660 ft) to the north and parallel to the ancient great breakwater discovered in 1915 forms the external breakwater stretching eastwards from north of Abu Bakar Rock, now at depths ranging from 6.5 to 8.5 m (21.3 to 27.9 ft). The external basin of the ancient port laid between the

two breakwaters. The artificial structures surrounding the harbor, exclusive of those of Pharos Island, are 4 km (2.48 mi) long. The sea walls are in uneven pieces, mostly 10 to 30 m (33 to 100 ft) separated by intervals varying between 4.5 and 2 m (1.6 and 6.6 ft).

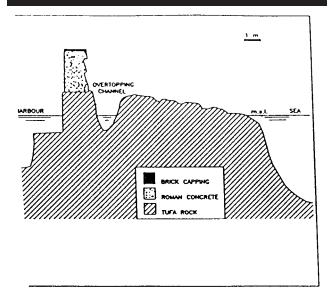
Figure 7. Cross-section of the existing Roman "carved rock breakwater" with overspill stilling channel at Ventotene (Built 2 BC).

Coastal defense history is, naturally, closely linked to harbor creation and development. Primitive breakwaters were put in place occasionally with ramps allowing the top of the waves to pass over them. Phoenicians had devised wave catchers by excavating holes and establishing trenches in the rocks lining the shores (Raban, 1988). Carved breakwaters were cut out of bedrock: a suitable wave-absorber profile was created which had a gentle grooved slope at the waterline. The classical example dates from 2 before the present, is still visible at Ventotene; it had an over-spill. One may see in it an early version of today's Fontvieille breakwater (Principality of Monaco) (Figure 7).

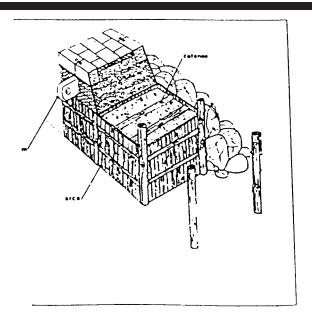
Figure 8. Reconstruction of the Roman construction system of a vertical water with cast-in-situ concrete within wooden forms and tie-rods (Clementi, 1981).

Greek and Etruscan breakwaters and sea-walls consisted in rubble mounds topped by cut rocks; though no mortar was used, neighboring blocks were sometimes held together by clamps and joints made out of metal. With the discovery of pozzolanic ash hydraulic cement solid breakwaters could be built underwater, and several vertical composite concrete walls have been preserved from the second century before our era to the fifth century. Clementi (1981) provides an illustration of a vertical breakwater made *in situ* within a wooden frame and tie-rods. Toe protection against scouring was provided occasionally by a bronze slab (Oleson, 1988) (Figure 8).

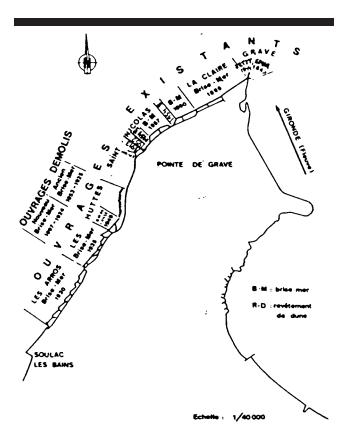
Figure 12. Shoreline protection, Pointe de Grave, France. After Laboratoire Central d'Hydraulique de France, 1979. Redrawn and modified by R. H. Charlier.

ing" notwithstanding a lengthy transport for rocks and short lifespan of wood (Franco, 1996). Strict environmental regulation governing shore protection can be traced back to legal documents of 1282 and 1339: prohibition to cut or burn trees from coastal forests, to pick mussels from rock revetments, to let cattle walk the dikes, to remove sand, and vegetation, from beach or dune, and to export materials used in coastal defense (Grillo, 1989). The *Magistrato alle acque*, created in 1501, invited suggestions to reduce the high cost of the coast defenses, so, in the 18th century, appeared rip-rap revetments, gabions, staircase placed limestone blocks, and the use of mortar and steel links and flexible steel strips became common (Figures 11, 12).

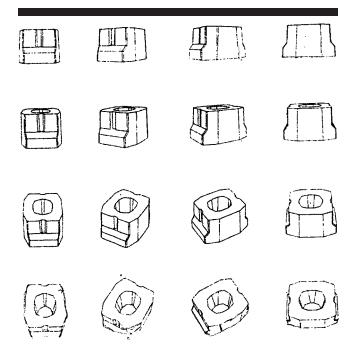
Figure 15. Various views of the "Haro" used in breakwater and groin construction.

As elsewhere, in the Mediterranean, engineers and environmentalists have second thoughts about hard structures, e.g. detached rubble mound breakwaters, are being replaced by star-shaped piles and perforated and articulated blocks—somewhat reminding of the Belgian designed Haro —and submerged barriers, all not infrequently combined with artificial beach nourishment, also by-passing. An environmental impact assessment is in process as regards mobile storm surge barriers (Figure 15).

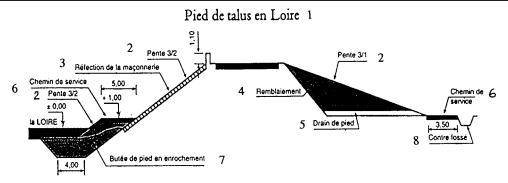
Figure 18. Reinforcement of the Levee Project (Loire River). Legend: 1. Talus foot in the Loire. 2. Slope. 3. Masonry repair. 4. Embankment. 5. Foot drain. 6. Service path. 7. Rubble mound foot block. 8. Counter ditch. (All measurements in meters).

embankments between 1904 and 1926 in such tidal rivers as the Loire. Made of wooden poles or stakes garnished with chestnut tree claires, a rubble-mound string allows to insure their foundation towards the bottom. Such groins had medieval forerunners, some of which still subsist, for instance at St. Georges-sur-Loire: they were constructed of small poles placed very close to one another with small size rubble stones, mostly covered by alluvions as time went by (Figure 18).

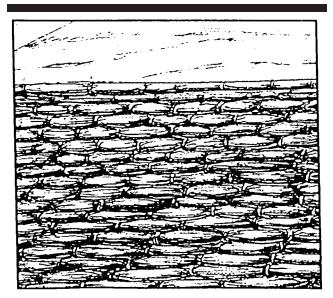
Figure 19. Revetment of a "turcie" (small individual dike) in 1967. Reproduced from a photograph from the Departmental Archives of Maine-et-Loire by B. Rousseau.

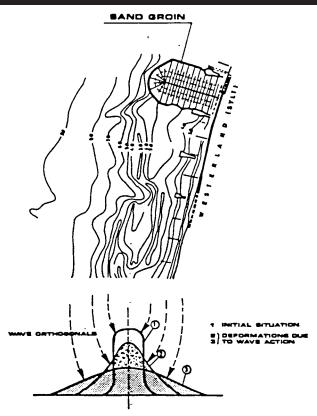
Figure 21. Construction of sand groin as coastal protection, Sylt, West Germany. Source: HAECON N.V., Ghent, Harbour and Engineering Consultants

Along the coasts of Germany, especially those on the North Sea, situations similar to those of Denmark and The Netherlands prevailed throughout history. The eastern Friesland islands belong politically to Germany but differ in no way from their counterparts under Dutch sovereignty. Groins were implanted along the coast and some failures made history. Beaches on Sylt and Langeoog received artificial nourishment (Charlier, Demeyer, Decroo, 1998) (Figure 21).

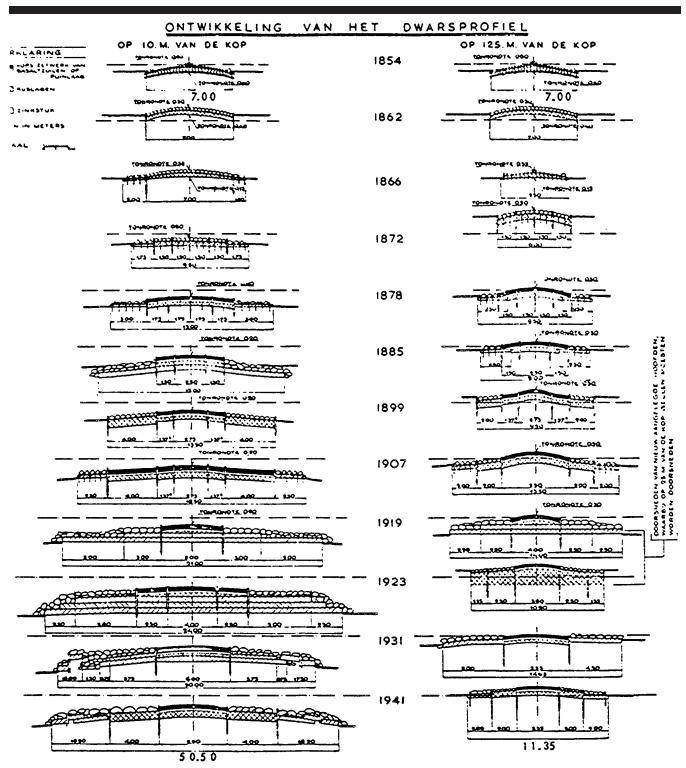
Figure 23. Development of groins in Holland 1854-1941 (Visser, 1953).

Groin-like structures were put in place, in The Lowlands (today parts of The Netherlands, Belgium and Northern France) well before the dawn of the 16th century. There is no information on what they looked like; on the other hand we are far better informed on the history of development of protective structures, streamlined and submitting themselves as little as possible to the forces of waves and currents, covering the last 100 to 150 years. Even though the groins have expanded size-wise, the engineering principles remained the same: stone (rubble) pitching on gravel and mattresses in the center, stones on mattresses on the sides with two, or more, pile walls as supports (Figures 23, 24, 25).

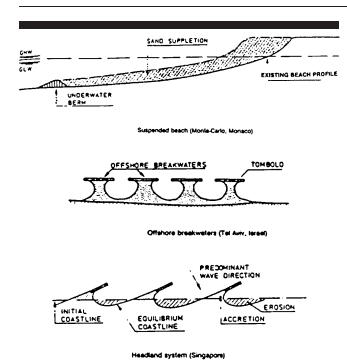
Figures 27–29. Some beach-restoration possibilities. Top, suspended beach (Monte Carlo, Monaco); Center, offshore breakwaters (Tel Aviv, Israel); Bottom, headland system (Singapore). Source: HAECON N.V., Ghent, Harbour and Engineering Consultants, Belgium.

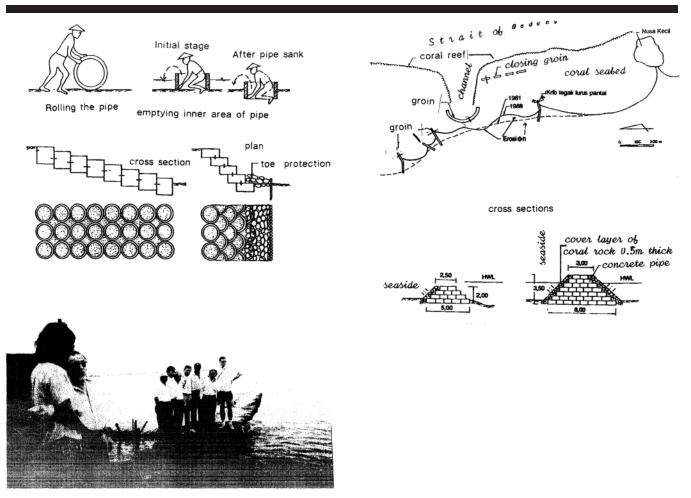
Figure 30B. Java, Indonesia. Concrete round pipes used to build breakwaters near a tourist resort (Belgian co-operation project. Author is second in picture front, to the left).

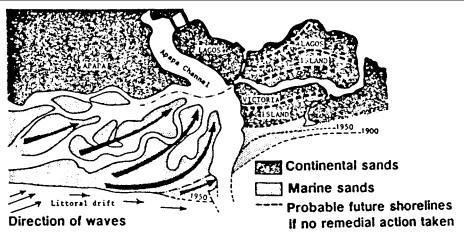
Figure 32. Shoreline shift, Victoria Beach Lighthouse, Lagos. After M. Akle, "Problèmes d'érosion côtière dans le Golfe du Bénin," Siren 29 (September 1985): 20–31.

The West African coastline, southwards of Senegal, has suffered severe erosion for decades, and land loss reached alarming and devastating proportions. Seawalls, groins and revetments have mostly been ineffective in stemming erosion. Local authorities ask for help in sand nourishment projects while recommending simultaneously semi-permeable groins, disused oil field hoses and sand-bagging. Construction of moles in Lagos has caused steady retreat of the coastline since 1900. Shoreline protection schemes include groins on Victoria Island near Lagos (Nigeria) (Figure 33) but also beach nourishment, sea-walls in Dakar (Senegal), groins on Jamestown Beach and revetments on Labadi Beach both near Accra, offshore breakwaters in Conakry (Guinea), St. Louis and Rustique (Senegal). "Local" methods are bulkheads, sand-mattresses and -bagging in Brass (Nigeria), timber groins, Chicoco blocks, wooden bulkheads and afforestation (Figures 31-34).

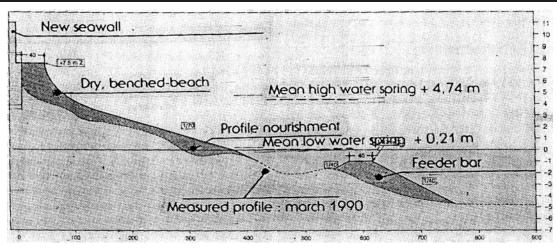
Figure 35. Relative position of feeder bar, beach and dry benched beach (De Haan, Belgium).

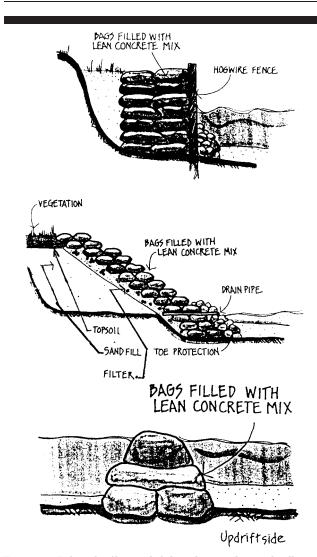
Figure 36. Relatively efficient, slightly sophisticated, in use locally since the fifties, these schemes may be a base for artisanal protection devices in developing countries: using bags filled with lean concrete and held with hog wire fencing an inexpensive "groin" may be constructed, even improved with filter and drain and toe protection. On the right, devices made of H-piles and railroad ties; pile-and-plank; anchored floating tires; a sloping model with concrete blocks or slabs, and rock filter with filter cloth.

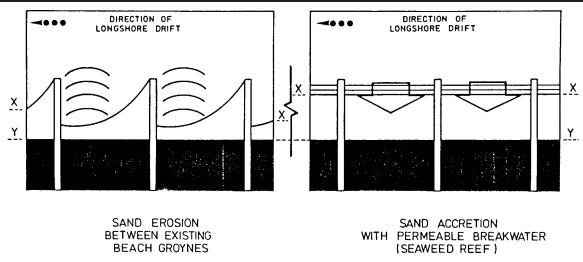
Figure 37. Beach stabilization, scheme with algae.

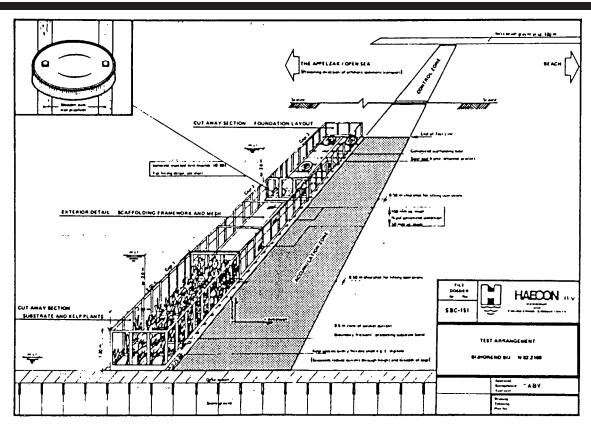
Figure 38. —Cages array for algae artificial reef. Source: HAECON N.V., Ghent, Harbour and Engineering Consultants.

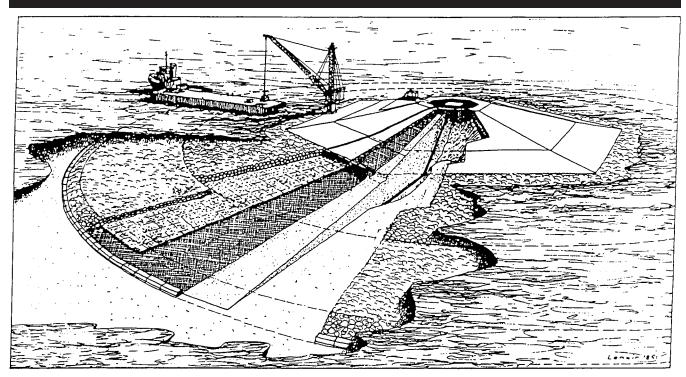
Figure 39. Boskalis Westminster's award winning design for a slope-protected, sand-fill island to be used by the Dutch hydrocarbon company NAM as a pipeline valve station.
