Three Recent and Lesser-Known Glacier-Related Flood Mechanisms in High Mountain Environments

Authors: Byers, Alton C., Shugar, Dan H., Chand, Mohan Bahadur, Portocarrero, Cesar, Shrestha, Milan, et al.

Source: Mountain Research and Development, 42(2)

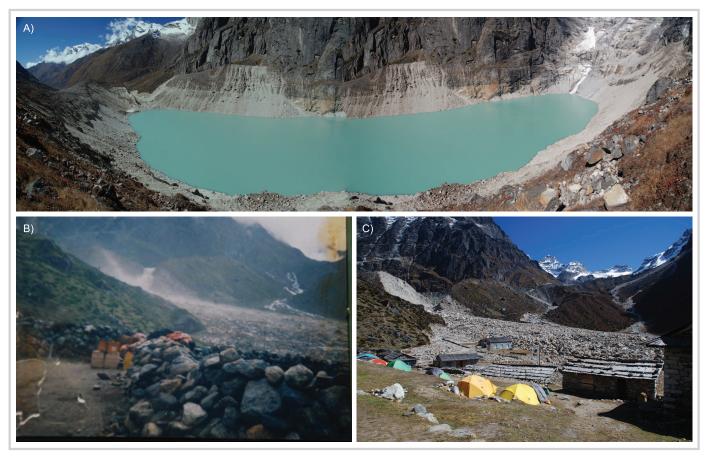
FIGURE 2 (A) Tama Pokhari in the Makalu-Barun National Park, Nepal, provides a good example of a lake where a glacial lake outburst flood (GLOF) was triggered by an ice avalanche from overhanging ice (far right of the photograph). The flood occurred on 3 September 1998. In 2010 the breached terminal moraine can be seen to the far left. (B) One of the only known photographs of a GLOF in progress at its source. Water can be seen cascading over the Tama Pokhari's newly breached terminal moraine, which reportedly was repeated in a series of distinct waves. (C) The same general location in 2010, showing the extensive damage caused to what had been the northeastern section of Tagnag village (4350 m). Downstream impacts were also considerable. (Photos A and C by Alton C. Byers; B by Lhakpa Sherpa)

A number of lesser studied cryospheric processes that can also result in major landslide, debris flow, hyperconcentrated slurry, and/or other major glacier-related flood events are beginning to receive attention. In the current article, we briefly examine and focus on 3 of these lesser-known and less well documented phenomenaenglacial conduit floods (Rounce et al 2017), permafrostlinked rockfall and debris flows (Byers et al 2019), and earthquake-triggered floods (Byers et al 2017)—based on recent field studies and the first-hand experience of several of the authors. Detailed descriptions of the methods employed for each interdisciplinary study can be found in the respective citations above. While recognizing that all examples could fall under an overarching "glacier flood" or "cascading hazard process" heading, we argue that each type of event still needs more focused research to achieve the best understanding of their causes, consequences, and mitigation opportunities. Although englacial conduit floods are rare in the Peruvian Andes, they are becoming increasingly common in glaciers throughout the other high mountain regions of the world; changes in permafrost, and consequential catastrophic events, have been documented not only for the Himalaya, but also for the European Alps, Andes, and other high mountain regions; and earthquakes remain a constant and potential trigger for GLOFs throughout the high mountain world. Finally, the authors also believe that the 3 case studies presented, individually and collectively, provide valuable lessons learned that could have applications to other high mountain regions of the world. They include (1) the need to study catastrophic events as soon after their occurrence as possible, given the ephemeral nature of geomorphic evidence; (2) the importance of combining field-based work with state-of-the-

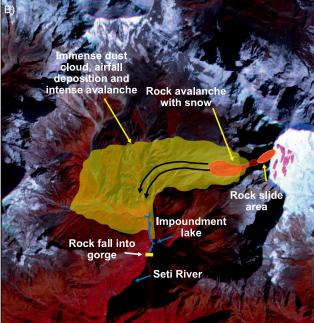
FIGURE 5 Schematic diagram of the origins of the (A) Chamoli flood, Uttarakhand, India, 7 February 2021, and (B) Seti River flood, Nepal, 5 May 2012. (Chamoli flood diagram courtesy of NASA, 2021; Seti River image courtesy of Planet, 27 October 2020)

The impacts of global warming trends can be particularly conspicuous in glaciated landscapes, notably in the form of rapidly receding glaciers and the formation of glacial lakes (Shugar et al 2021). Growing evidence suggests that similar changes are also occurring at above 6000 m elevations, in the form of thawing permafrost that can impact the mechanical strength and hydraulic permeability of high elevation rock faces (Haeberli et al 2017). Massive rockfall from these rock faces, previously constrained by millennia of year-round freezing temperatures, can set in motion a cascade of catastrophic processes below, including rockfalls, debris flows, explosive impact with glaciers below, massive dust clouds, and high winds, in addition to triggering glacier-related floods downstream (Figure 5).

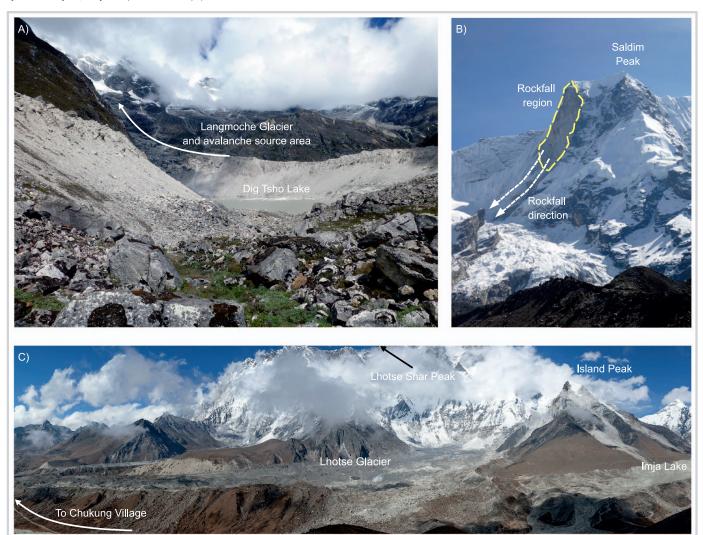
FIGURE 6 Images of (A) Dig Tsho, Khumbu, Nepal, after the 25 April 2015 earthquake and resultant glacial lake outburst flood (GLOF), the second GLOF the lake has experienced since 1985; (B) Saldim Peak after the 17 June 2017 separation of rock from the north-facing face; and (C) Lhotse glacier, Khumbu, Nepal. (Photos A and B by Alton C. Byers; C by Lhakpa Sonam Sherpa)

Most high mountain countries have clearly entered an era of accelerated glacier and high mountain hazards, most of them poorly understood. Although rock or ice avalanche-triggered proglacial GLOFs have been studied in considerable detail during the past several decades, less attention has been given to other cryospheric flood phenomena such as englacial conduit floods, permafrost-linked rockfall and avalanches, earthquake-triggered glacial lake floods, and recurrent flooding of seasonal proglacial lakes (Figures 6 and 7).
