Risk-conscious Reconstruction in Pakistan-administered Kashmir

A Case Study of the Chakhama Valley

Markus N. Zimmermann^{1*} and Shireen S. Issa²

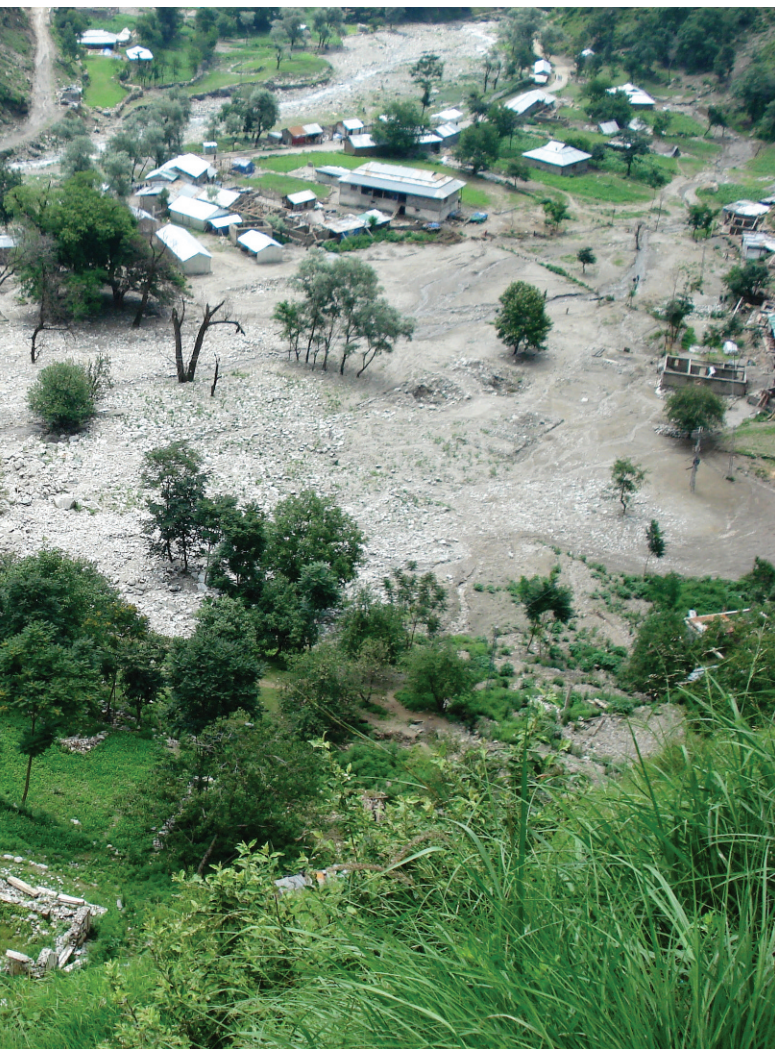
FIGURE 2 Debris flow in March 2007 caused further damage to shelters built after the earthquake at Nardajian (upper valley). (Photo by Markus Zimmermann, 15 July 2007)

- The probability of landslides, rockfall, and flooding increased (Figure 2).
