Panorama of the History of Coastal Protection

Authors: Charlier, Roger H., Chaîneux, Marie Claire P., and Morcos, Selim

Source: Journal of Coastal Research, 2005(211) : 79-111

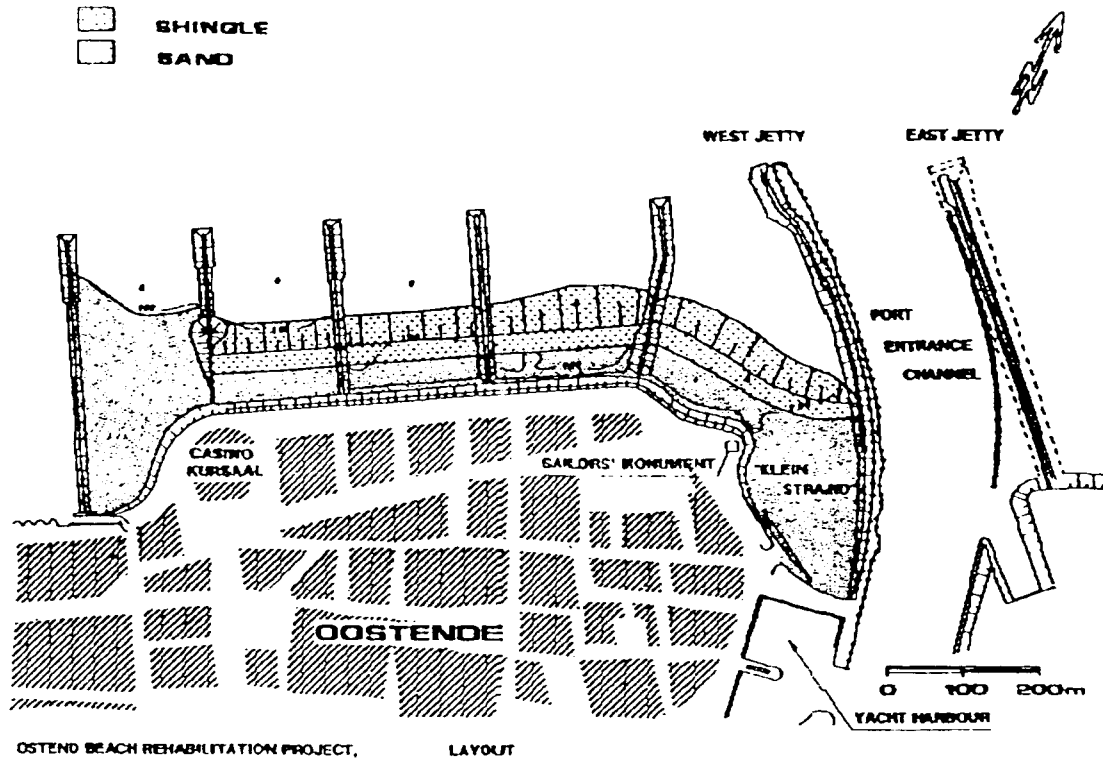
Figure 2. Layout of the beach rehabilitation project at Oostende, Belgium.

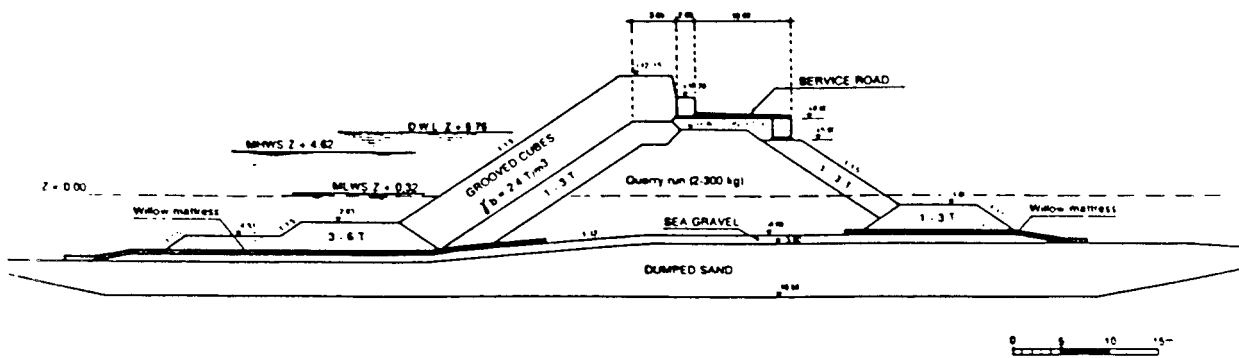
Figure 3. Typical cross-section of Zeebrugge outer harbour breakwaters.

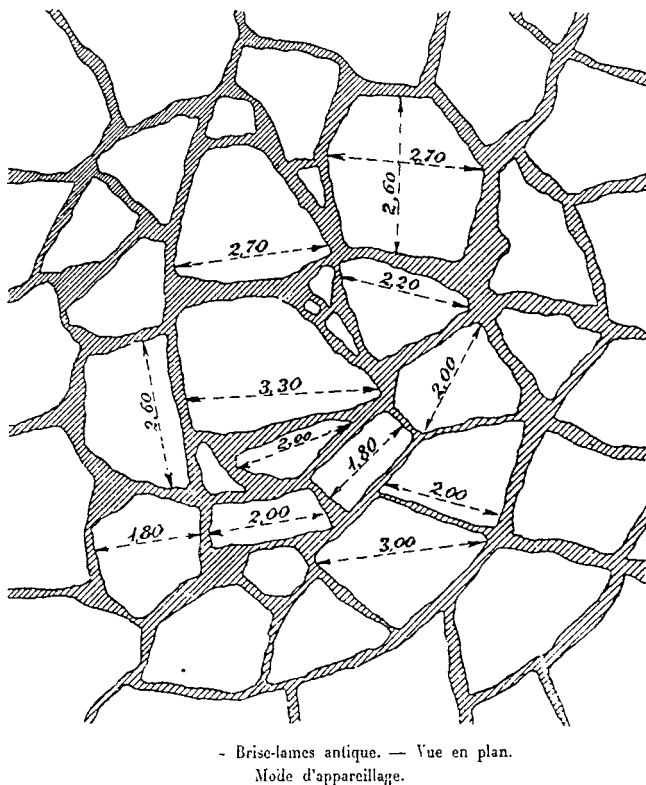
Figure 5. Upper surface view of the Great Ancient Breakwater. After Jondet, 1916.

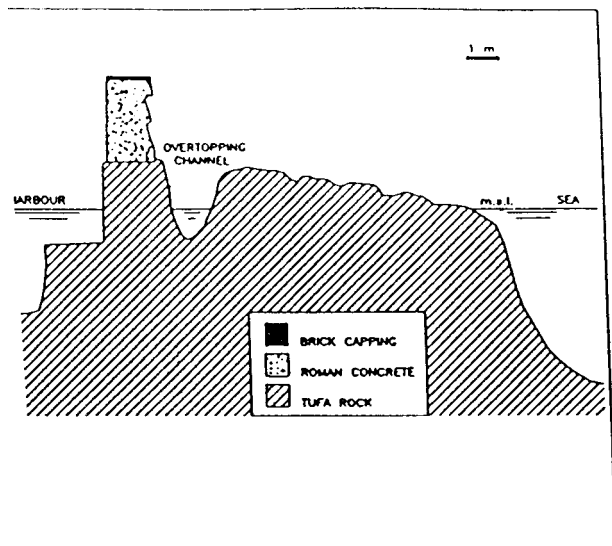
Figure 7. Cross-section of the existing Roman "carved rock breakwater" with overspill stilling channel at Ventotene (Built 2 BC).

Coastal defense history is, naturally, closely linked to harbor creation and development. Primitive breakwaters were put in place occasionally with ramps allowing the top of the waves to pass over them. Phoenicians had devised wave catchers by excavating holes and establishing trenches in the rocks lining the shores (RABAN, 1988). Carved breakwaters were cut out of bedrock: a suitable wave-absorber profile was created which had a gentle grooved slope at the waterline. The classical example dates from 2 before the present, is still visible at Ventotene; it had an over-spill. One may see in it an early version of today's Fontvieille breakwater (Principality of Monaco) (Figure 7).

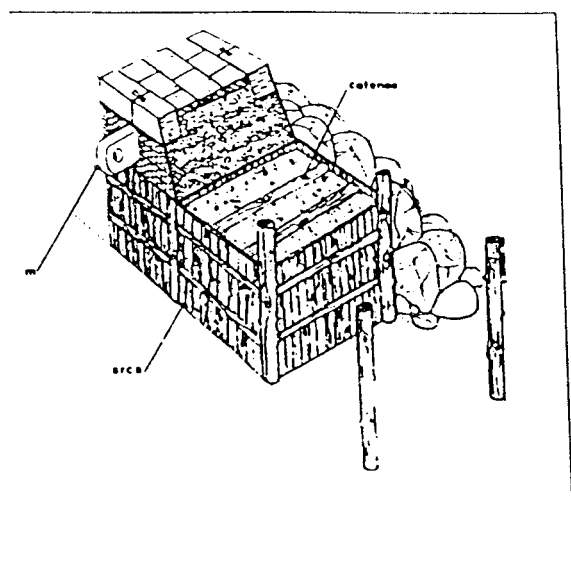
Figure 8. Reconstruction of the Roman construction system of a vertical water with cast-in-situ concrete within wooden forms and tie-rods (Clementi, 1981).

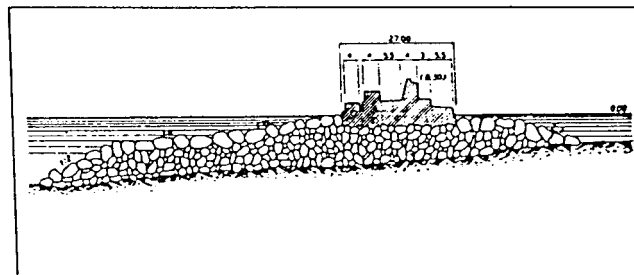
Figure 9. Modern section of the Trajan island breakwater of Civitavecchia harbour.

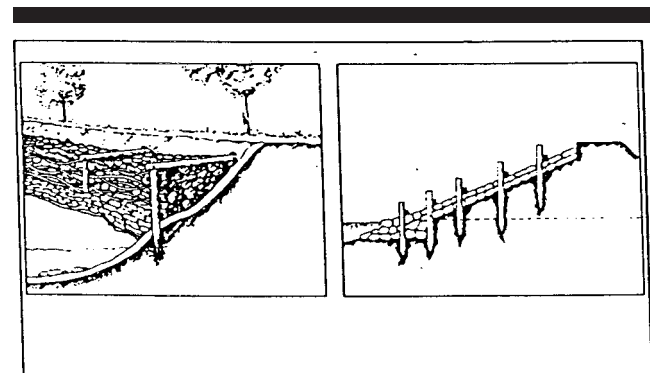
Figure 13. Ancient coastal defences in Venice: rubble vetments within timber piled fences (6th to 17th century).

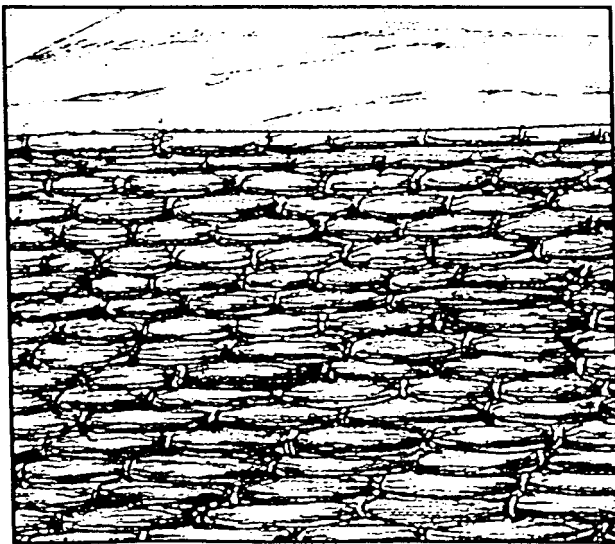
Figure 19. Revetment of a "turbie" (small individual dike) in 1967. Reproduced from a photograph from the Departmental Archives of Maine-et-Loire by B. Rousseau.

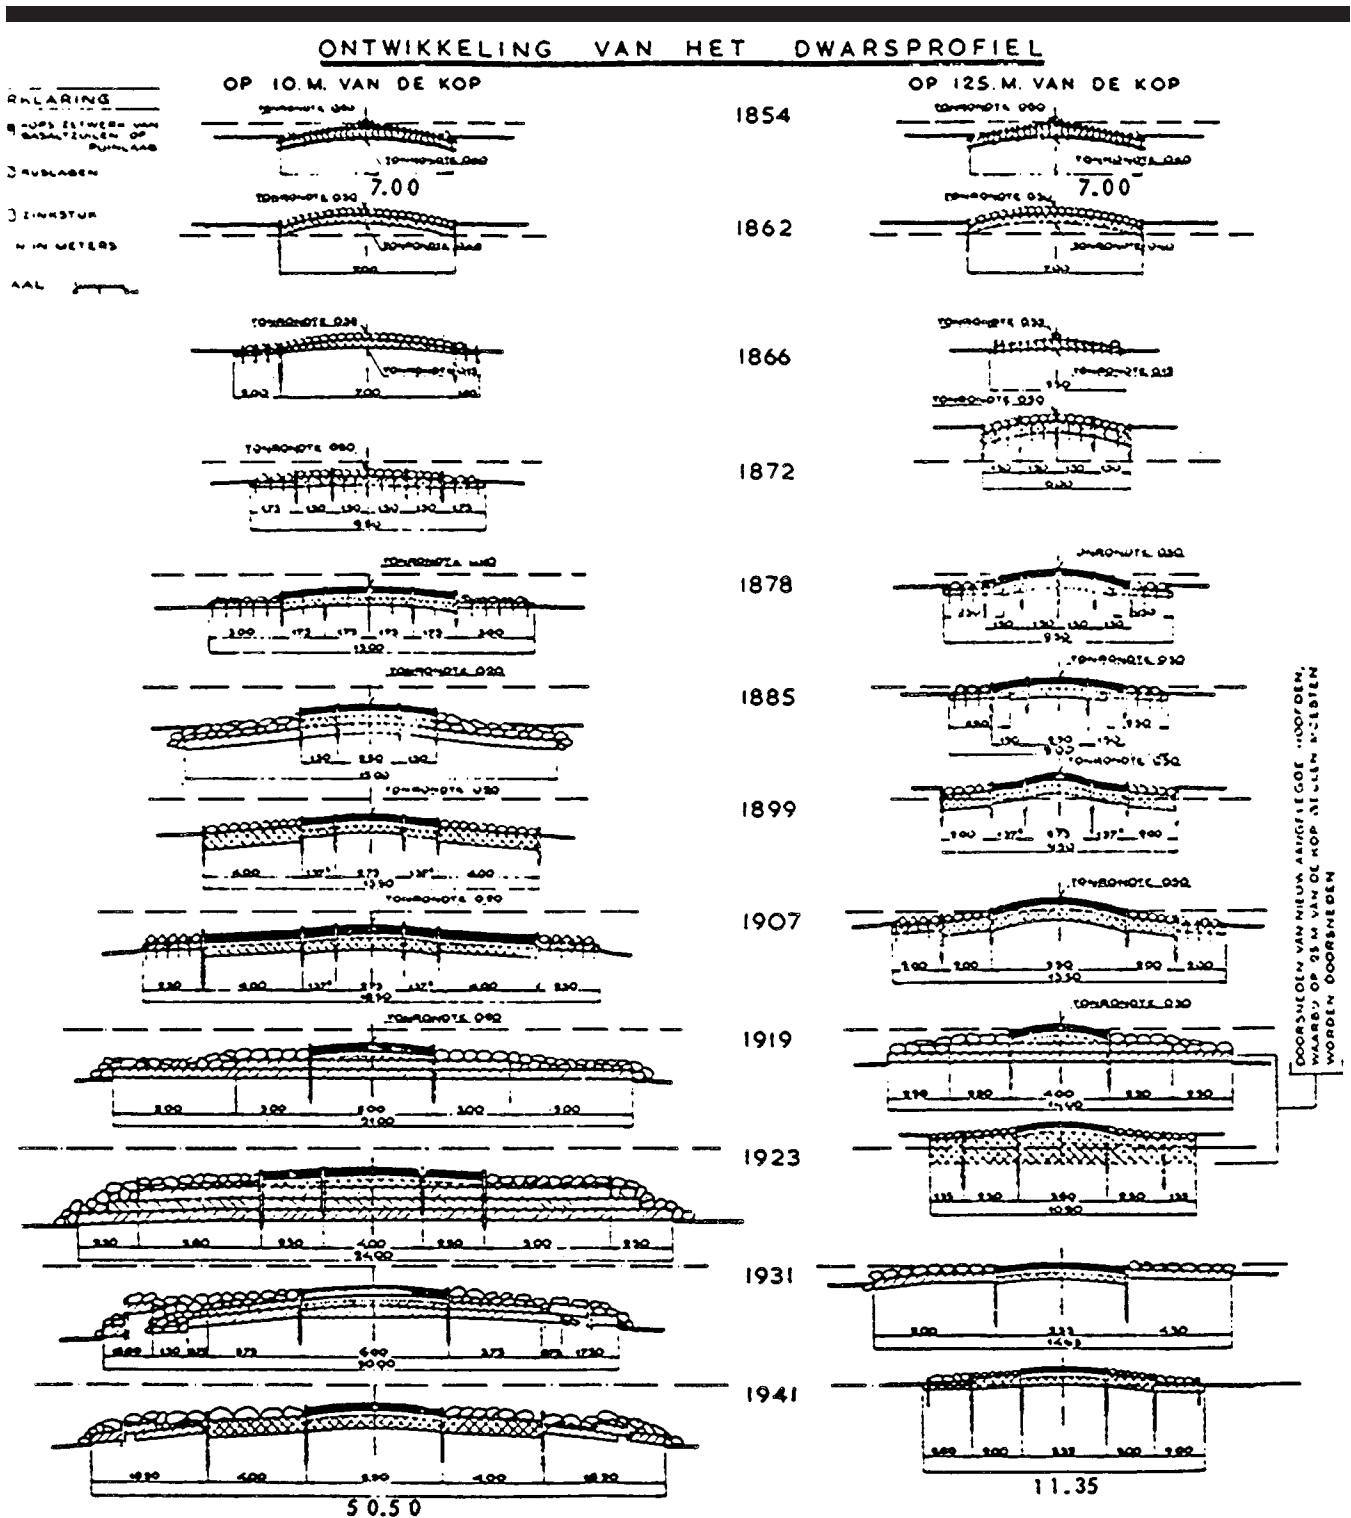
Figure 23. Development of groins in Holland 1854-1941 (Visser, 1953).

Groin-like structures were put in place, in The Lowlands (today parts of The Netherlands, Belgium and Northern France) well before the dawn of the 16th century. There is no information on what they looked like; on the other hand we are far better informed on the history of development of protective structures, streamlined and submitting themselves as little as possible to the forces of waves and currents, covering the last 100 to 150 years. Even though the groins have expanded size-wise, the engineering principles remained the same: stone (rubble) pitching on gravel and mattresses in the center, stones on mattresses on the sides with two, or more, pile walls as supports (Figures 23, 24, 25).

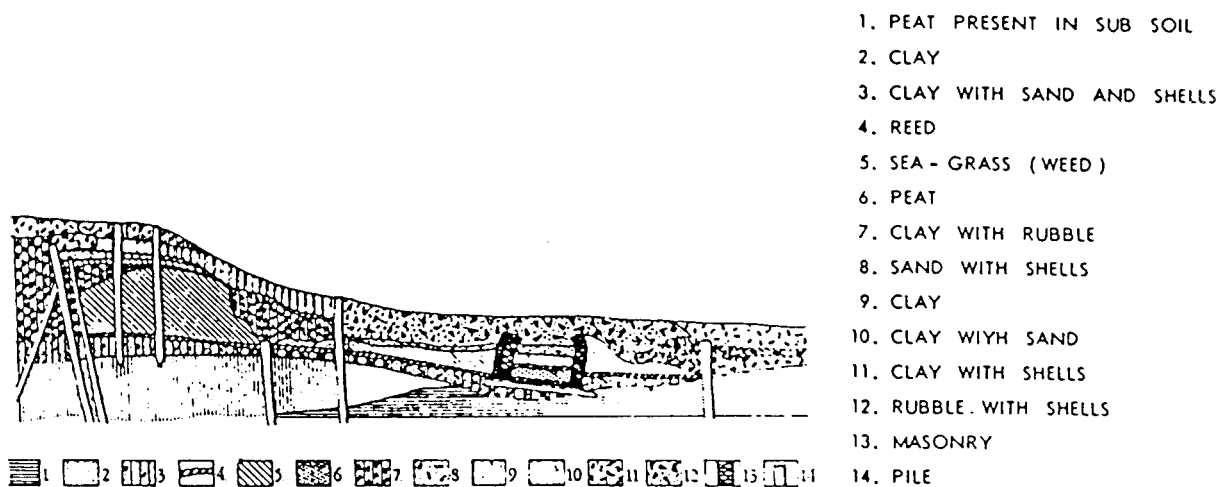
Figure 25. Cross section of ancient dike with pile support ("Antiquity and Survival", 1959).

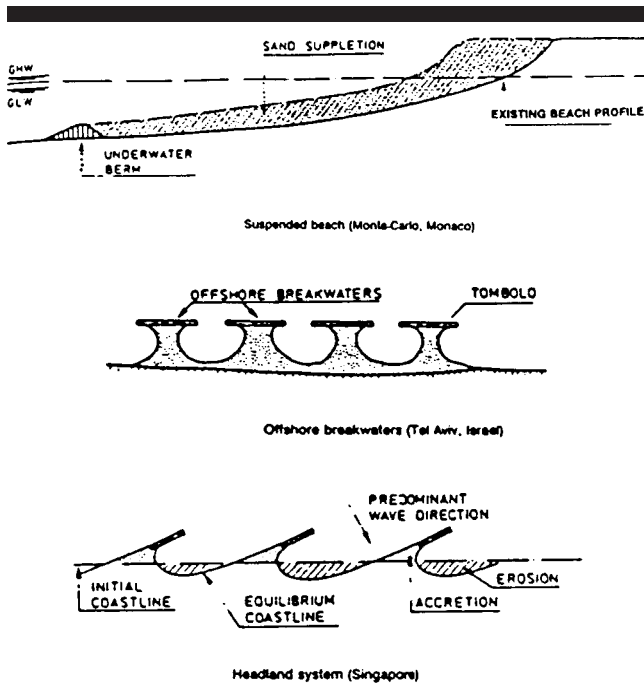
Figures 27–29. Some beach-restoration possibilities. Top, suspended beach (Monte Carlo, Monaco); Center, offshore breakwaters (Tel Aviv, Israel); Bottom, headland system (Singapore). Source: HAECON N.V., Ghent, Harbour and Engineering Consultants, Belgium.

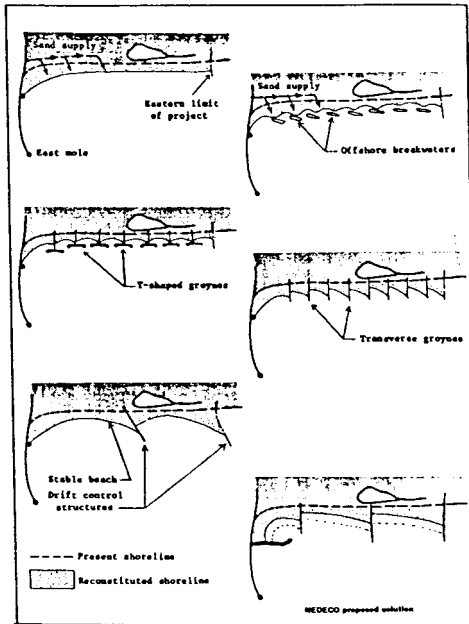
Figure 34. Proposed protection scheme for Kpémé and Anécho (Togo).

The West African coastline, southwards of Senegal, has suffered severe erosion for decades, and land loss reached alarming and devastating proportions. Seawalls, groins and revetments have mostly been ineffective in stemming erosion. Local authorities ask for help in sand nourishment projects while recommending simultaneously semi-permeable groins, disused oil field hoses and sand-bagging. Construction of moles in Lagos has caused steady retreat of the coastline since 1900. Shoreline protection schemes include groins on Victoria Island near Lagos (Nigeria) (Figure 33) but also beach nourishment, sea-walls in Dakar (Senegal), groins on Jamestown Beach and revetments on Labadi Beach both near Accra, offshore breakwaters in Conakry (Guinea), St. Louis and Rustique (Senegal). “Local” methods are bulkheads, sand-mattresses and -bagging in Brass (Nigeria), timber groins, Chicoco blocks, wooden bulkheads and afforestation (Figures 31–34).

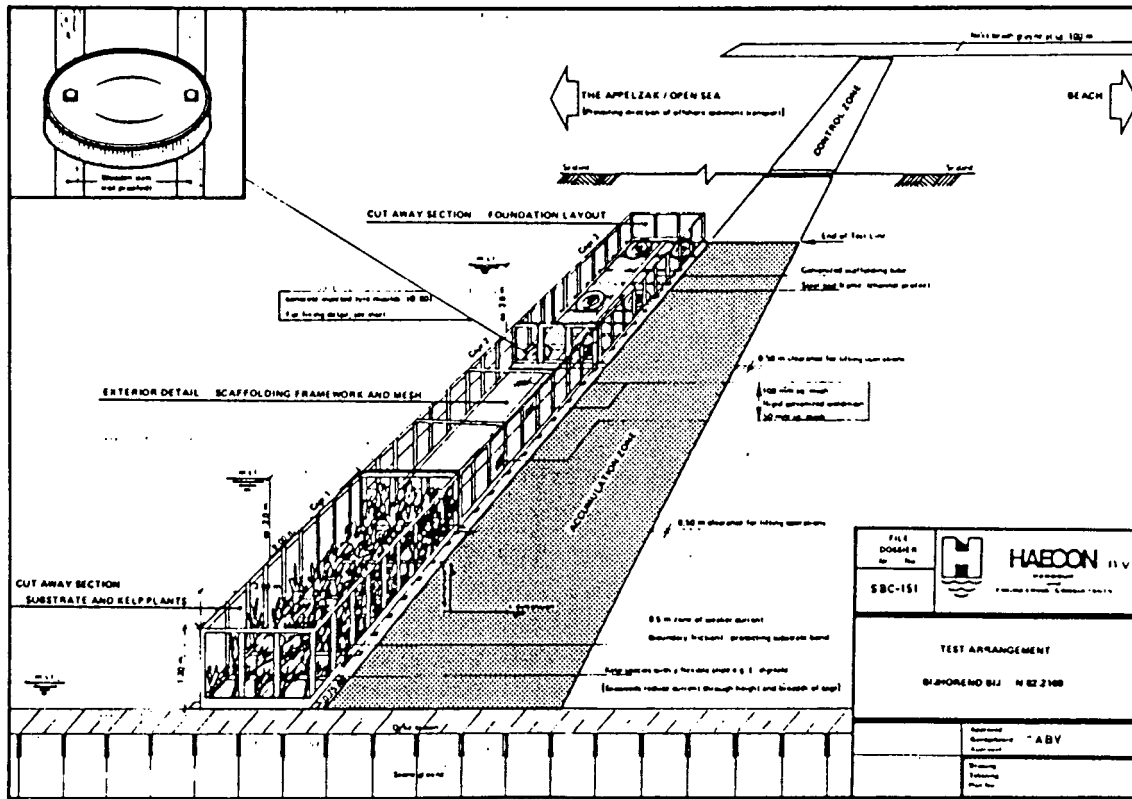
Figure 38. —Cages array for algae artificial reef. Source: HAECON N.V., Ghent, Harbour and Engineering Consultants.

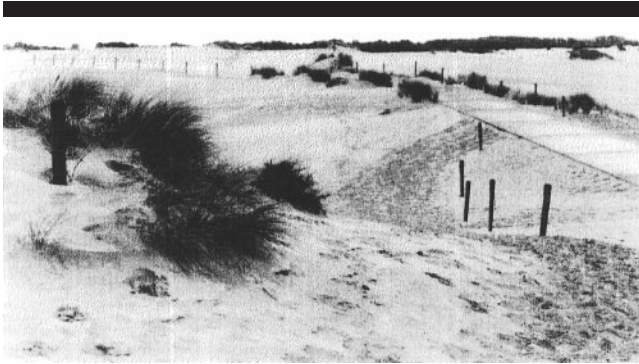
Figure 41. Entrance channels provided for the sea into the dunes where once armored seawalls had toe protection. Photograph courtesy Flemish daily from Ghent; Belgium “Het Volk”.
