## **Panorama of the History of Coastal Protection**

Authors: Charlier, Roger H., Chaîneux, Marie Claire P., and Morcos, Selim

Source: Journal of Coastal Research, 2005(211) : 79-111

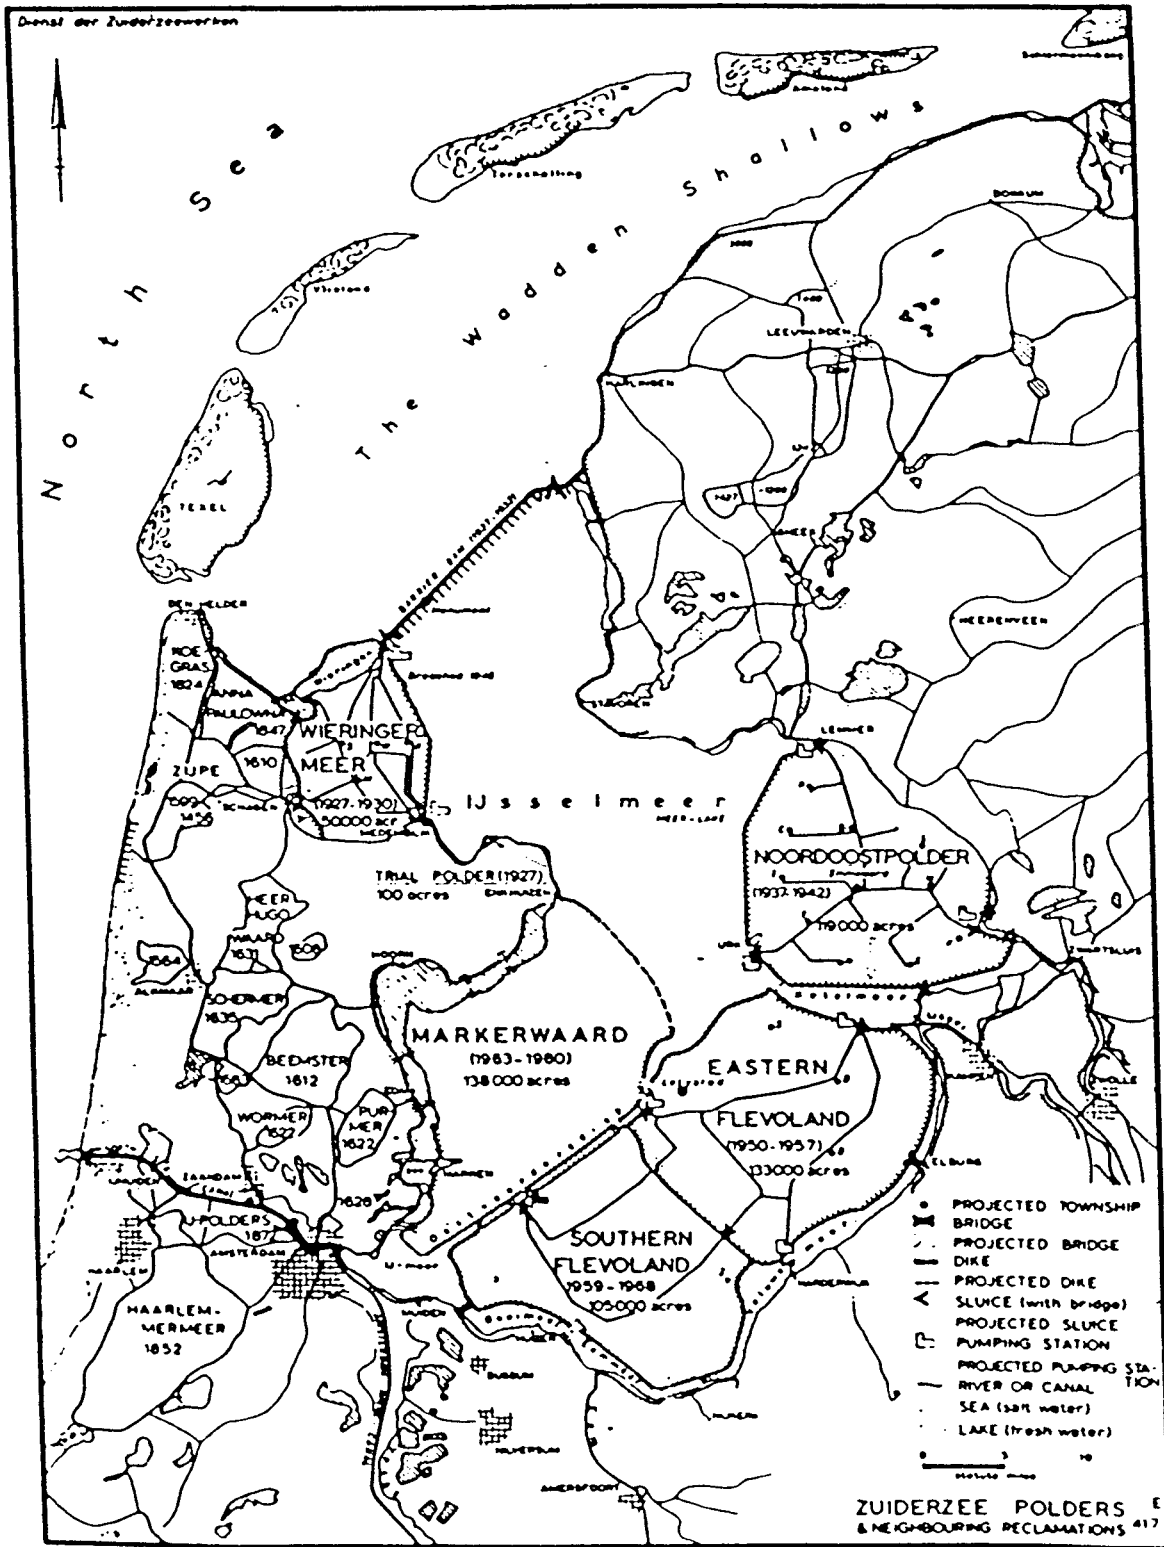
Figure 1. Reclamations in The Netherlands. Top left caption of figure reads "Dienst der Zuiderzee-werken." Bottom caption reads "ZUIDERZEE POLDERS AND NEIGHBORING RECLAMATIONS."

The Dutch, then commonly known as Hollanders, Zeelanders and Brabanters, and the Frisians (Lat.: *Frisii*) were either the first, certainly among the first in Northern Europe, to protect their establishments by earth mounds, and this as early as a thousand years ago. Even then the sea-level was rising. And by the twelve hundreds they had managed reclamation and some coastal protection, particularly among estuaries, the Dordrecht area being an example (Figure 1).

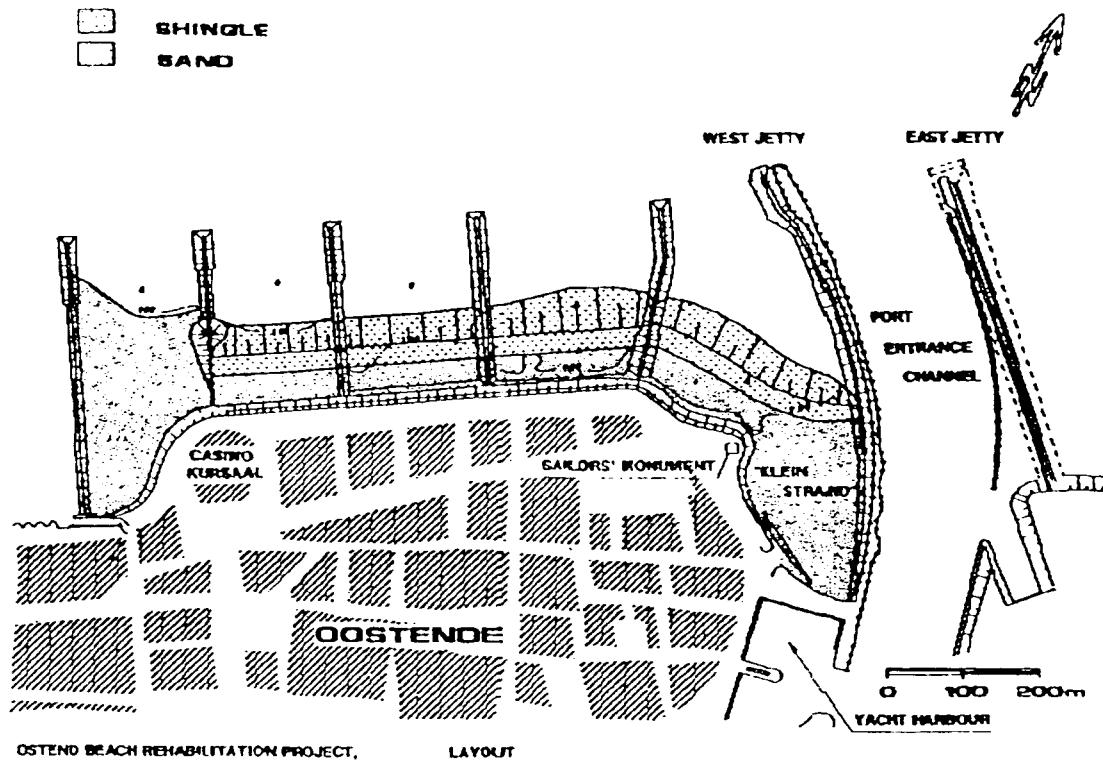
Figure 2. Layout of the beach rehabilitation project at Oostende, Belgium.

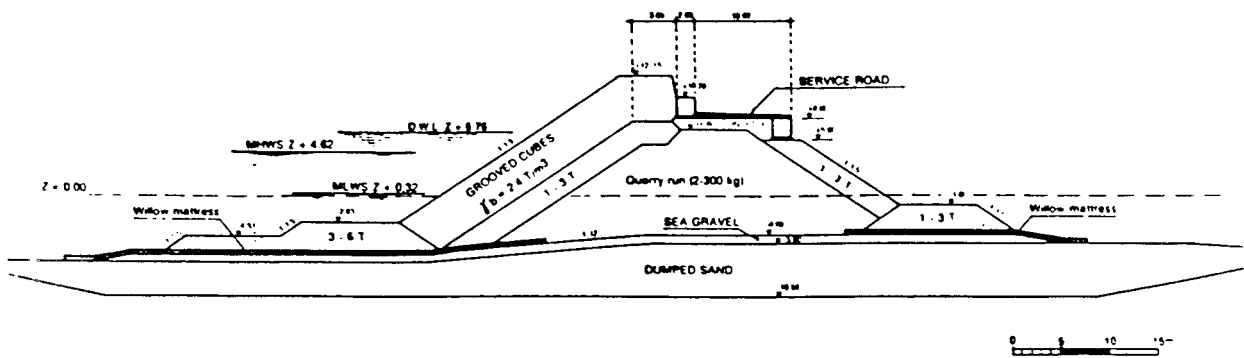
Figure 3. Typical cross-section of Zebrugge outer harbour breakwaters.

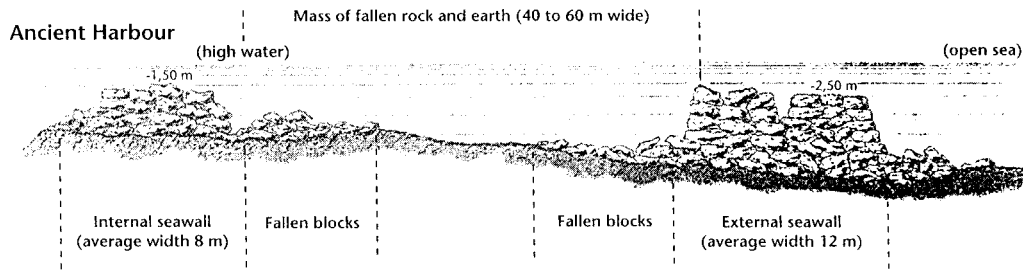
Figure 4. An average section across the Great Ancient Breakwater. After Jondet, 1916.

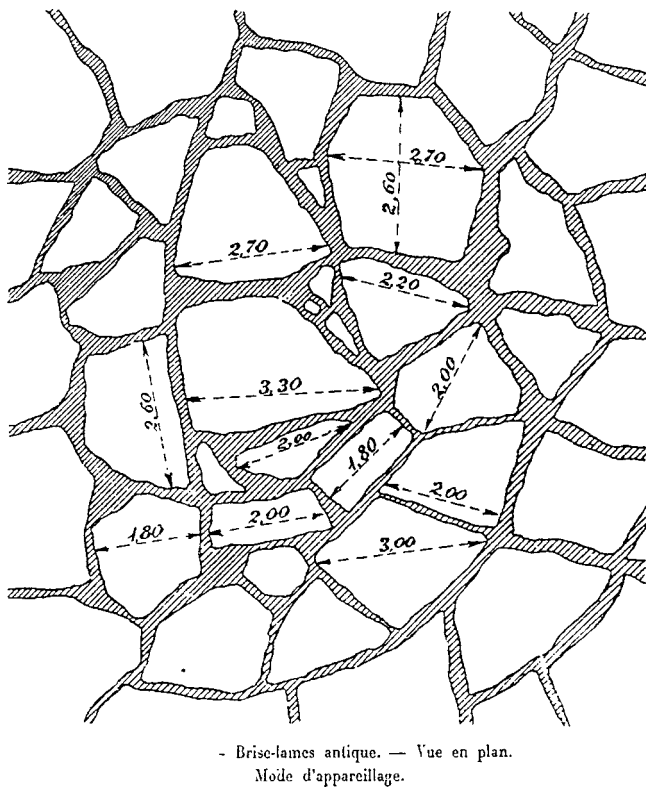
Figure 5. Upper surface view of the Great Ancient Breakwater. After Jondet, 1916.

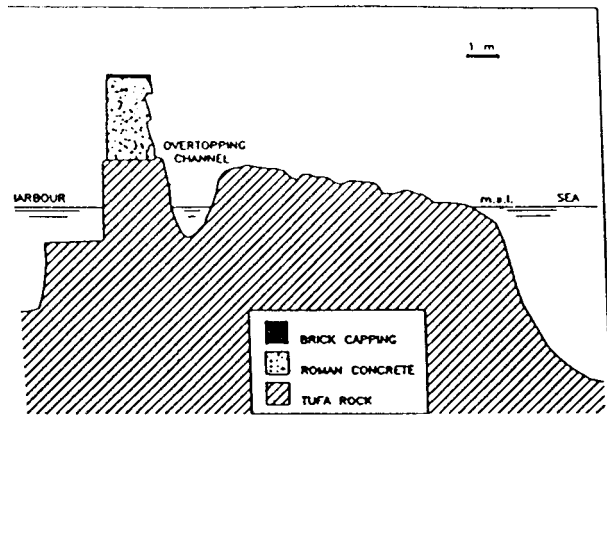
Figure 7. Cross-section of the existing Roman "carved rock breakwater" with overspill stilling channel at Ventotene (Built 2 BC).

Coastal defense history is, naturally, closely linked to harbor creation and development. Primitive breakwaters were put in place occasionally with ramps allowing the top of the waves to pass over them. Phoenicians had devised wave catchers by excavating holes and establishing trenches in the rocks lining the shores (RABAN, 1988). Carved breakwaters were cut out of bedrock: a suitable wave-absorber profile was created which had a gentle grooved slope at the waterline. The classical example dates from 2 before the present, is still visible at Ventotene; it had an over-spill. One may see in it an early version of today's Fontvieille breakwater (Principality of Monaco) (Figure 7).

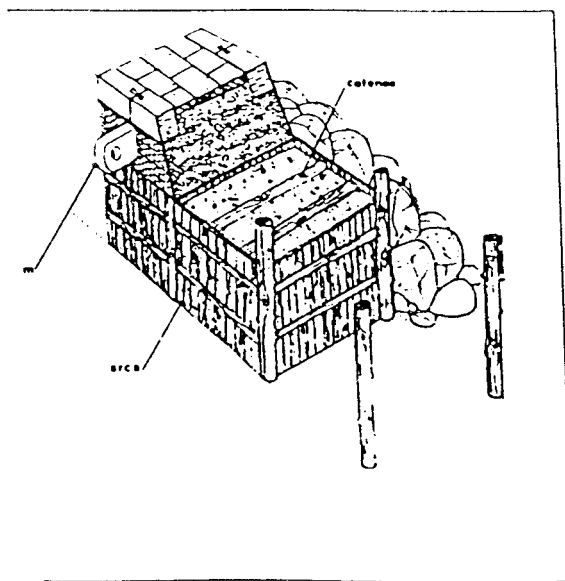
Figure 8. Reconstruction of the Roman construction system of a vertical water with cast-in-situ concrete within wooden forms and tie-rods (Clementi, 1981).

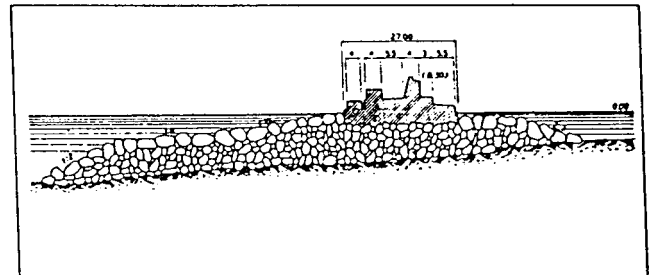
Figure 9. Modern section of the Trajan island breakwater of Civitavecchia harbour.

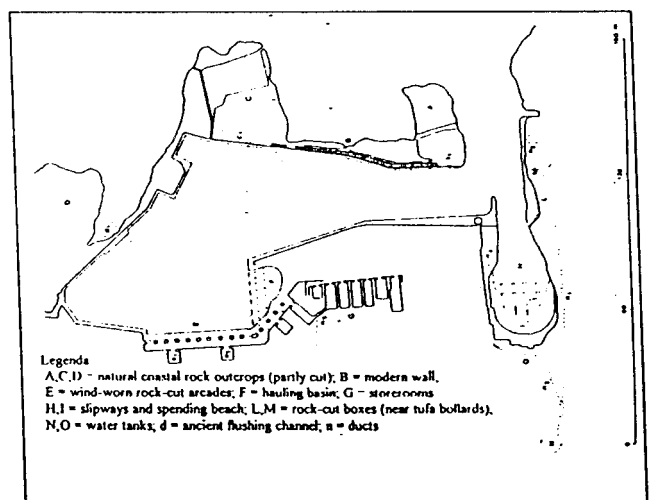
Figure 10. Layout of the Roman imperial port of Ventotene.

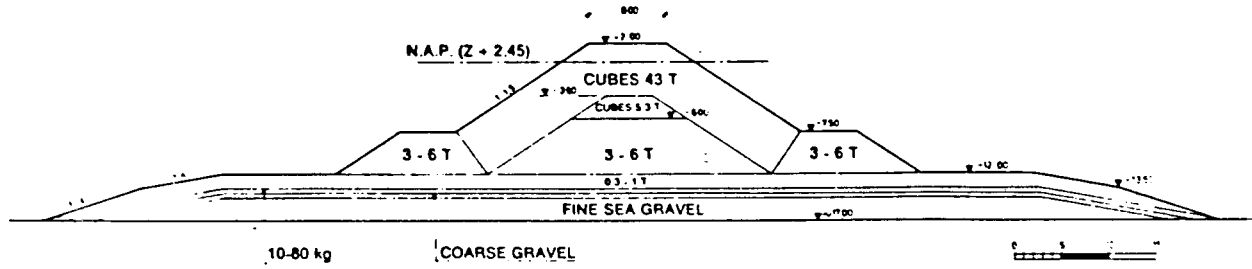
Figure 11. Cross-section of the North Breakwater at Rotterdam.

ing” notwithstanding a lengthy transport for rocks and short lifespan of wood (FRANCO, 1996). Strict environmental regulation governing shore protection can be traced back to legal documents of 1282 and 1339: prohibition to cut or burn trees from coastal forests, to pick mussels from rock revetments, to let cattle walk the dikes, to remove sand, and vegetation, from beach or dune, and to export materials used in coastal defense (GRILLO, 1989). The *Magistrato alle acque*, created in 1501, invited suggestions to reduce the high cost of the coast defenses, so, in the 18th century, appeared rip-rap revetments, gabions, staircase placed limestone blocks, and the use of mortar and steel links and flexible steel strips became common (Figures 11, 12).

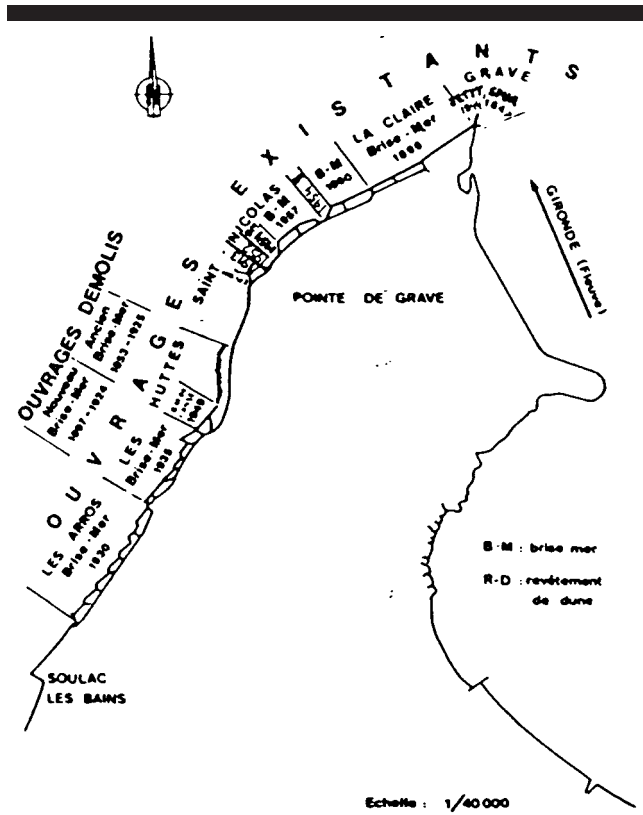
Figure 12. Shoreline protection, Pointe de Grave, France. After Laboratoire Central d'Hydraulique de France, 1979. Redrawn and modified by R. H. Charlier.

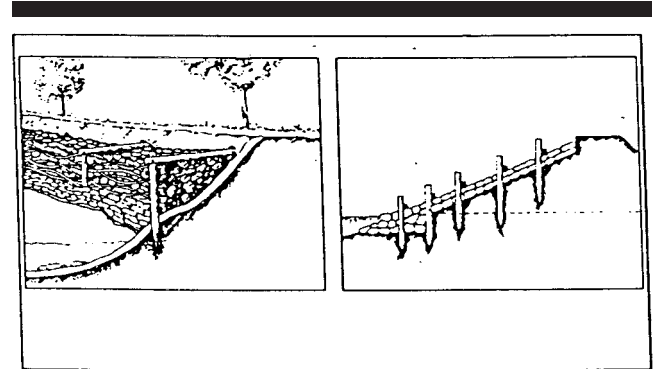
Figure 13. Ancient coastal defences in Venice: rubble vetments within timber piled fences (6th to 17th century).

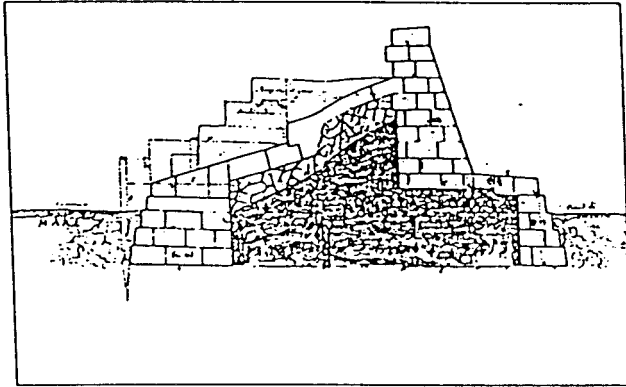
Figure 14. Original design of the "murazzi" seawall by Zandrini in 1743.

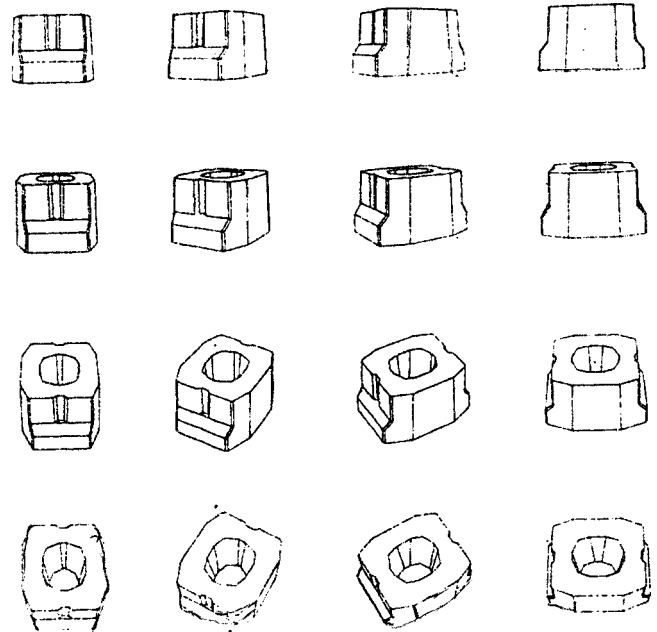
Figure 15. Various views of the "Haro" used in breakwater and groin construction.

As elsewhere, in the Mediterranean, engineers and environmentalists have second thoughts about hard structures, e.g. detached rubble mound breakwaters, are being replaced by star-shaped piles and perforated and articulated blocks—somewhat reminding of the Belgian designed Haro<sup>TM</sup>—and submerged barriers, all not infrequently combined with artificial beach nourishment, also by-passing. An environmental impact assessment is in process as regards mobile storm surge barriers (Figure 15).

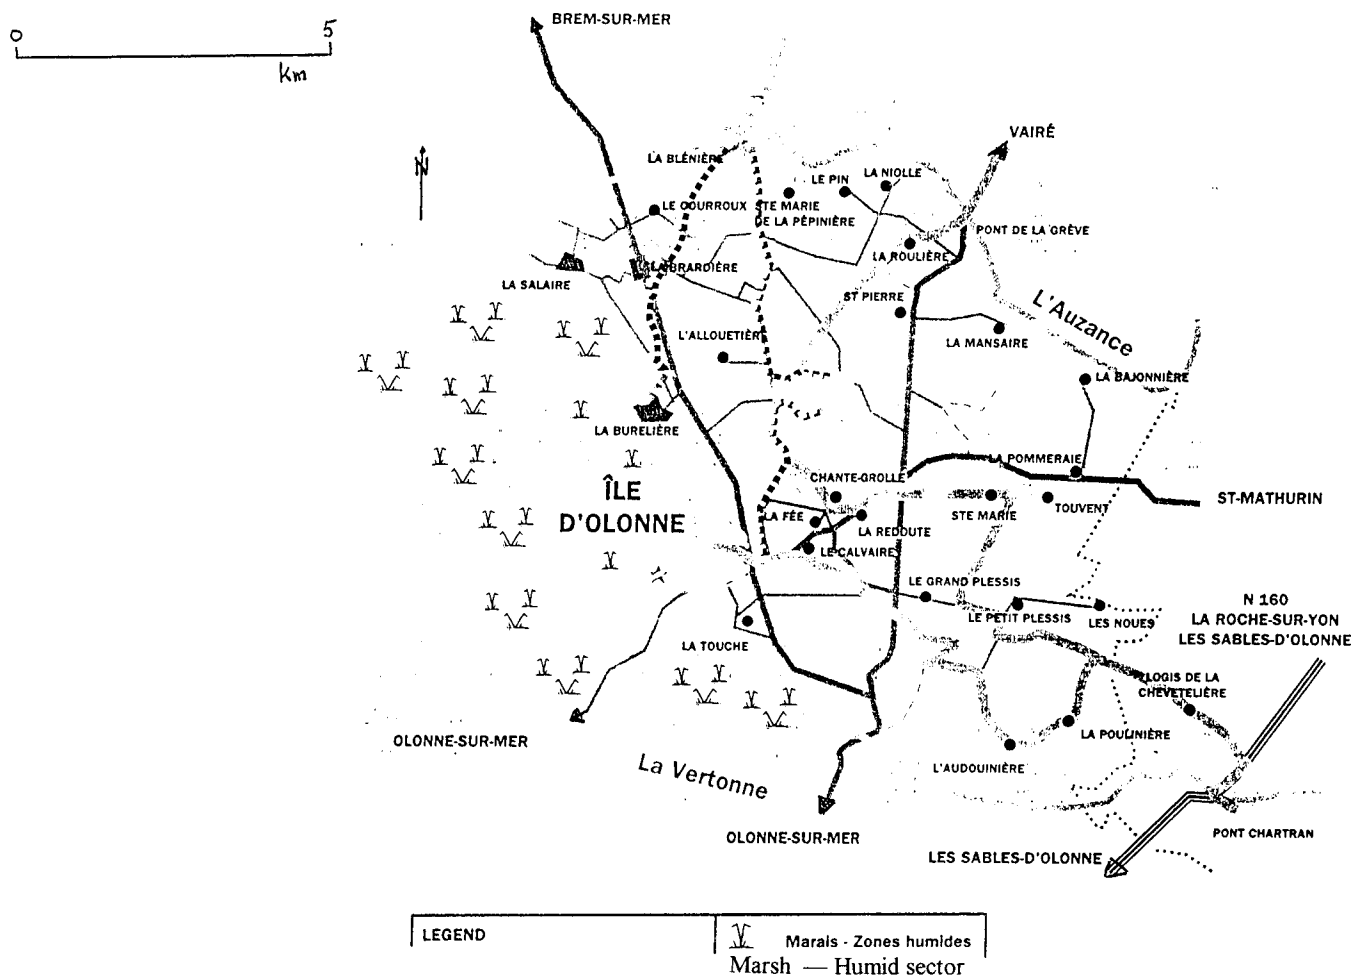
Figure 16. Location map of “marshes” (viz. wetland) in SW France.

Drying up of the Breton-Vendean (Figures 16, 17) wetland (marsh) is largely due to Dutch technicians who established, in the XVIIth century, a canals and tide channels network by means of dikes. Low farms, similar to many of those encountered in Flanders and Holland, called *bourrines* (perhaps after the Dutch-Flemish word *boerin*, meaning the farmer's wife, or more probably *bourre*, a type of *pise* (dry-wall stone facing), occupy hillocks and buttes, formerly islands of the ancient shoreline (Figure 17).

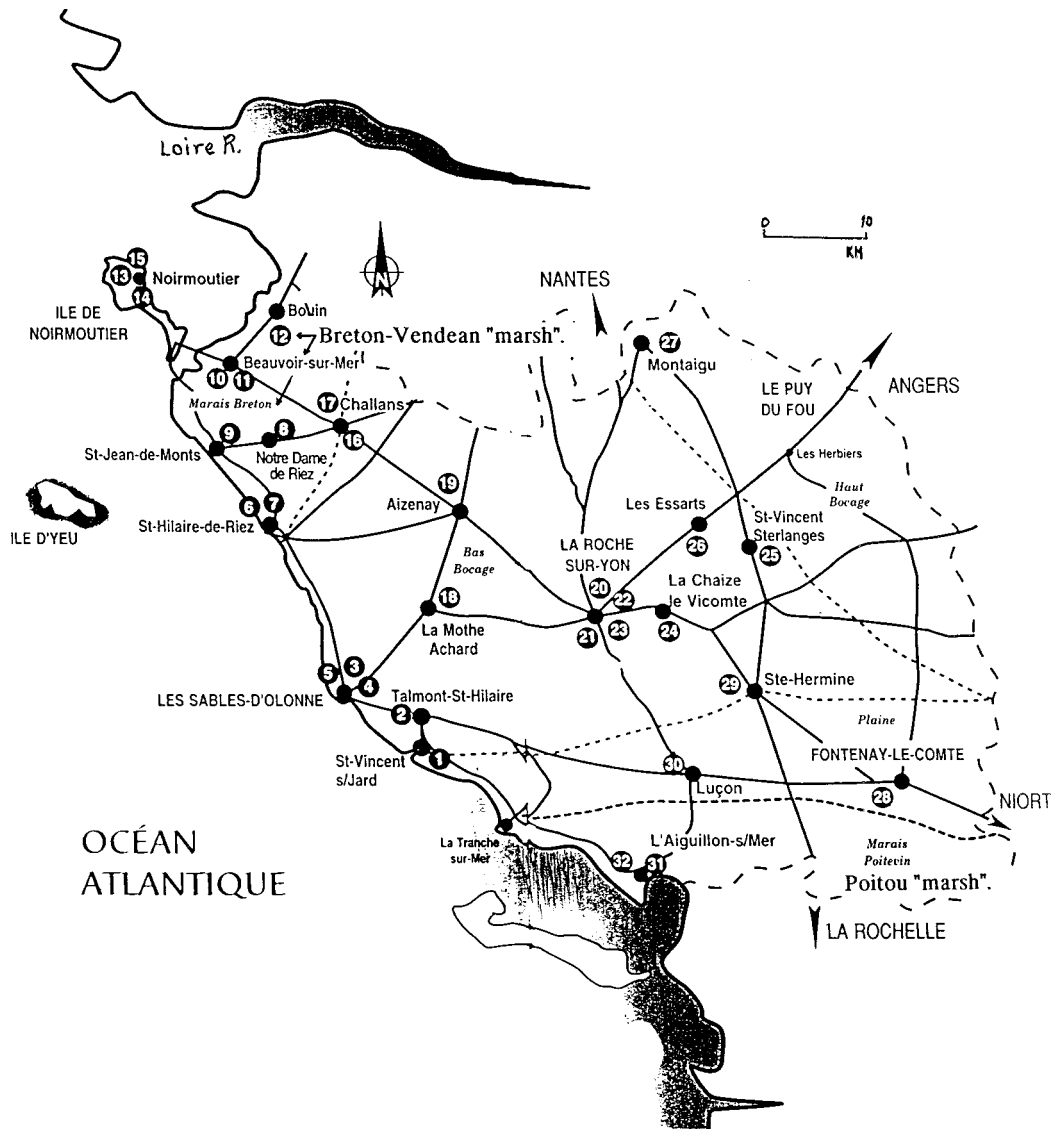
Figure 17. Location map Polders and reclaimed wetlands of Atlantic France. Legend: 1–5: dikes and marshes; 6–12: Breton-Vendean marsh; 13: dikes; 14: salt-extraction marshes (*marais salants*), polders; 15: dikes; 16–17: reclaimed marsh; 18–19: low bocage area; (20–27 not relevant to this paper); 28: Poitou marsh; 28–30: examples of former harbors, now inland; 31–32: dikes.

landers' Belt". Gradual colonization of the marsh proceeded henceforth with dike building: Limousins' Levee, dikes of the Moors, of Morocco, of the Wagons, of Aiguillon, 1771-dike, Year VII-Village. Dikes-protected polders were established in the 19th and 20th centuries on the mainland, for instance St. Seran polders, near Bouin, Bourgneuf Bay, and on Noirmoutier Island (Sebastopol Polders) (Figures 16, 17). The former wetlands encompass landwards the humid marsh—nicknamed the Green Venice and close to the ocean the dry marsh cut up by dikes and canals (Figure 17).

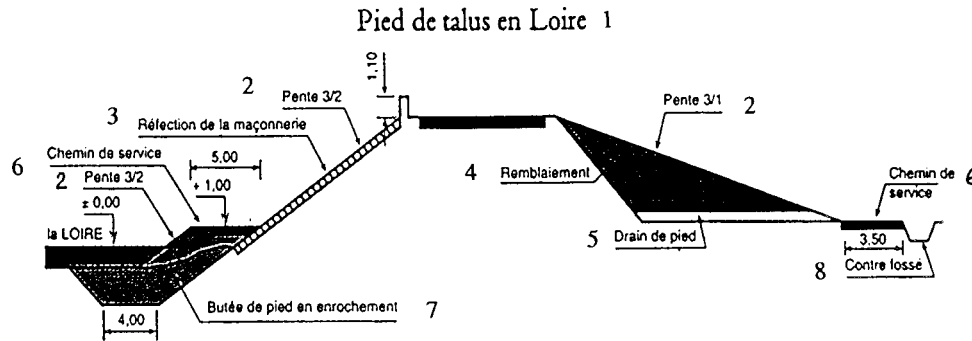
Figure 18. Reinforcement of the Levee Project (Loire River). Legend: 1. Talus foot in the Loire. 2. Slope. 3. Masonry repair. 4. Embankment. 5. Foot drain. 6. Service path. 7. Rubble mound foot block. 8. Counter ditch. (All measurements in meters).

embankments between 1904 and 1926 in such tidal rivers as the Loire. Made of wooden poles or stakes garnished with chestnut tree claires, a rubble-mound string allows to insure their foundation towards the bottom. Such groins had medieval forerunners, some of which still subsist, for instance at St. Georges-sur-Loire: they were constructed of small poles placed very close to one another with small size rubble stones, mostly covered by alluvions as time went by (Figure 18).

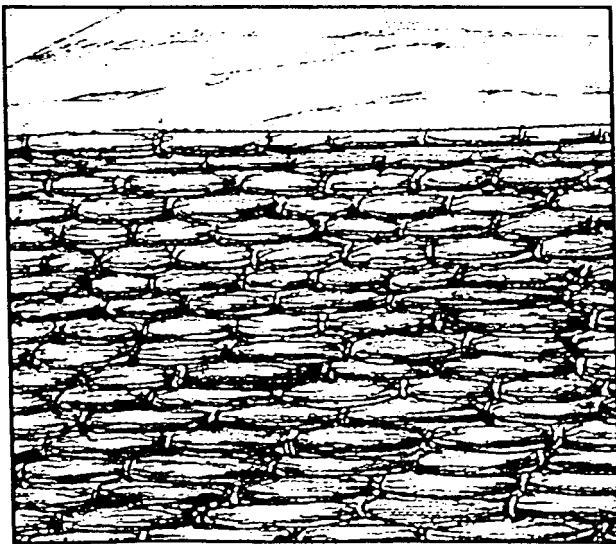
Figure 19. Revetment of a "turbie" (small individual dike) in 1967. Reproduced from a photograph from the Departmental Archives of Maine-et-Loire by B. Rousseau.

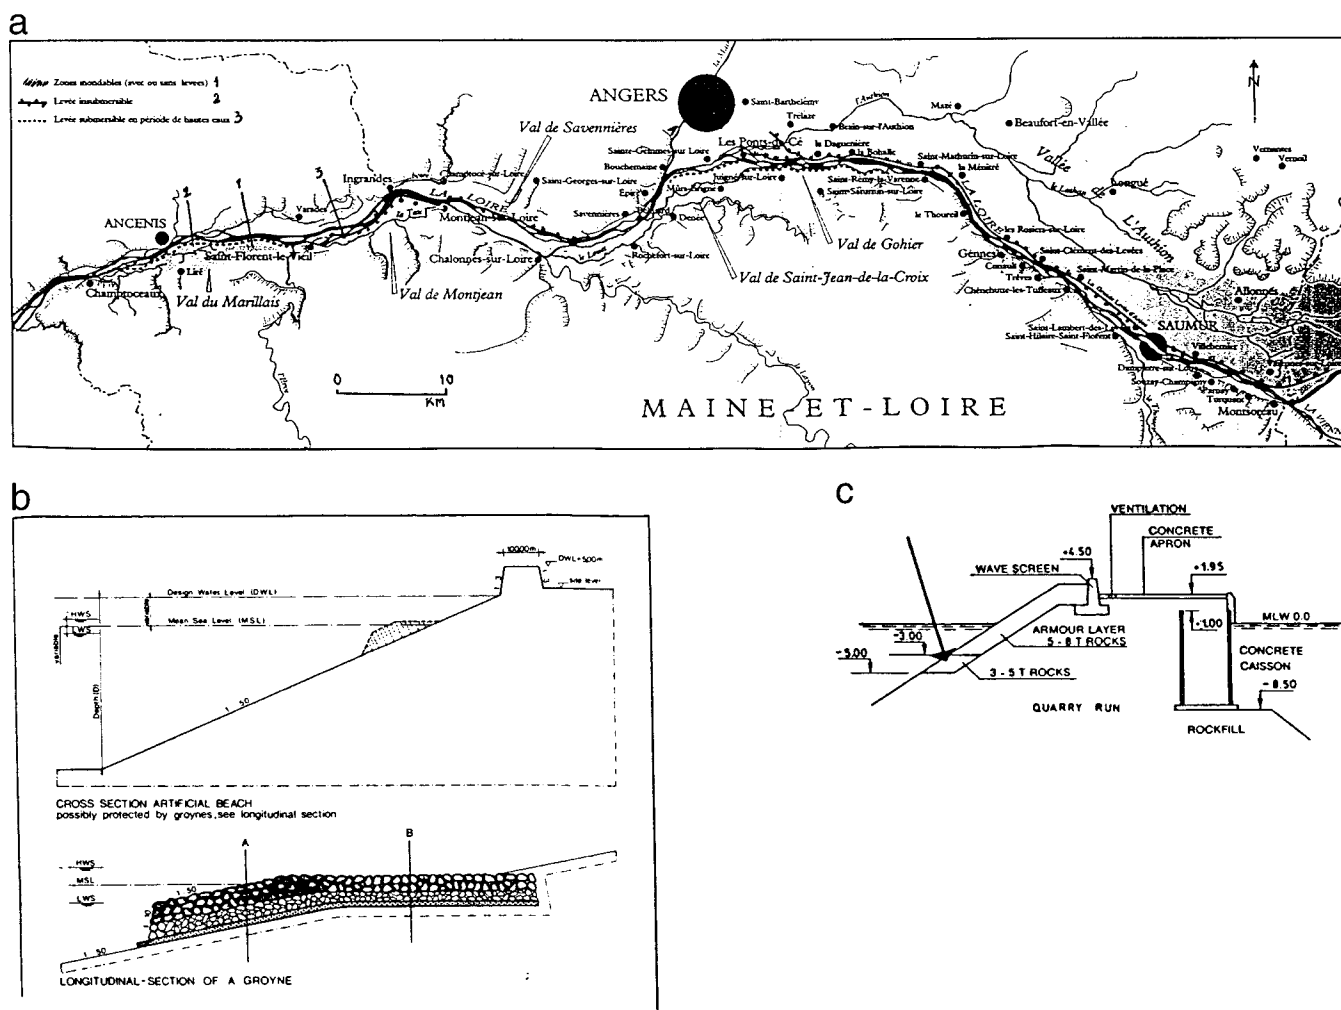
Figure 20. 20a. Map of the Loire in the French Département de Maine-et-Loire. River mouth lies west. (Infographic M. Brugier) Legend: relative city size shown by circle dimension; dark line: river course; shaded area: submersible area with or without levees; - - - -: insubmersible levee; - - - -: submersible levee at high water. 20b. Longitudinal-section of a groyne. 20c. Torshavn Breakwater, Denmark (after Sorensen *et al.*, 1965).

less get blamed for lack of foresight in believing in an in-submersible dike without waste-weirs capable of keeping a river in a bed that proved too narrow. Major improvements have been underway in the nineties (Figure 20).

of concrete blocks placed by specially conceived cranes, each block weighing from 4 to 8 tons, often with side slopes of 2 to 8 tons of granite. Nevertheless erosion was not stopped outside the groynes' extreme end, and furthermore the outer parts were not kept up. Lack of maintenance played a role. The land ends were extended gradually as dunes and dikes were withdrawn. Artificial nourishment using bay and offshore sources has not, surprisingly, been called upon though needed, in particular on the Lime Fiord Barriers (Figures 20b, 20c).

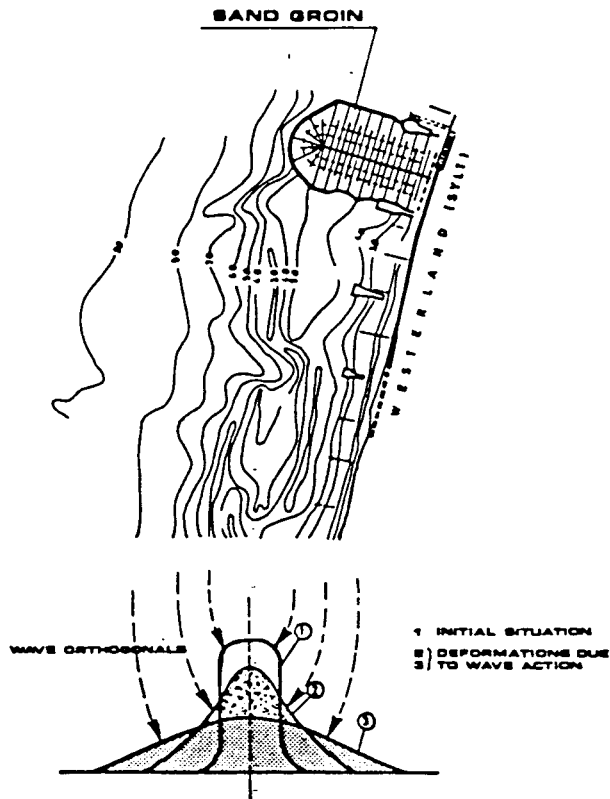
Figure 21. Construction of sand groin as coastal protection, Sylt, West Germany. Source: HAECON N.V., Ghent, Harbour and Engineering Consultants.

Along the coasts of Germany, especially those on the North Sea, situations similar to those of Denmark and The Netherlands prevailed throughout history. The eastern Friesland islands belong politically to Germany but differ in no way from their counterparts under Dutch sovereignty. Groynes were implanted along the coast and some failures made history. Beaches on Sylt and Langeoog received artificial nourishment (CHARLIER, DEMEYER, DECROO, 1998) (Figure 21).

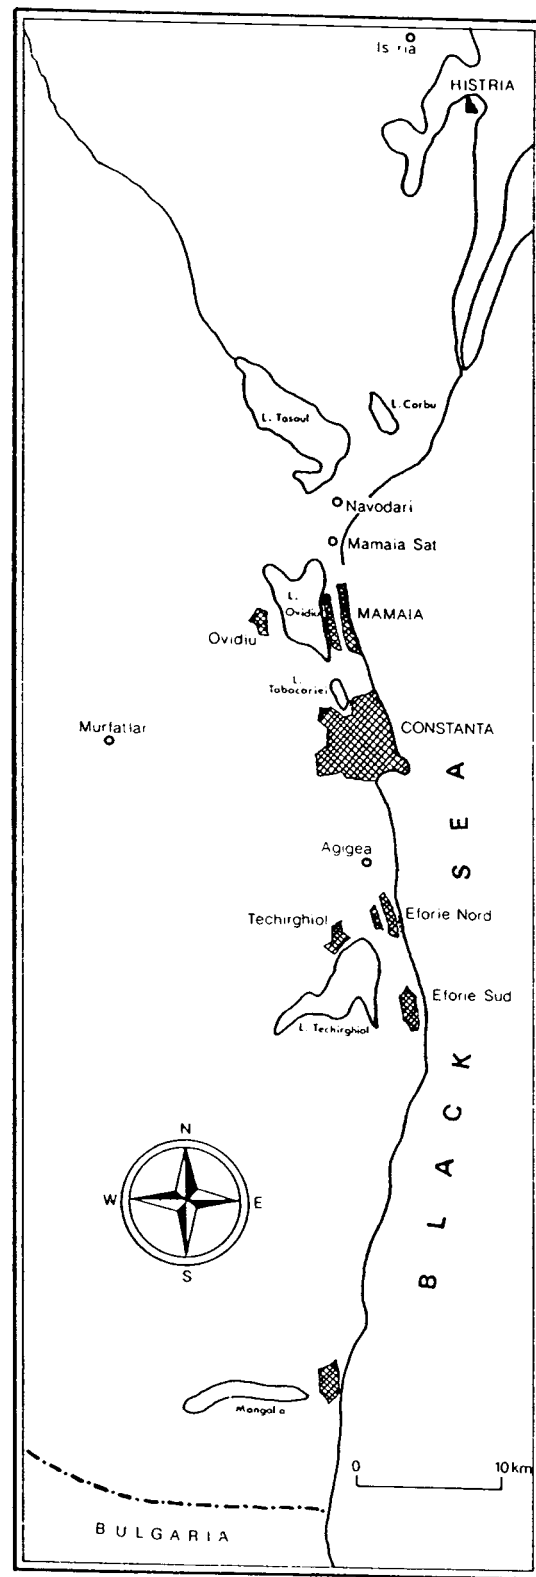
Figure 22. Modifications of a segment of the coastline on the Romanian sector of the Black Sea. The coastline has left inland several salt water lakes (*limans*), but currently the coast requires protection measures.

Romania has long opted for the hard coastal defenses to protect its coastal zone activities which, besides tourism, include industries, agriculture and fisheries. Annual beach profiles have shown an erosion rate reaching as high as 60 and even 70% (Figure 22).

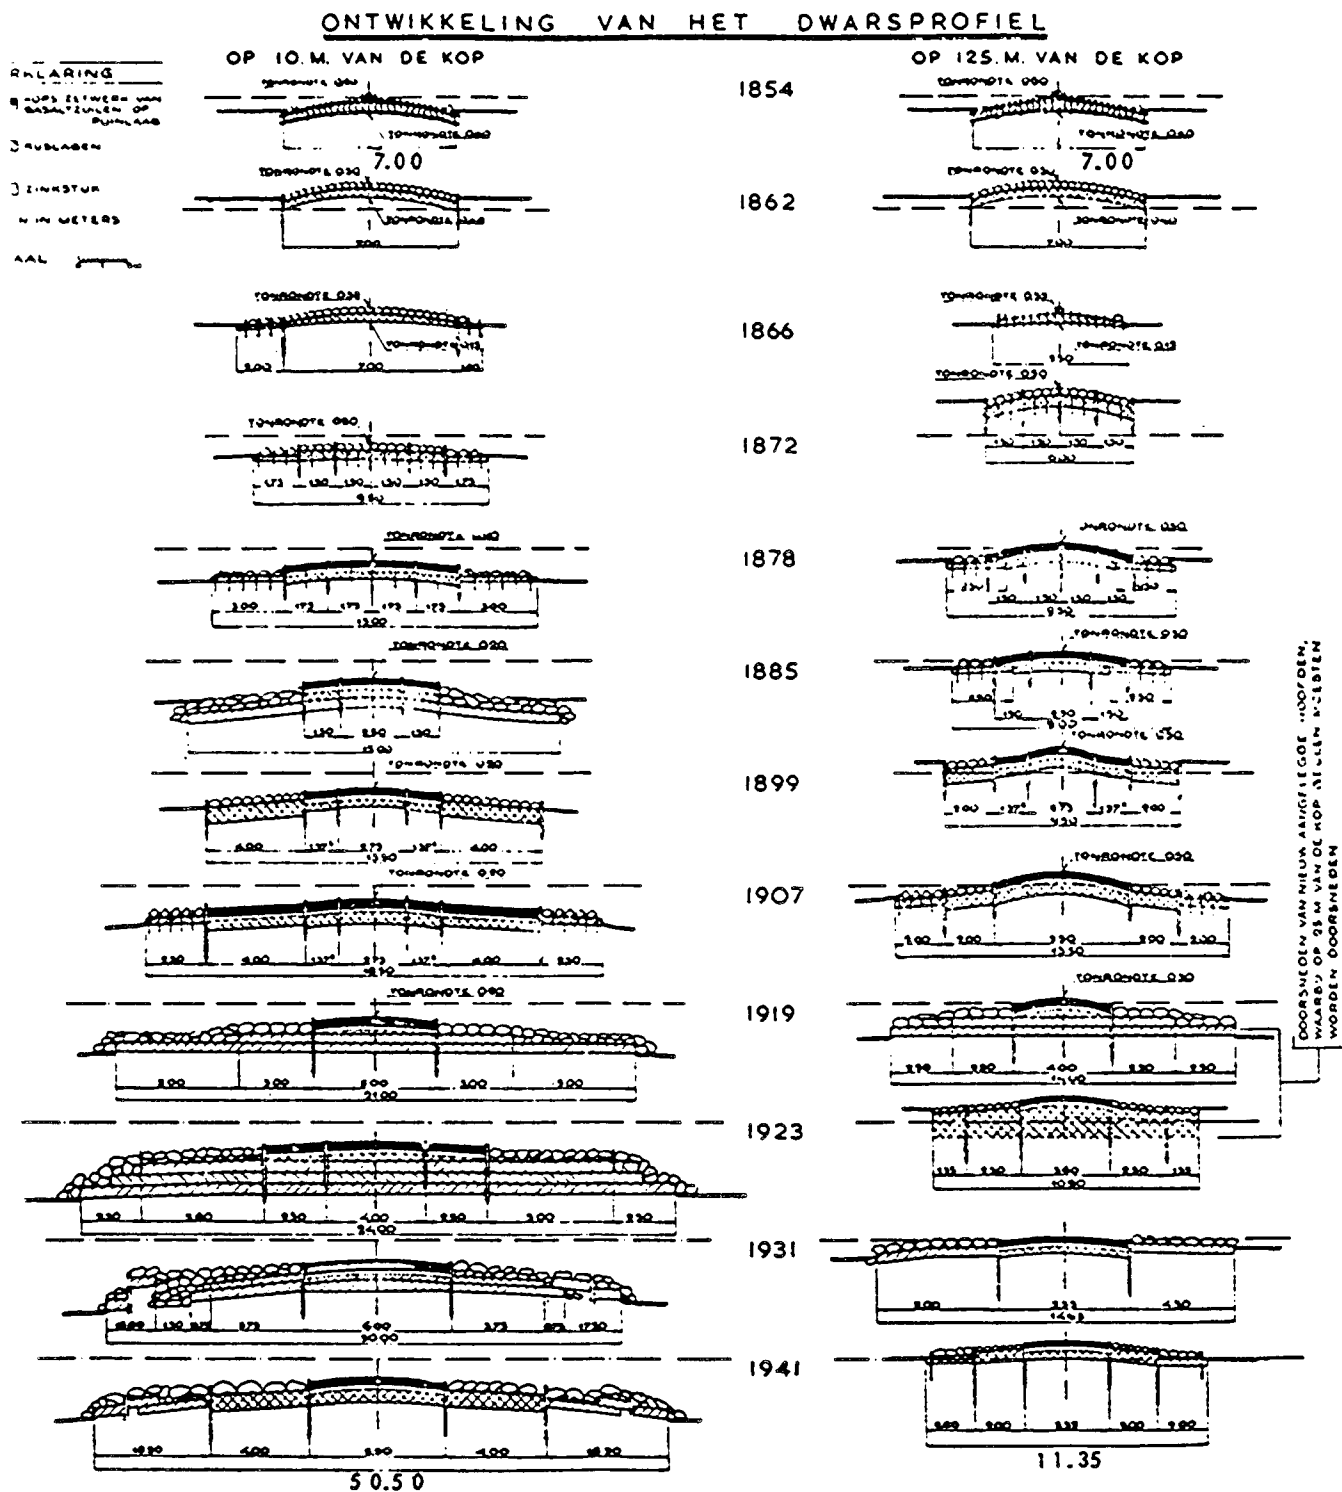
Figure 23. Development of groins in Holland 1854–1941 (Visser, 1953).

Groin-like structures were put in place, in The Lowlands (today parts of The Netherlands, Belgium and Northern France) well before the dawn of the 16th century. There is no information on what they looked like; on the other hand we are far better informed on the history of development of protective structures, streamlined and submitting themselves as little as possible to the forces of waves and currents, covering the last 100 to 150 years. Even though the groins have expanded size-wise, the engineering principles remained the same: stone (rubble) pitching on gravel and mattresses in the center, stones on mattresses on the sides with two, or more, pile walls as supports (Figures 23, 24, 25).

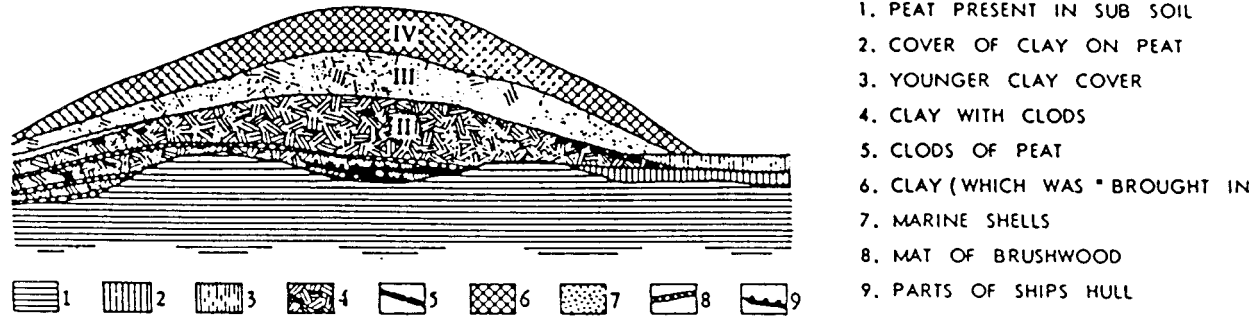
Figure 24. Cross section of ancient dike, Netherlands. ("Antiquity and Survival", 1959).

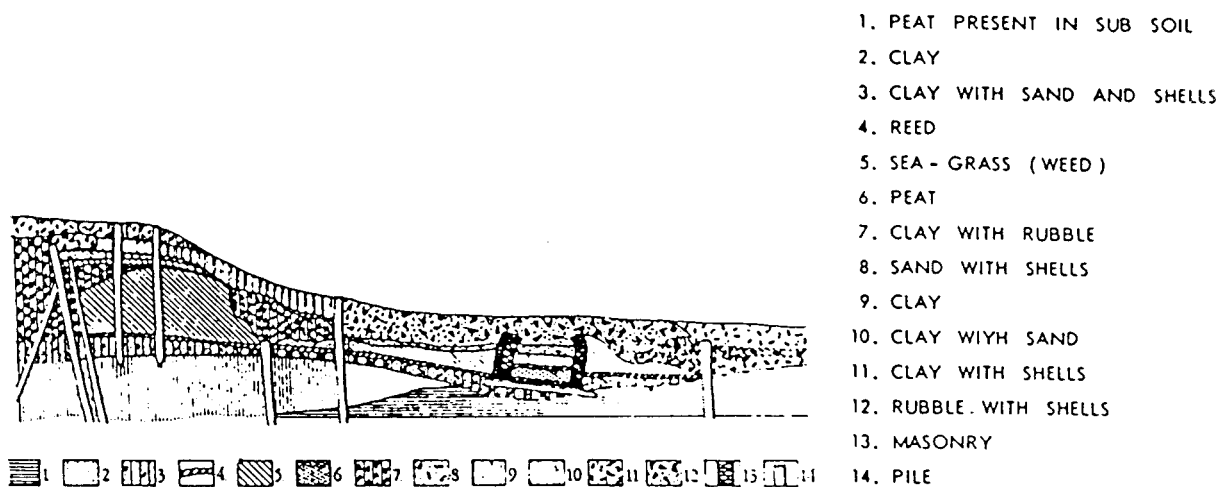
Figure 25. Cross section of ancient dike with pile support ("Antiquity and Survival", 1959).

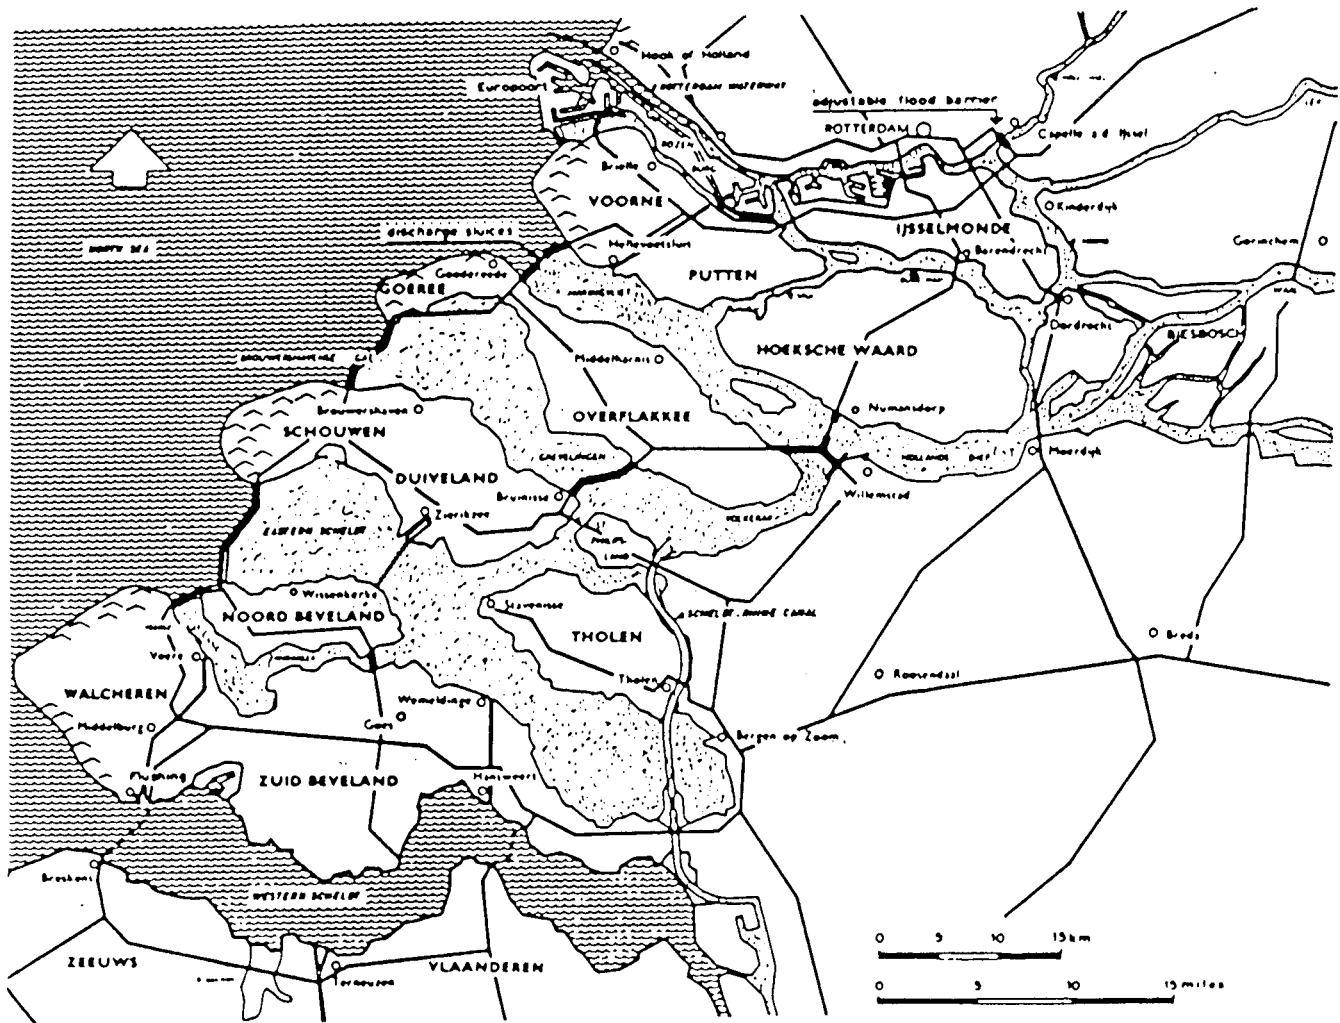
Figure 26. Map of The Netherlands Delta-Plan.

been said about the “Delta-Works” and there was no unanimity about their completion. Their impact has not always been favorable for areas of the upstream Scheldt River (Dutch: Schelde; French: Escaut) (Figure 26).

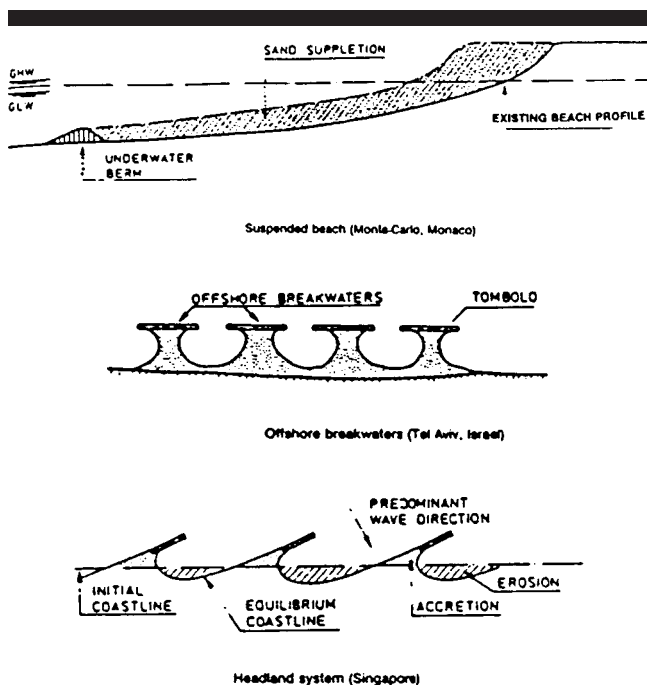
Figures 27–29. Some beach-restoration possibilities. Top, suspended beach (Monte Carlo, Monaco); Center, offshore breakwaters (Tel Aviv, Israel); Bottom, headland system (Singapore). Source: HAECON N.V., Ghent, Harbour and Engineering Consultants, Belgium.

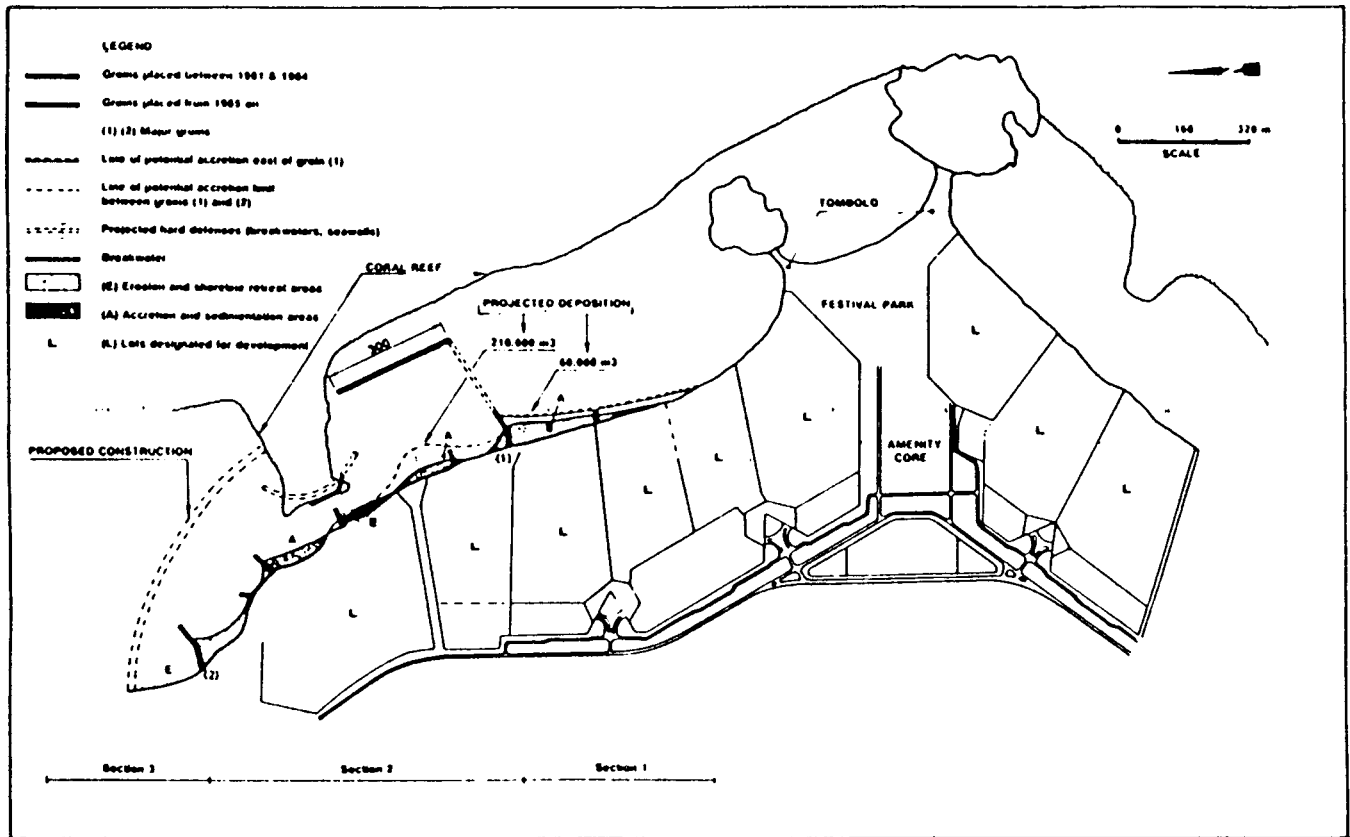
Figure 30A. Location of defenses, erosion, and accretion along some shore areas of Bali, Indonesia. After Indonesian Institute of Hydraulic Engineering.

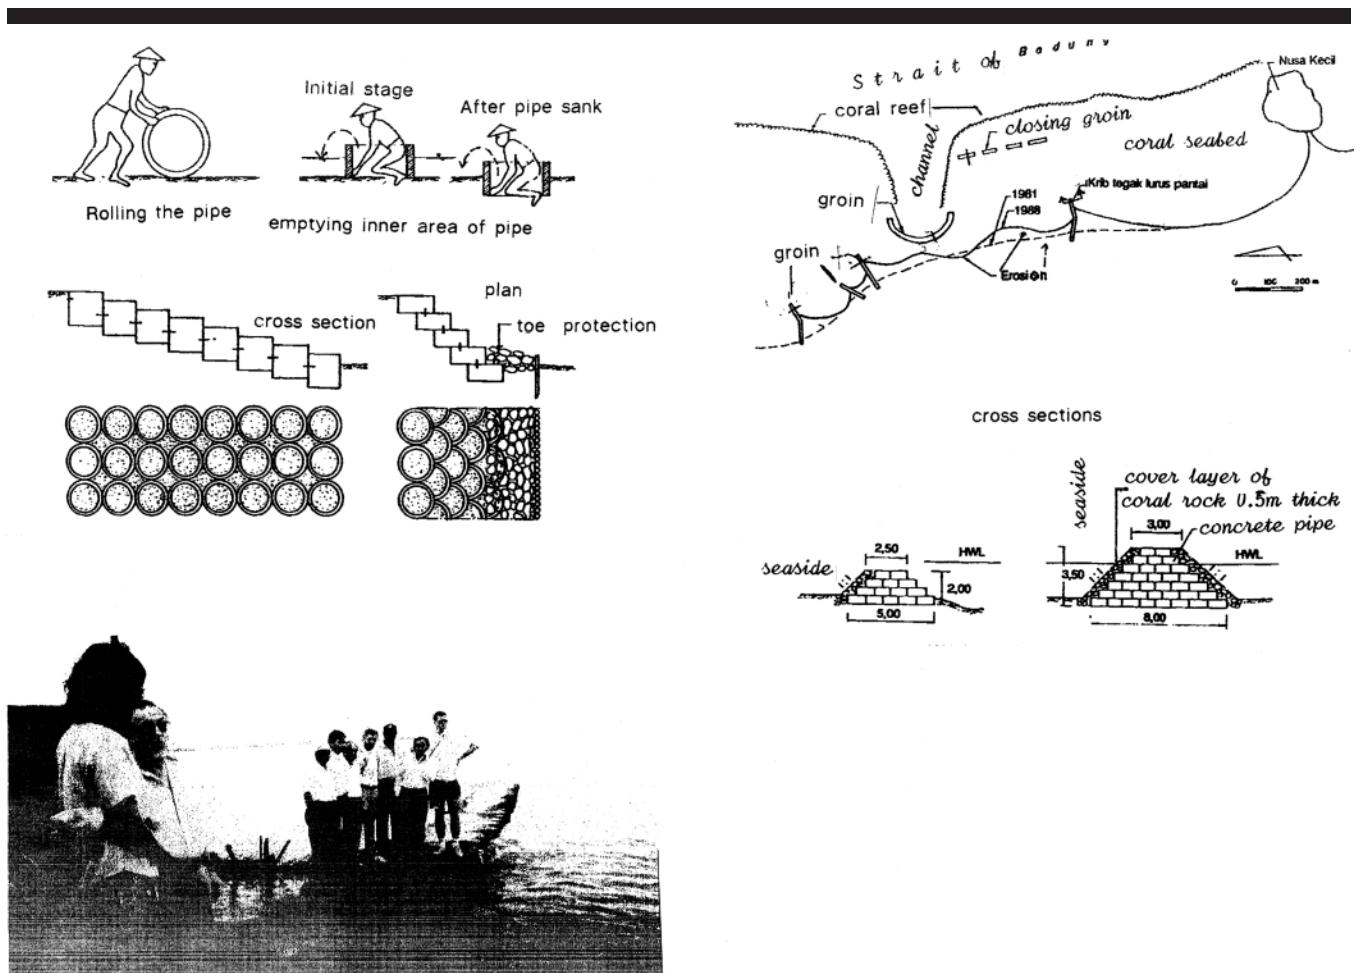
Figure 30B. Java, Indonesia. Concrete round pipes used to build breakwaters near a tourist resort (Belgian co-operation project. Author is second in picture front, to the left).
