## **Panorama of the History of Coastal Protection**

Authors: Charlier, Roger H., Chaîneux, Marie Claire P., and Morcos, Selim

Source: Journal of Coastal Research, 2005(211) : 79-111

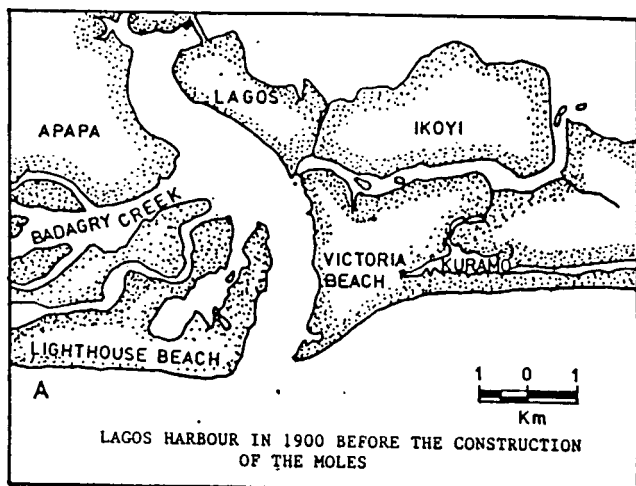
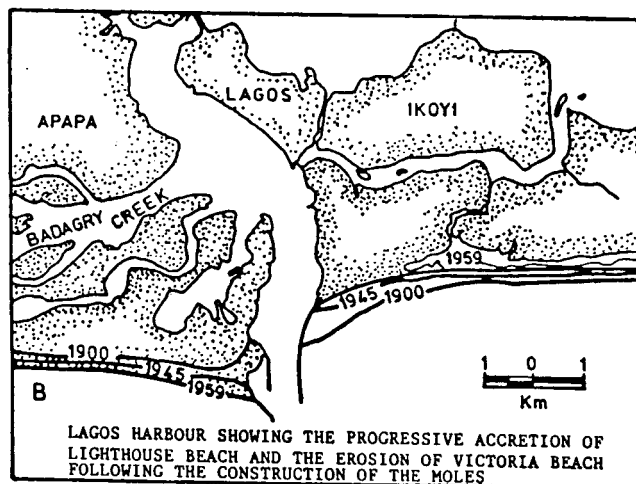
Figure 31. The Lagos coastline before (A) and after (B) the construction of the breakwaters (after IBE *et al.*, 1984).

The West African coastline, southwards of Senegal, has suffered severe erosion for decades, and land loss reached alarming and devastating proportions. Seawalls, groins and revetments have mostly been ineffective in stemming erosion. Local authorities ask for help in sand nourishment projects while recommending simultaneously semi-permeable groins, disused oil field hoses and sand-bagging. Construction of moles in Lagos has caused steady retreat of the coastline since 1900. Shoreline protection schemes include groins on Victoria Island near Lagos (Nigeria) (Figure 33) but also beach nourishment, sea-walls in Dakar (Senegal), groins on Jamestown Beach and revetments on Labadi Beach both near Accra, offshore breakwaters in Conakry (Guinea), St. Louis and Rustique (Senegal). “Local” methods are bulkheads, sand-mattresses and -bagging in Brass (Nigeria), timber groins, Chicoco blocks, wooden bulkheads and afforestation (Figures 31–34).

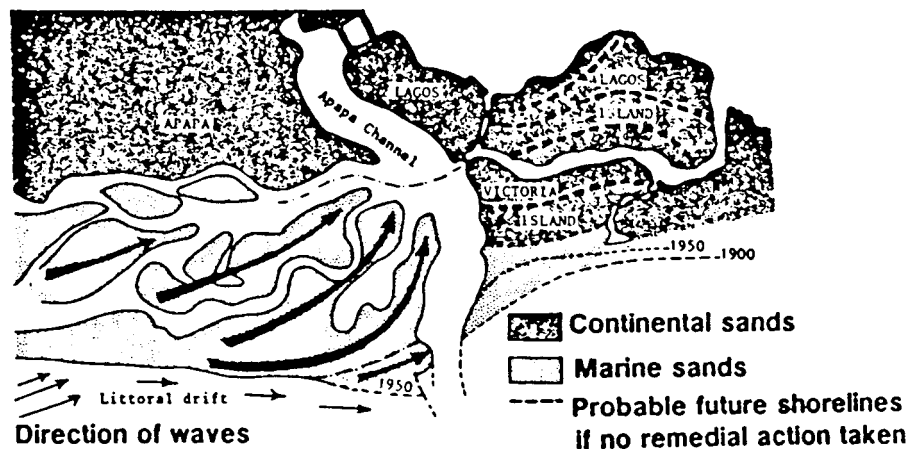
Figure 32. Shoreline shift, Victoria Beach Lighthouse, Lagos. After M. Akle, "Problèmes d'érosion côtière dans le Golfe du Bénin," *Siren* 29 (September 1985): 20-31.

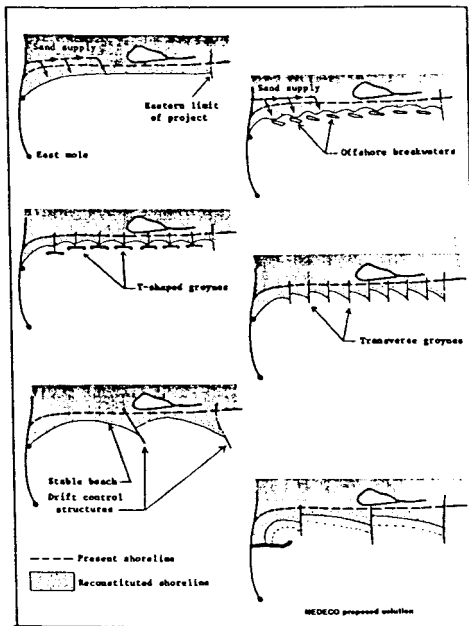
Figure 34. Proposed protection scheme for Kpémé and Anécho (Togo).

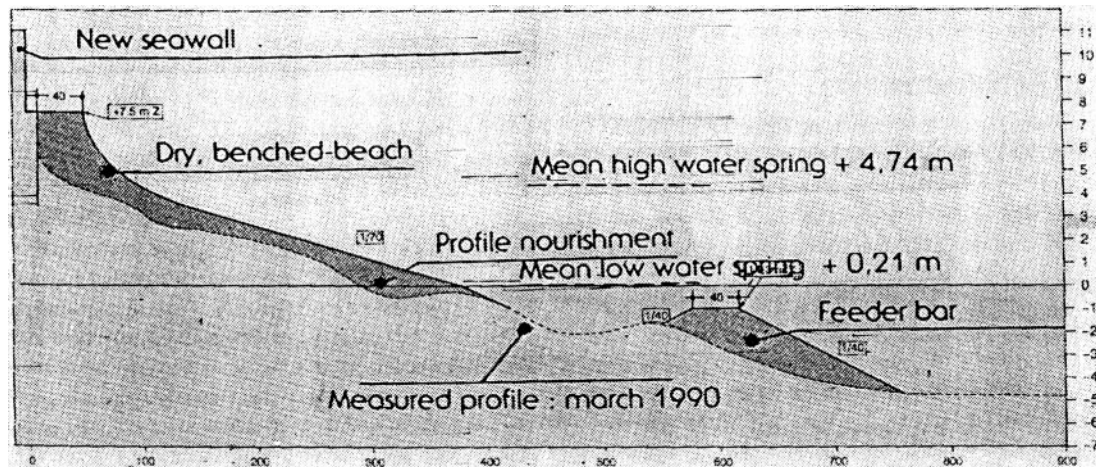
Figure 35. Relative position of feeder bar, beach and dry benched beach (De Haan, Belgium).

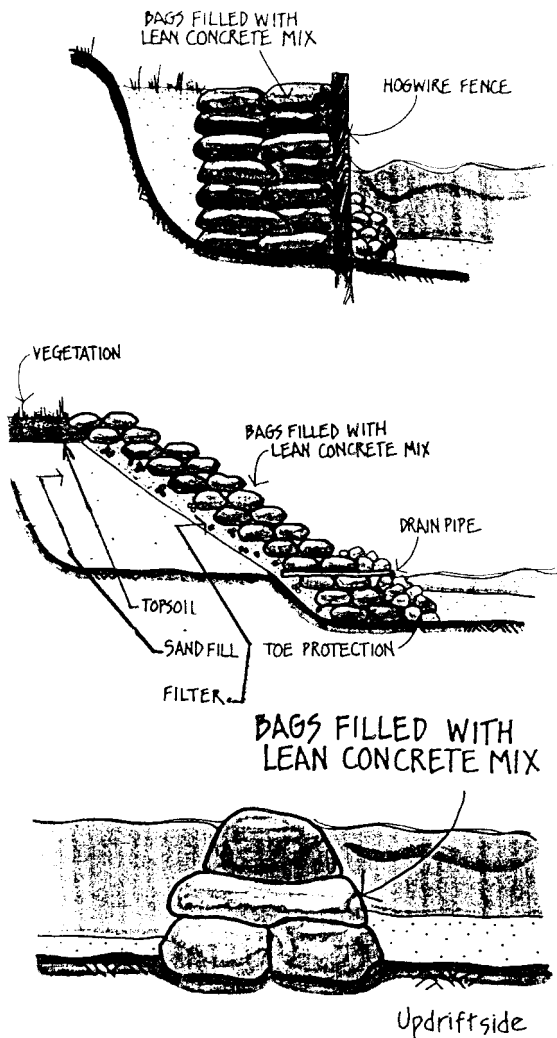
Figure 36. Relatively efficient, slightly sophisticated, in use locally since the fifties, these schemes may be a base for artisanal protection devices in developing countries: using bags filled with lean concrete and held with hog wire fencing an inexpensive “groin” may be constructed, even improved with filter and drain and toe protection. On the right, devices made of H-piles and railroad ties; pile-and-plank; anchored floating tires; a sloping model with concrete blocks or slabs, and rock filter with filter cloth.

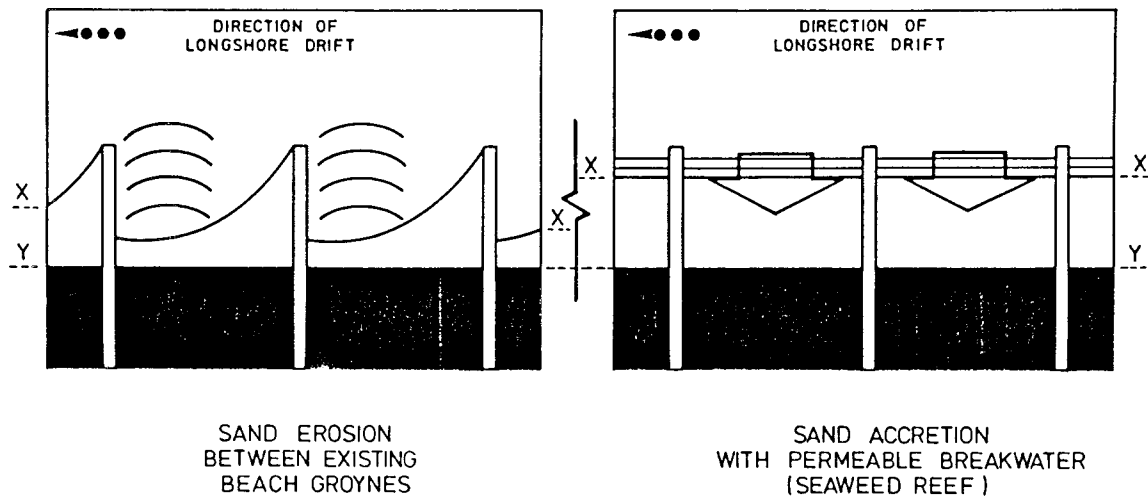
Figure 37. Beach stabilization, scheme with algae.

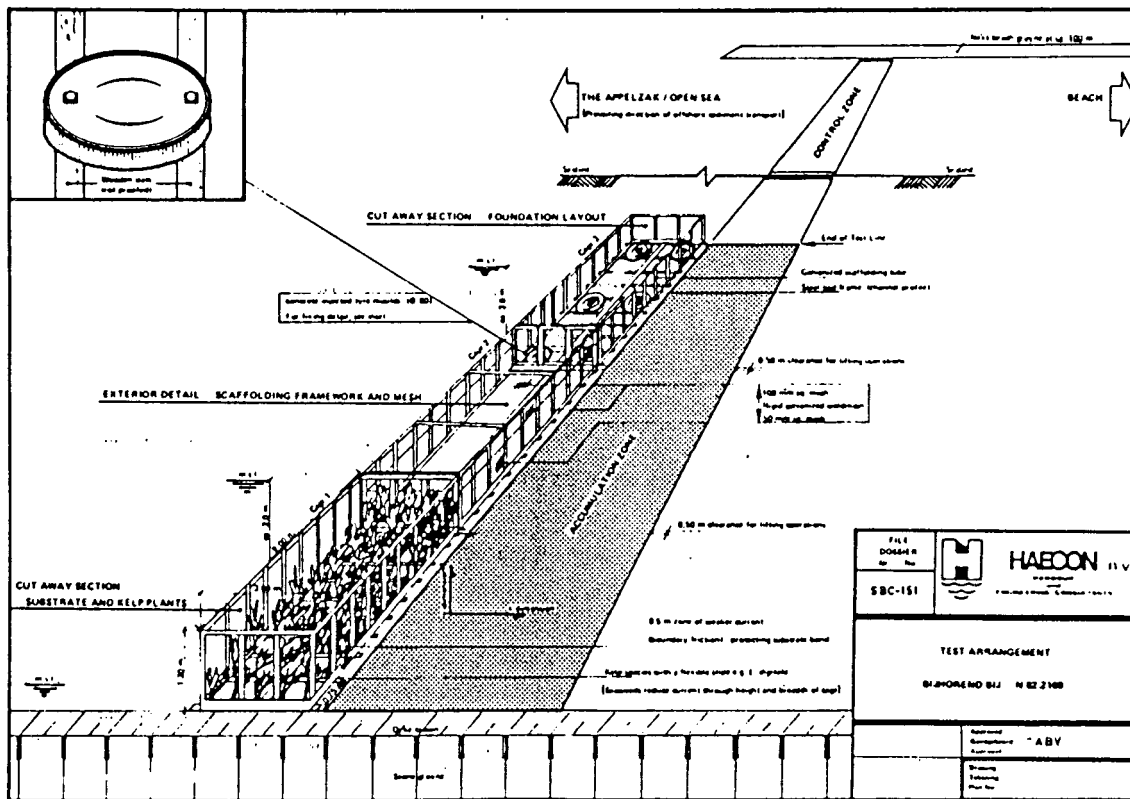
Figure 38. —Cages array for algae artificial reef. Source: HAECON N.V., Ghent, Harbour and Engineering Consultants.

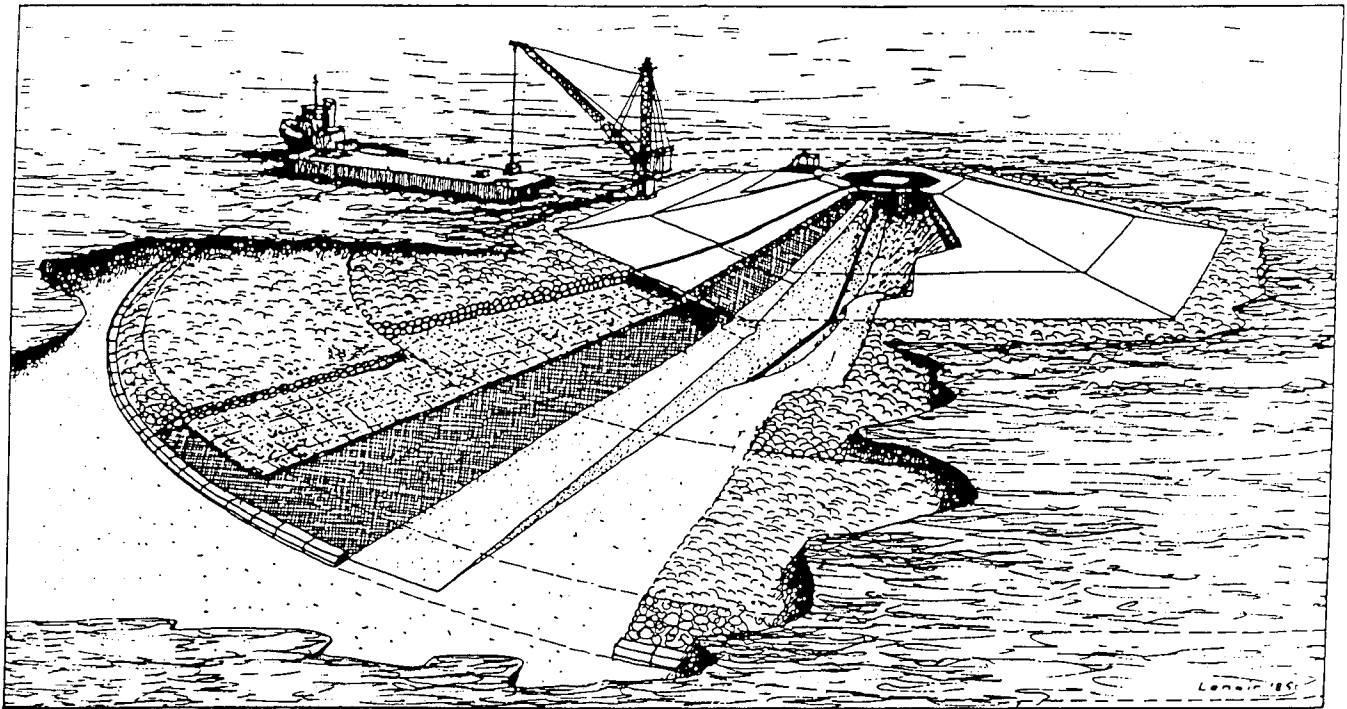
Figure 39. Boskalis Westminster's award winning design for a slope-protected, sand-fill island to be used by the Dutch hydrocarbon company NAM as a pipeline valve station.

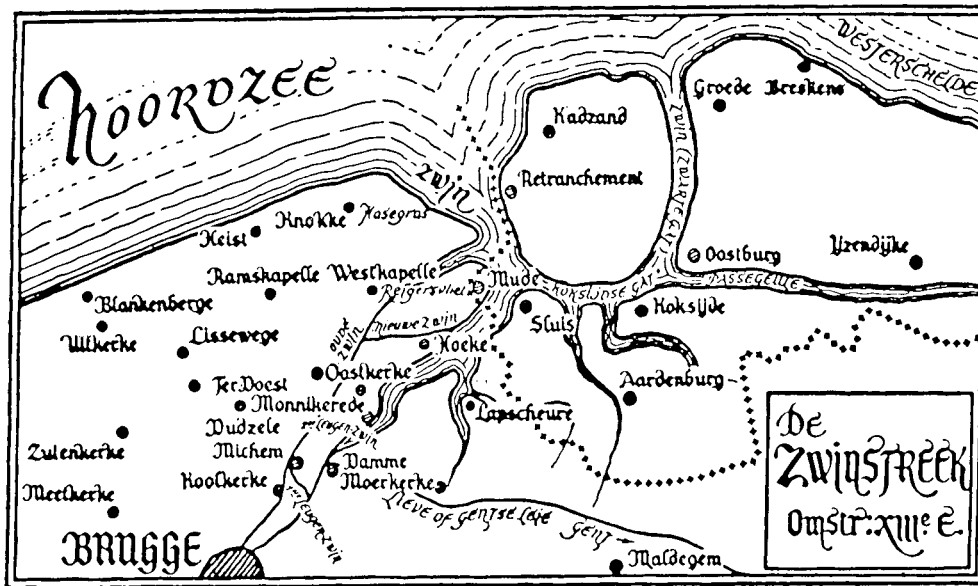
Figure 40. The Zwin Region in the 13th century. The inlet allowed large ships (for the times) to reach Brugge—then nicknamed the Venice of the North because of its wealth, ship traffic and canals (*reien*). Notice the “inland” location of the towns of Knokke, Heist, Blankenberge, e.g., currently on the shore, prior to the subsequent “advance” of the sea; the ++++ boundary, superimposed (not by author) on the original map, is meaningless for a 13th century document, it represents the 19th century Belgian-Netherlands State boundary. (Translations: *Noordzee* = North Sea; *Westerschelde* = Western arm of Scheldt River; Brugge = Bruges; *Lieve of Gentse Leve* = Ghent branch of Lys River).

largest beach-nourishment project in the world in Heist-Knokke-Zoute, Belgium has been monitored since its completion? Conclusions are satisfactory and convincing for the Authority concerned. In this regard on the Belgian-Dutch border, the Zwin natural channel access that once linked Bruges and the North Sea, now an ornithological reserve, and already merely a deep coastal indentation, is further silting progressively. Beach nourishment nearby on the border's both sides may be, partly, responsible. To decide whether to "feed" requires indeed a wide scope inquiry on results, even if these seem to confirm the optimism of teams having tried out the profile approach or laboratory tested soft methods. (De Wolf *et al.*, 1995; Arwosika, 1997; Johnson and Johnson, 1997) (Figure 40).

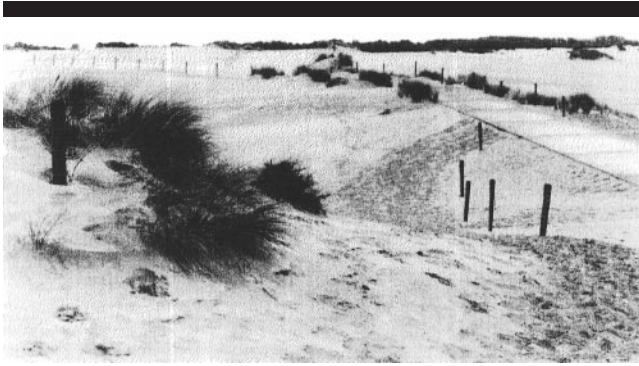
Figure 41. Entrance channels provided for the sea into the dunes where once armored seawalls had toe protection. Photograph courtesy Flemish daily from Ghent; Belgium “Het Volk”.
